ALTOGETHER ARCHAEOLOGY  
MODULE 9-D REPORT

**NENTHEAD LEAD MINES,  
NENTHEAD, CUMBRIA**

NENTHEAD LEAD MINES, NENTHEAD, CUMBRIA  
COMMUNITY ARCHAEOLOGY PROJECT

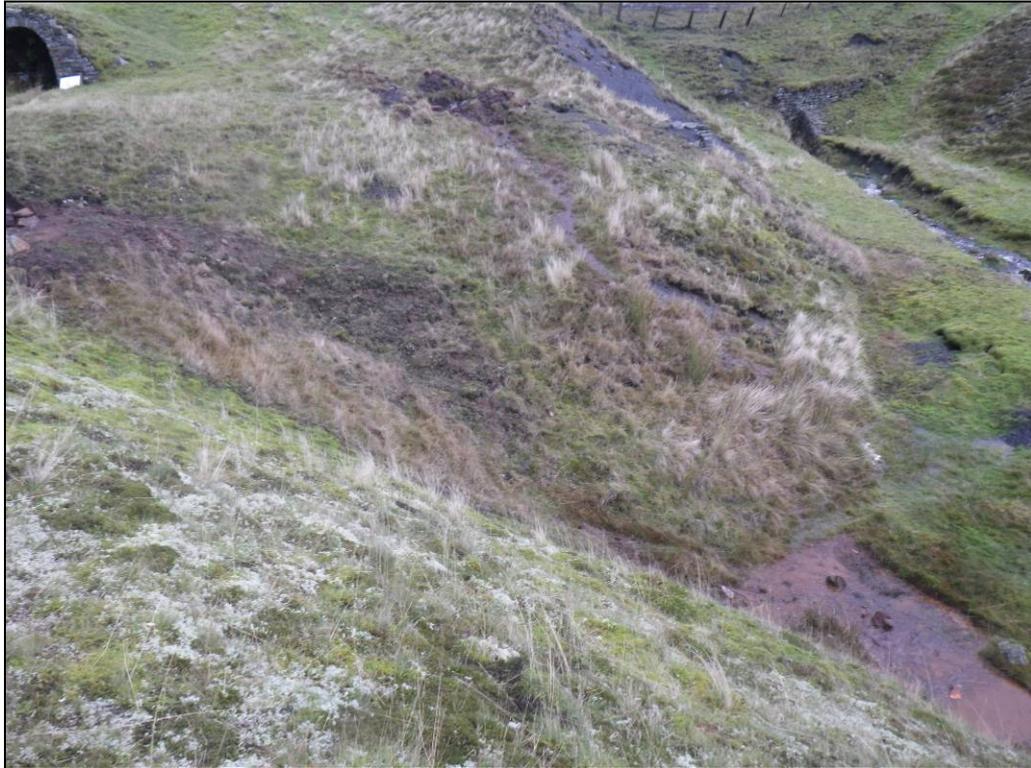
- 10.32 Two vulnerabilities were noted along the length of leat (2615, Plate 10). The entire length of the structure was overgrown and choked by long grass. The section towards the mouth of Firestone Level had collapsed completely blocking the line of the leat.
- 10.33 The exit of the leat, adjacent to the spoil heap, was causing water to wash down the hill and pool in large quantities at the bottom, similarly to leat (0029) in this location. This is carrying spoil from the Firestone Level into the burn, which, whilst probably not toxic, could block culverts further to the west, dragging more toxic material at this point.

*Plate 10: Water pooling at base of hill from leat (2615), to the left of the image, and water from leat (0029) at the centre of the image.*

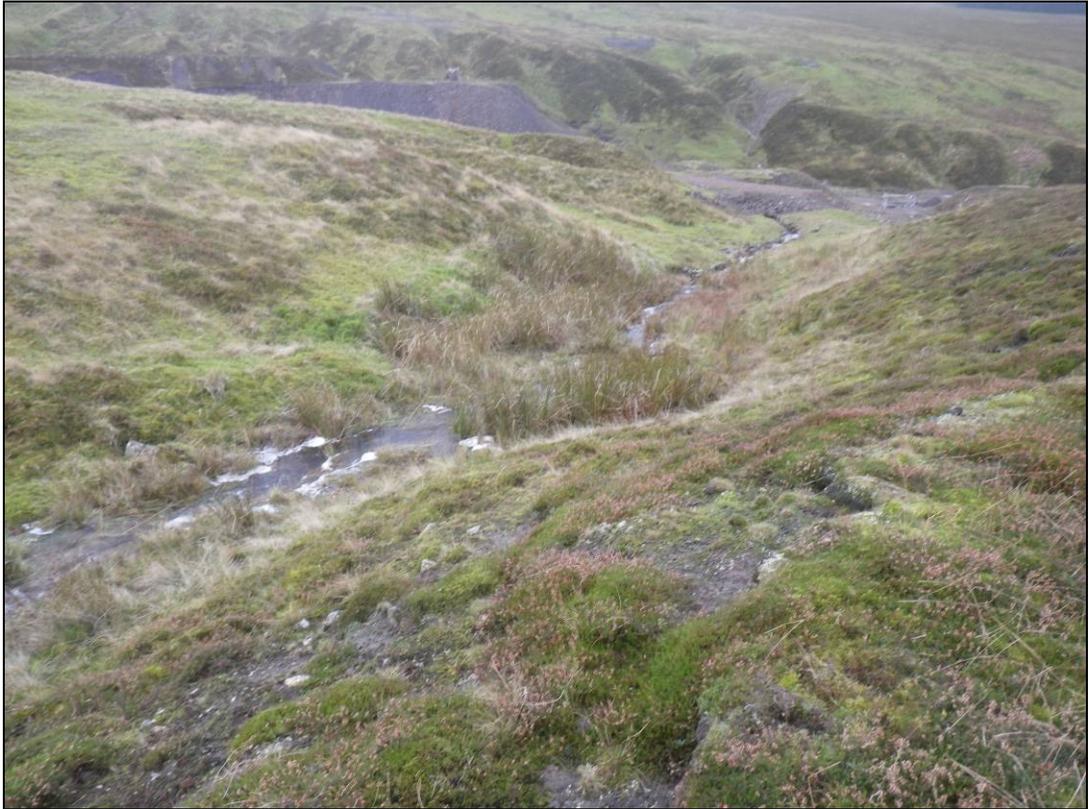
- 10.35 Culvert (2439) has numerous areas of vulnerability across its entire length. The structure is now heavily choked by long grass and weeds and is blocked by rubble from culvert (2440) all along its length. Some of the rubble probably relates to the later construction of pipeline (2442) used to feed the plant in Brewery Shaft from Handsome Mea, which cuts across this feature and was carried over a bridge.

*Plate 11: Water flowing from culvert (2439) down to culvert (2462).*

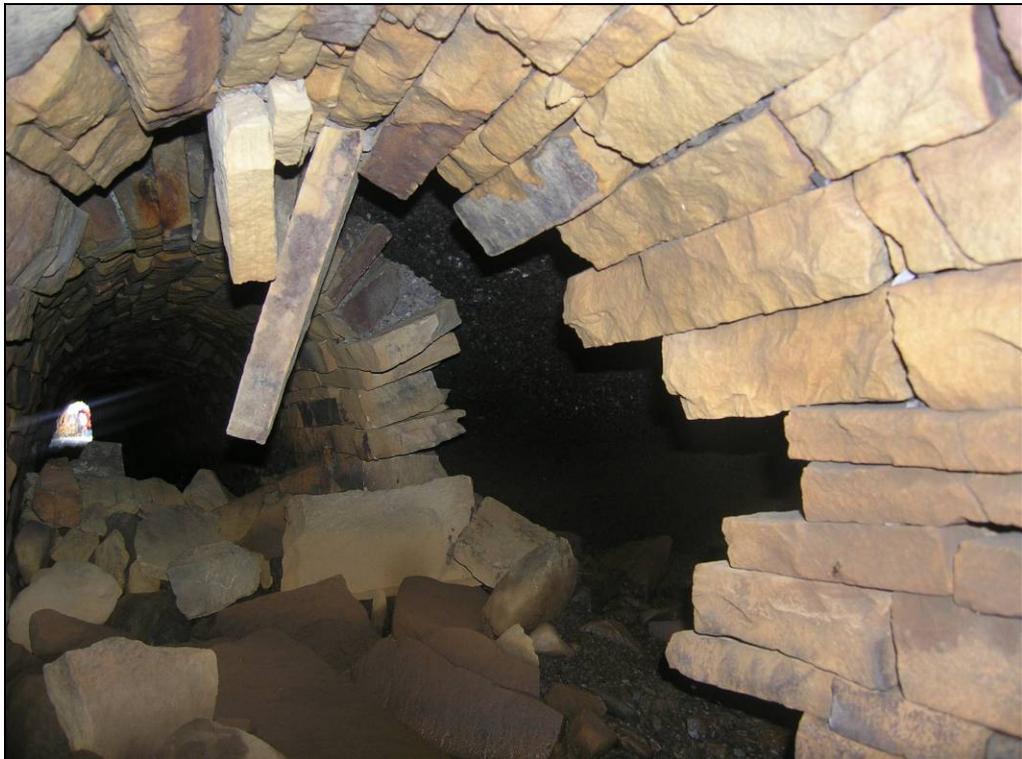
*Plate 12: Collapsed section of culvert (2462). Note large void behind collapse.*

- 10.36 The majority culvert (2462, Plates 11 and 12) is in good condition however, towards sluice gate (2619), the vaulting of the culvert has collapsed (Plate 12). The wooden base of the culvert has also been washed away at this point causing water to pool. This pooling has caused the surrounding gravel deposits to slowly wash away and undercut the supporting walls of the arch. As a result the collapse of the vaulting had created a significant blockage causing water to pool further up the line of the culvert. If left unattended this will cause further collapses of the vaulting.

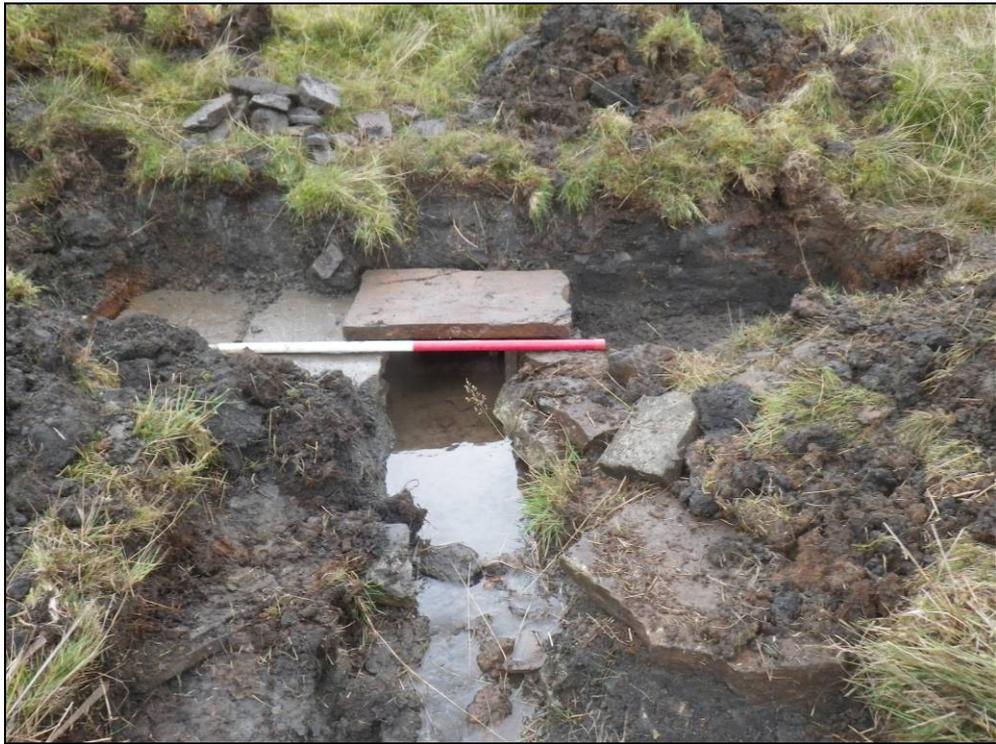
*Plate 13: Trench 1 showing leat (0029) diversion facing northeast.*

- 10.38 The trench showed that leat (0029) had been deliberately diverted away from its original course along where the launder would have spanned the gap across the burn. The leat joined the ditch leading to the launder and has been deliberately blocked by the placement of capping stones on edge in the ditch. This has caused the water to be diverted down the hill.
- 10.39 The purpose of this diversion is uncertain, but was probably done to stop water flowing over the

- 10.40 The water flowing out of leat (**0029**) at this location is not currently causing any damage to existing structures, but is pooling in large quantities at the base of the slope. This is causing the area beneath to become waterlogged. A potential solution to this problem could be the reinstatement of a timber launder across the burn, so that water can return into leat (**0029**) and then pool into a soakaway.
- 10.41 There are no blockages within the line of the leat exposed by Trench 1. No further work is recommended on this section of leat.

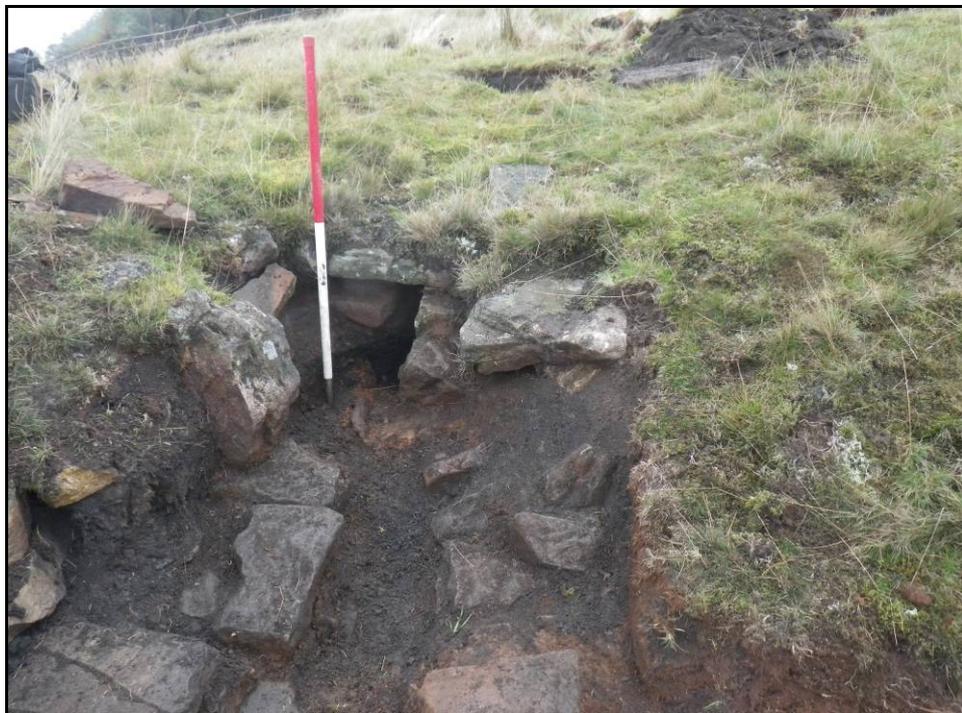
Plate 14: Trench 2 showing exit of leat (**2615**) facing northwest.

- 10.44 Not much of the original leat structure survived within this trench. Water exiting at this point has washed away the end of the structure and further erosion is highly likely. It is recommended that the

structure at the end of leat (**2615**) is reconsolidated to prevent further erosion. If further erosion occurs it is likely that the water will start bringing debris from Firestone spoil heap down the side of the burn and into the natural watercourse.

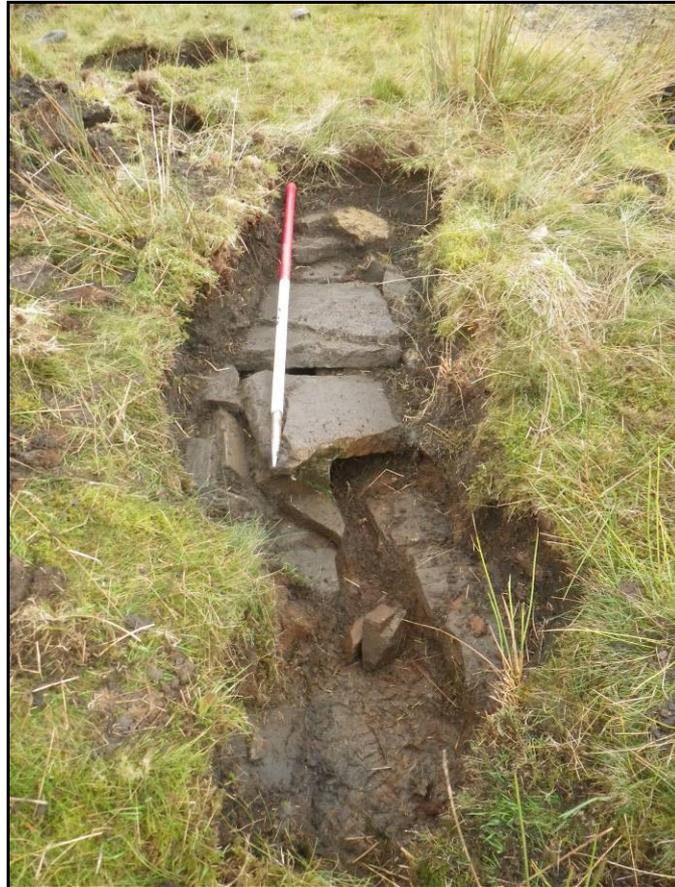
- 10.45 Trench 3, Plate 15, was located at the entrance of Firestone Level at NY 78743 43497. It was investigated to examine water pooling at the mouth of the level. The trench measured 1.00m by 0.50m and the location of this Trench is shown on Figure 5.
- 10.46 Trench 3 was excavated down to reveal the capstones of leat (**2615**). The side walls of leat (**2615**) had washed away on the southeast side. This had caused the limestone capstones to fall in and subsequently have blocked the leat causing water to pool.
- 10.47 It is recommended that reconsolidation work is carried out along this section of leat to rebuild the sidewalls that hold up the capstones. It was unclear why the side walls have washed away, so further investigation is required to understand the cause of the erosion.

*Plate 15: Trench 3 showing leat (**2615**) facing southwest.*

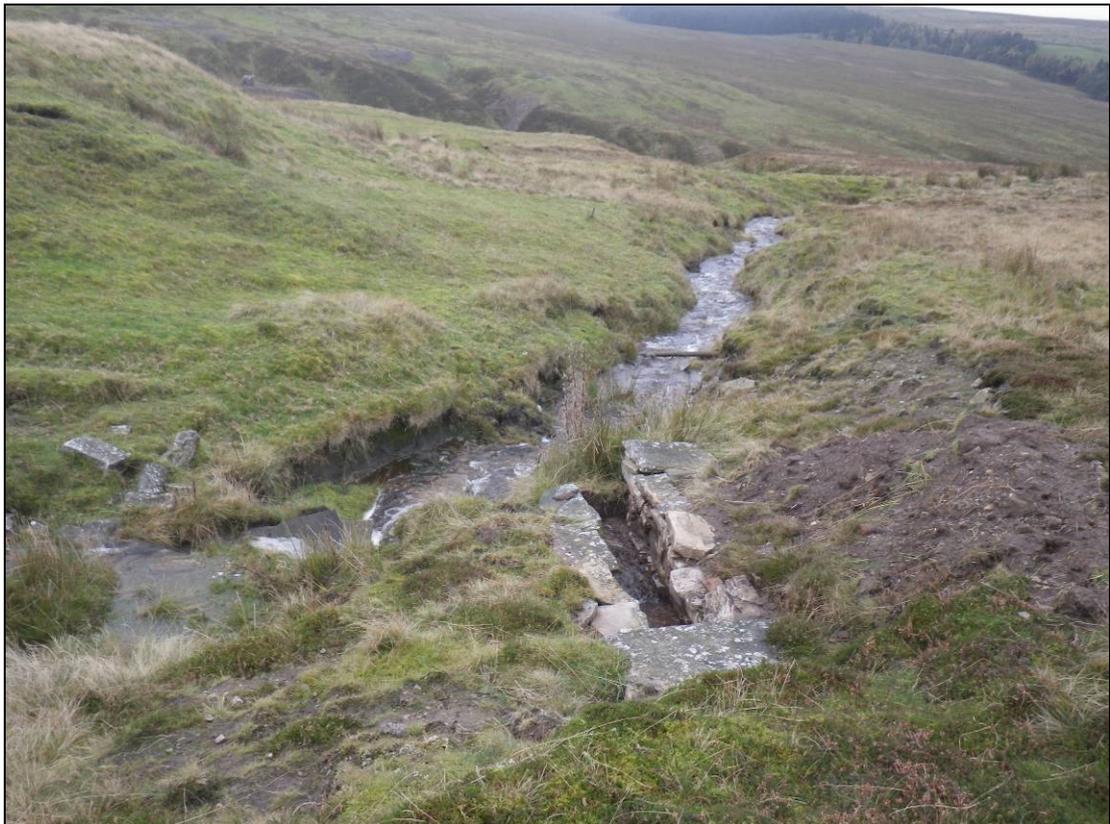
- 10.34 Culvert (2440) is in a fairly ruinous state and has become heavily choked by long grass at its outflow, causing water to pool and wash away the side and retaining walls of the culvert outfall. This has subsequently caused a major collapse of the retaining walls which have blocked the line of culvert (2439, Plate 11).

*Plate 17: Culvert (2440) facing southwest showing collapsed retaining walls.*

- 10.51 The blockage in the culvert comprised soil and fallen stonework. This was cleared by hand as far as practicably possible. It was noted that culvert (2440) is blocked further upstream towards (0032). A significant patch of long grass was not removed at the mouth of culvert (2440) due to its density and is subsequently causing a blockage.

- 10.53 It is recommended that further work is needed around culvert (2440). Large amounts of debris from the collapse of the retaining walls needs to be cleared to allow water from the reservoir to flow freely. Currently the overflow from the reservoir is washing over the wing wall debris and is further washing the bank away from culvert (2440). In time this will cause the leat to collapse. It is further recommended that culvert (2440) is reconsolidated after the debris is cleared to reinstate both retaining walls.

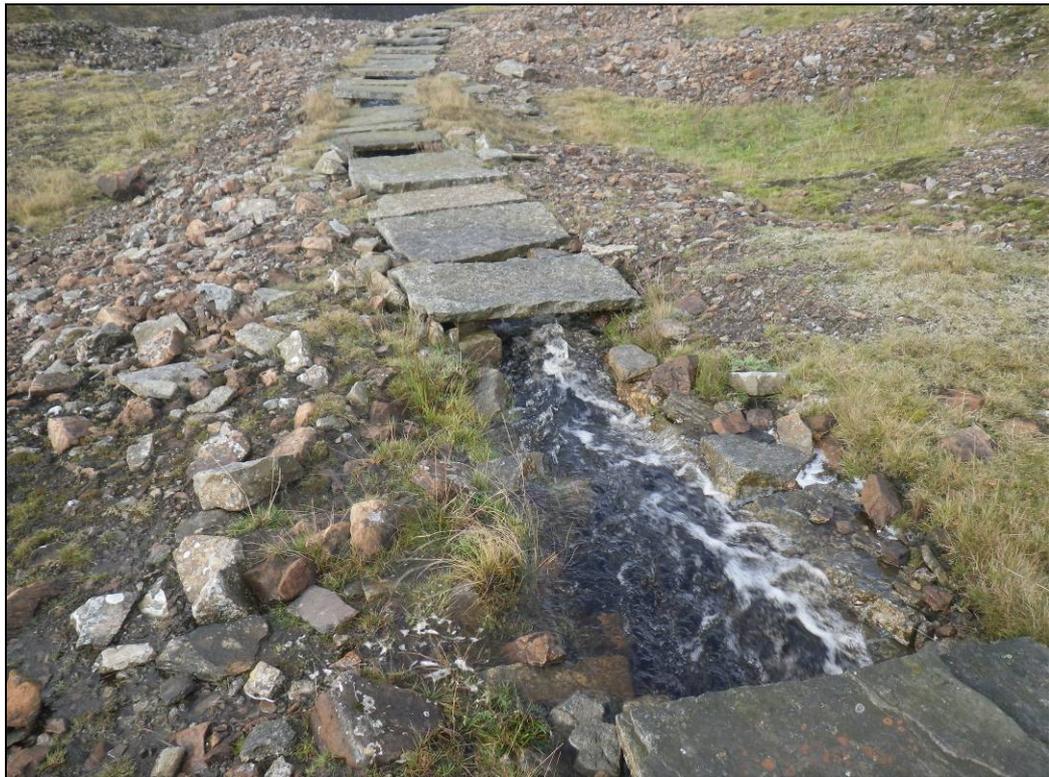
- 10.73 Following a period of heavy rainfall it was noted that leat (0010) was overflowing in the section between overflows (2580) and (2617). This was causing water to pool to the south, which if left unchecked could cause damage to the trackside leat.
- 10.74 A general loss of capstones has been noted across the length of the leat. Although not an immediate problem, the replacement of these missing capstones would help to limit the amount of debris falling into the leat.

*Plate 23: Leat (0010) struggling to cope with amount of water flowing through it. Notice water flowing out of the leat to the left of the image.*

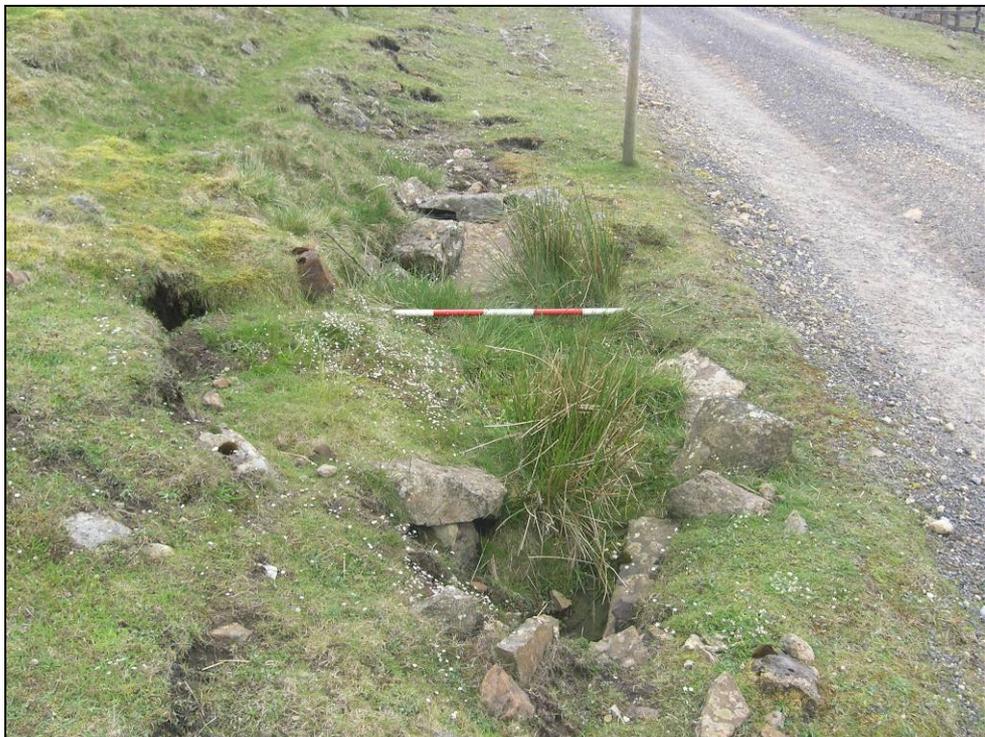
Plate 30: Collapse of leat (2460) adjacent to valve housing.

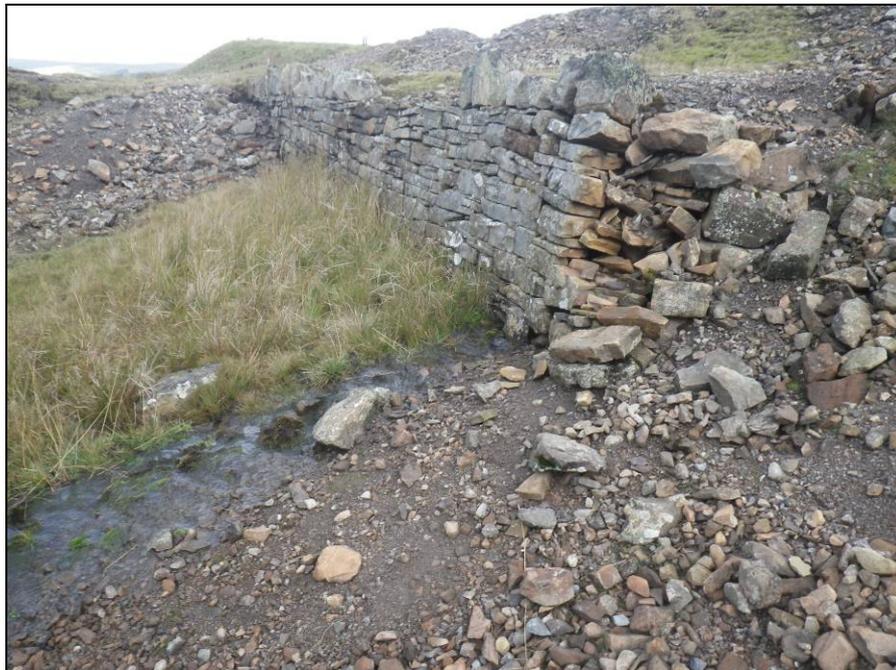
- 10.94 At the south eastern end of the trackside leat, directly beneath Handsome Mea, water was poaching through the base of the retaining wall from a soakaway created during the partial construction of the car park to the south of Handsome Mea, see Plate 31. This water was then flowing down slope to the southwest. Although unproven, this area of land is thought to be the location of a dressing floor and any water cutting across this area could potentially drag dressing waste into the natural watercourse. If left unattended water poaching through the wall could either completely undercut the structure causing it to collapse, or potential dressing waste could be dragged into the natural watercourse to the southwest.

*Plate 31: Water poaching through base of retaining wall and heading down slope to the southwest.*

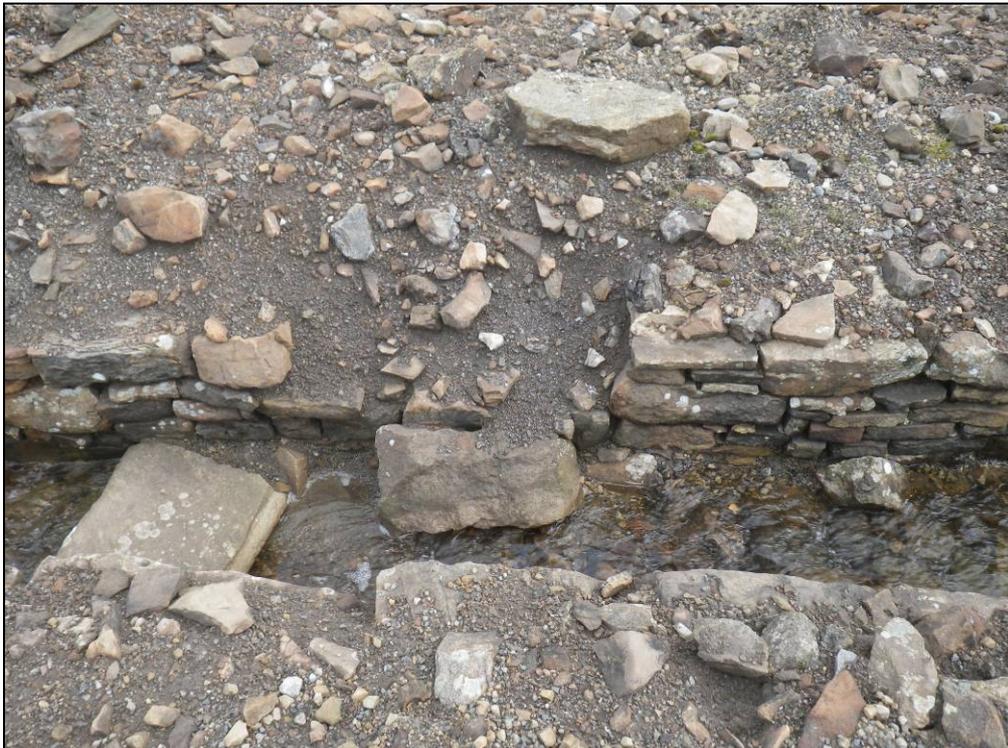
- 10.97 Numerous issues with the side walls of leat (2460) were identified during the survey. Various sections had begun to bulge along the north-eastern wall. This was probably caused by the pressure of the spoil heaps pressing up against the walls. Some of these sections had collapsed causing blockage issues and other sections were bulging inward slightly (Plate 32).

*Plate 32: Collapsed section of side wall.*

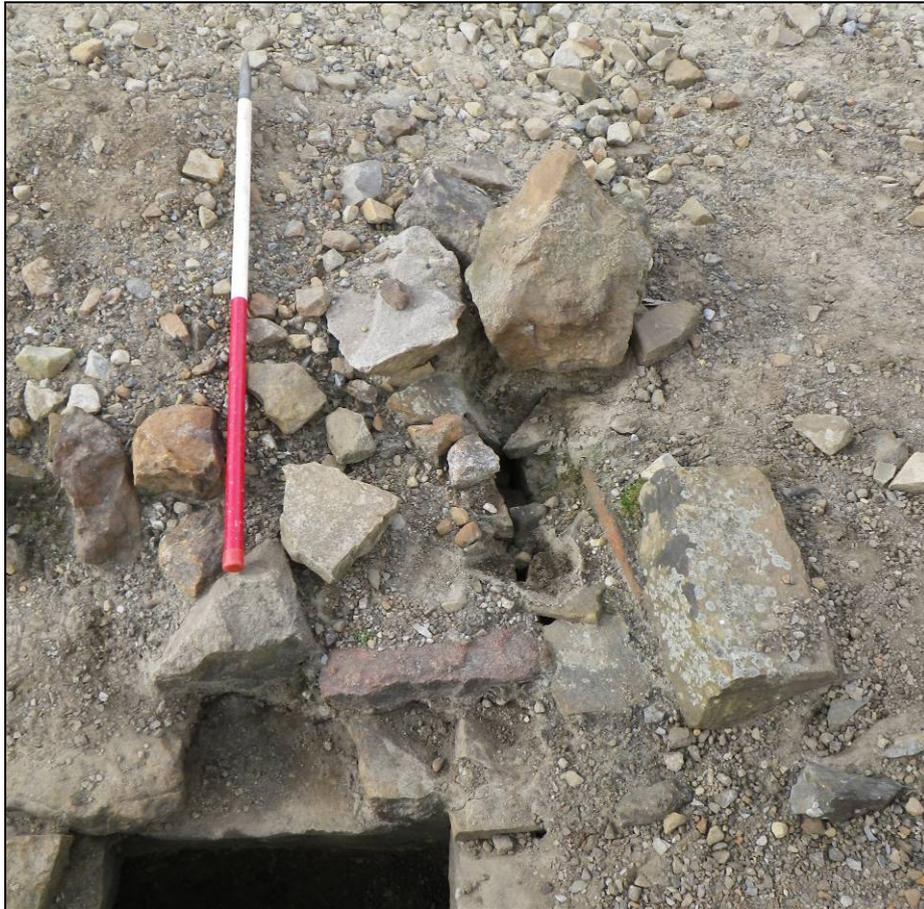
underneath the track way has been repaired with brick at some stage and is shown in Plate 33.

*Plate 33: Brickwork repair to leat (2620).*

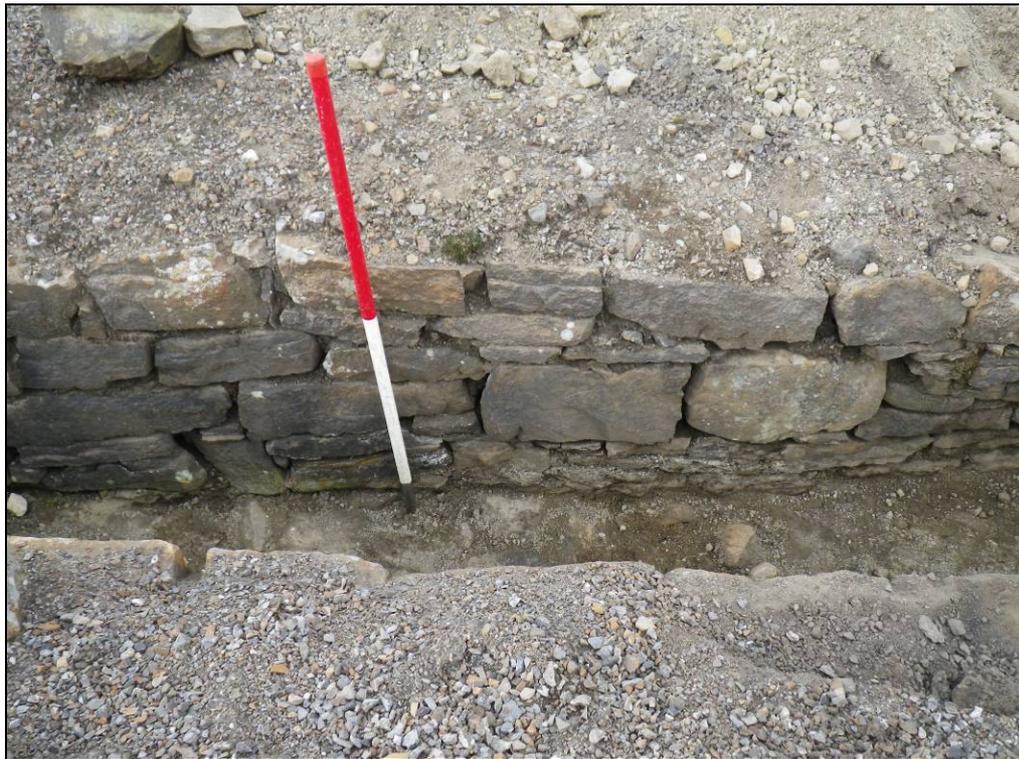
*Plate 36: Trench 13 showing leat (2460) with section of bulging wall to left of scale.*

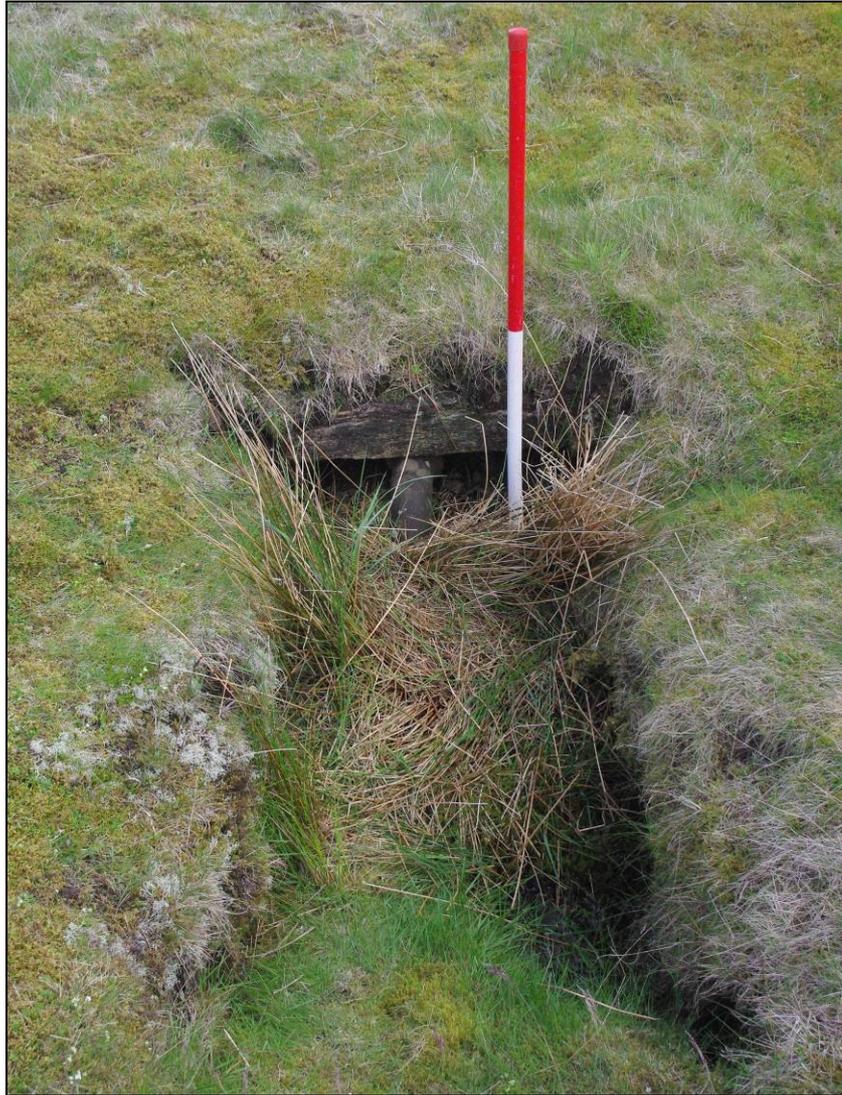
*Plate 43: Sump (2621) heavily choked by long grass and weeds.*

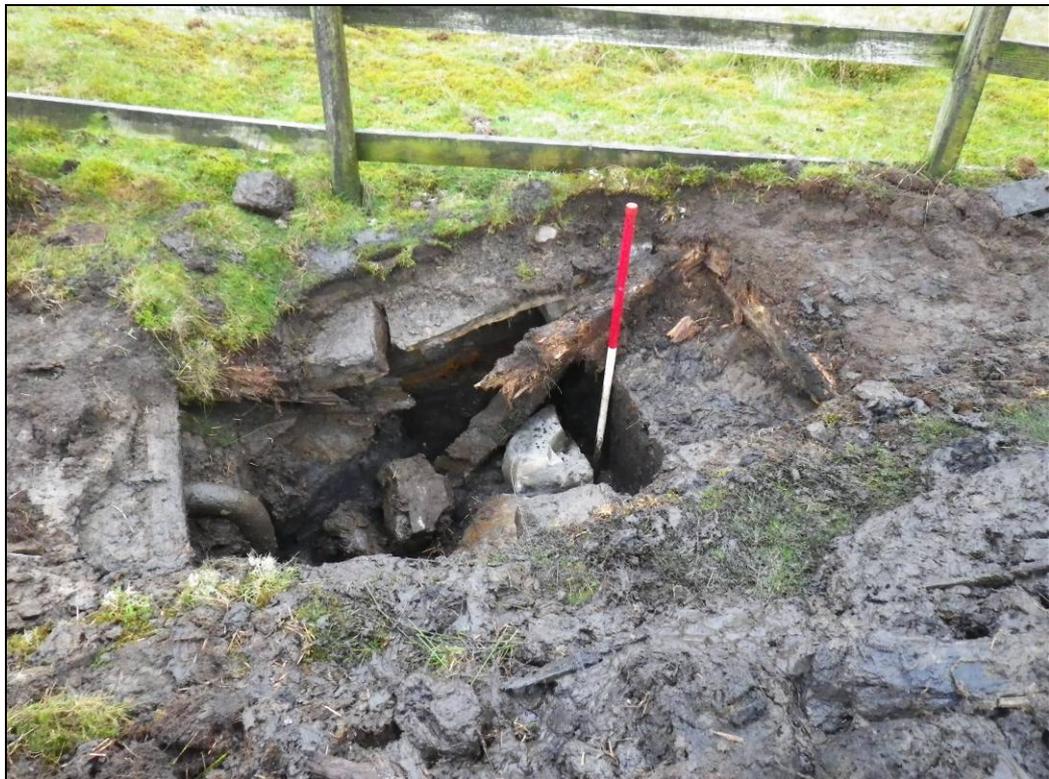
*Plate 47: Mid-excitation shot of collapsed support beam.*

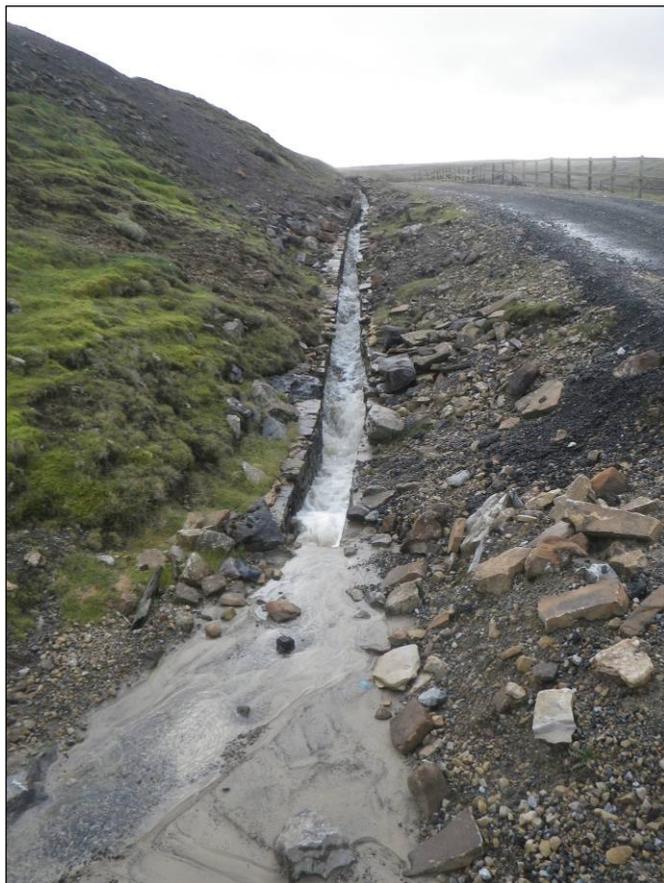
*Plate 53: Water diverted into leat (2462) from sluice gates. Note water pooling on surface and flowing into leat at bottom of image.*

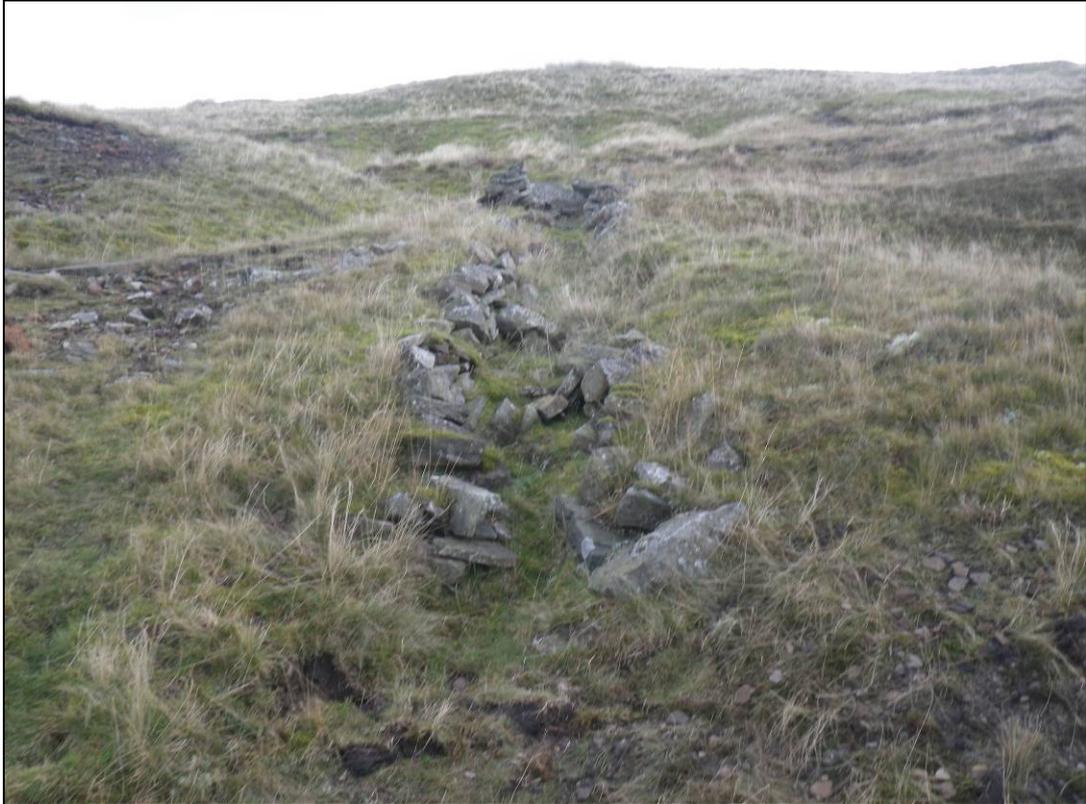
*Plate 54: Disused overflow leat (2617), facing east. Ditch can be traced joining road at bottom of image.*

- Reconsolidation of overflow leat (2617). This is currently in poor condition and vulnerable to collapse through natural erosion.

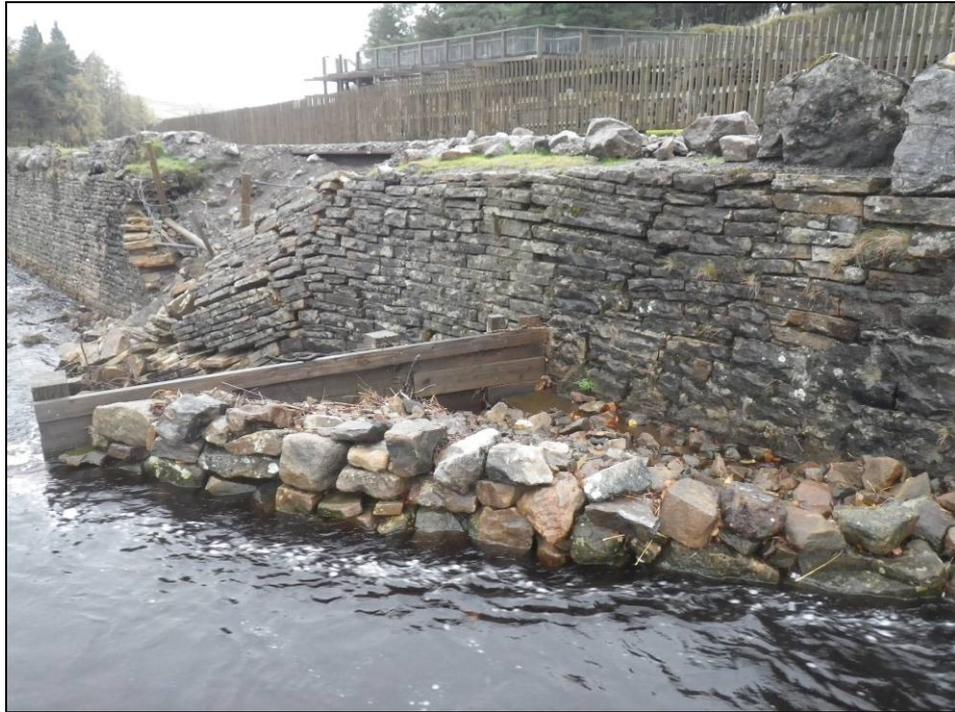
*Plate 62: Main flow of water diverted away from collapsed section of retaining wall.*
