The Possible Roman Road at Kirkhaugh, South Tyne Valley

Excavation Report, Sept 2022

ALTOGETHER ARCHAEOLOGY

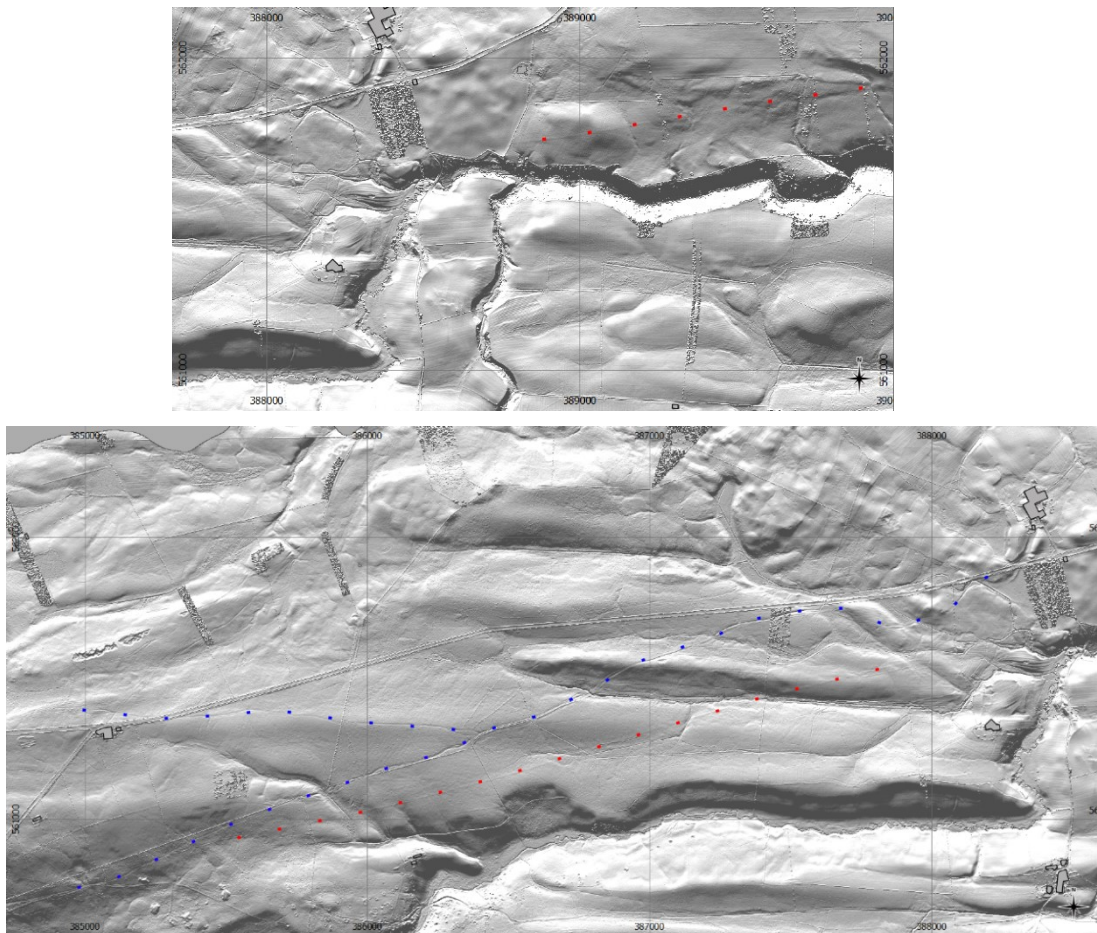
Figure 3: The sections of the road to the south-west of Hexham, Roman road marked by red dots and OS grid shown. At top: Eastern section. On right: Western section.

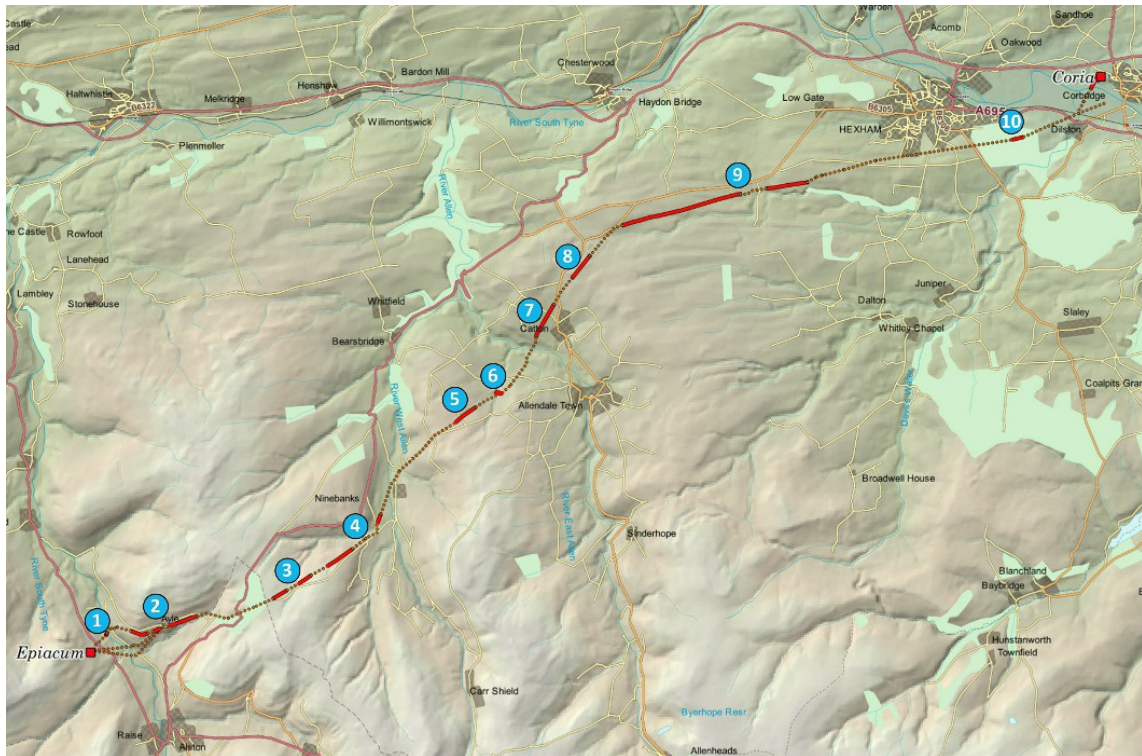
**Figure 4: The map of the Roman road by the RRA (Toller and Haken 2017).
The AA 2016 excavation examined the two sections labelled “9”. The Kirkhaugh section is “2”.**

The sections marked on this map are of varying degrees of certainty, but some, such as that near Catton “7” (see below) and at Kirkhaugh, show well on lidar, see Figure 5 (below).

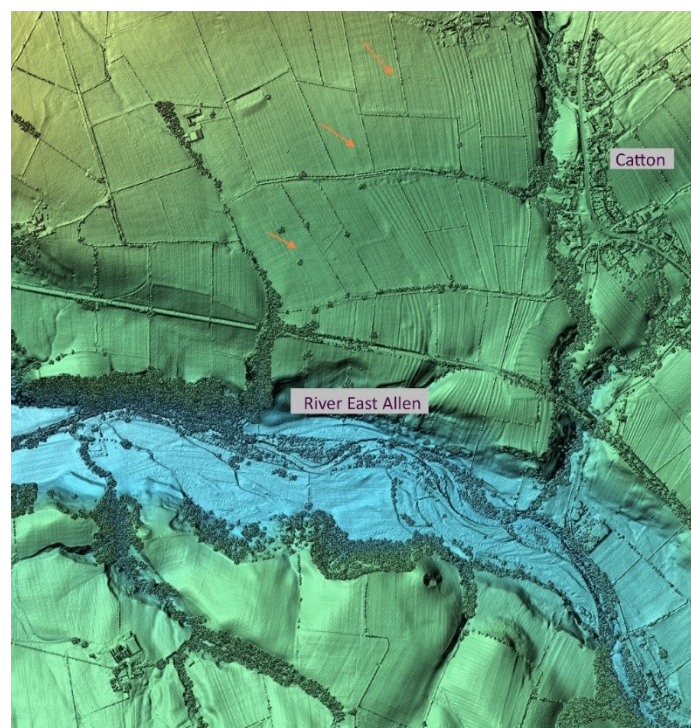
**Figure 5: Lidar image of the section of possible Roman road near Catton (orange arrows).
Lidar DSM local elevation mode. Image by Stephen Eastmead.**

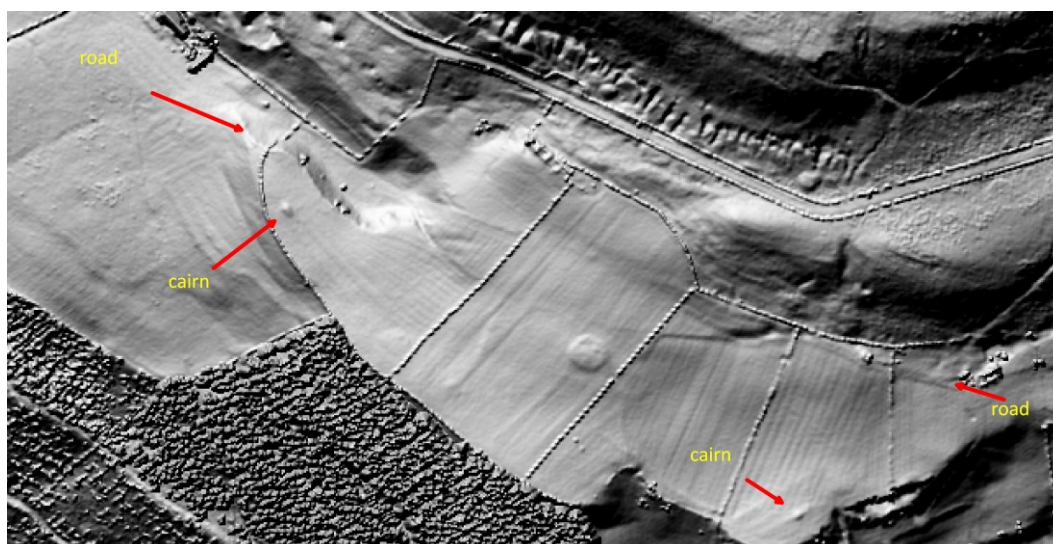
Figure 6: Lidar image of the section of possible Roman road near Kirkhaugh.

Lidar local-relief mode. Image by Stephen Eastmead.

The lidar image of the Kirkhaugh section shows it running along a level terrace at about 340m altitude on the hillside above Kirkhaugh in the bottom of the South Tyne valley. This section is about 400m long, of which the eastern half is beside or under field walls. Also shown on the lidar image are the Bronze Age cairns and the minor modern road to Ayle, running between stone walls 70m north of the Roman road. At the top of the image a line of pits runs along the hillside: These are labelled on the first edition (1860) Ordnance Survey map as coal pits, but on the second (1895) as lead workings. It is probable that they were coal pits as they run along a horizontal seam, outcropping on the hillside. Nearby at Ayle, coal-mining continued into the 21st century.

The road, seen on lidar, is in general a ridge approximately 6m wide, sometimes with roadside ditches. This ridge looks a possible “agger”, the causeway which provided the base for Roman roads. The details of Roman road construction varied between sites, at least partly depending on local availability of building materials: this is discussed in more detail in the 2016 excavation report (Green 2016). Although the section south of Hexham proved on excavation to have a width of about 6m between kerbstones, other sections of the same road would not necessarily have the same form.

As well as the two cairns to the south of the possible road, there is a flat-topped round turf-covered mound, seen midway between the two Bronze Age cairns (Figure 6) at NY70734921. It is 23m in diameter and has at least one small mound on its top. It seems to overlie the plough ridging, so when the cairns were investigated this structure was assessed as being a relic of mining (or other industrial process). However, there are no obvious shafts nearby and it is an unusual shape for a spoil-heap. Thus, its nature is unclear. It is close to where two tracks cross on the first edition OS map (Figure 7).

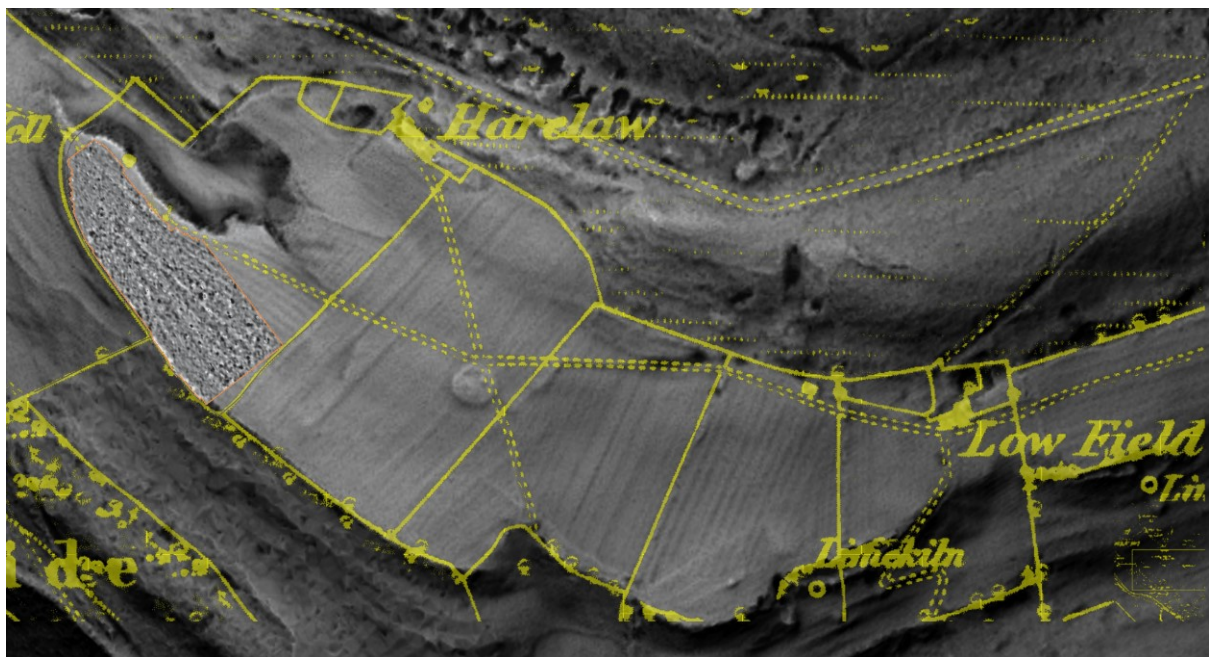
Figure 7: Geophysics survey (outlined in orange) and the first edition OS map (in yellow) superimposed on lidar image (same image as in Figure 6).

Two limekilns are shown on the first edition OS map (Figure 7: SE and SW of Low Field) on the edge of the limestone terrace, presumably using limestone quarried from its face and local coal from the workings on the hillside a short distance to the north. More information can be found at the British Geological Survey www.bgs.ac.uk.

The plan below shows the first edition OS map and the geophysics magnetometry data (bounded by a thin orange line) superimposed on the same lidar image used in Figure 6.

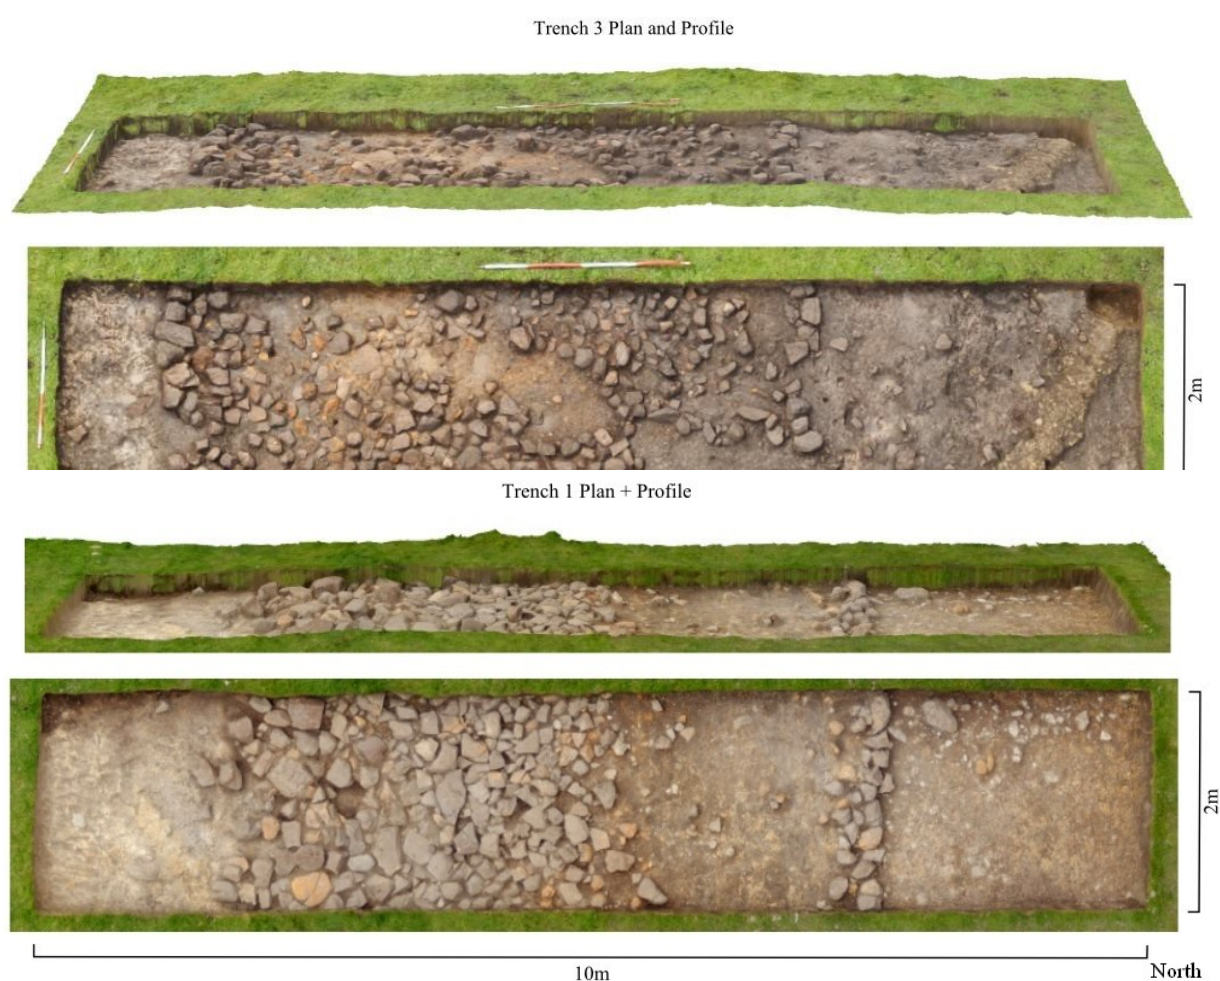
Figure 8: Two of the trenches of the 2016 excavations (from Green 2016). A vertical and oblique photogrammetry view is shown for each trench. Photogrammetry by Stephen Eastmead.

AA's excavation of the road south of Hexham (Green 2016, Green and Finch 2017) consisted of five trenches, each 2m wide, across a 250m stretch of the road. An additional two trenches were excavated across another section of the road 3km further east. The road was immediately under about 20cm of topsoil. The road surface consisted simply of cobble-stones placed directly on the subsoil (presumably after the topsoil had been cleared from the course of the road). No gravel, flagstones, or other surface material was found over the cobble-stones, so the road surface may have been simply topsoil rammed back onto the cobble-stones. In some trenches there was evidence of larger stones acting as kerbstones along the edge of the 6m wide road surface. In Trench 1 only 4m of the gap between the kerbstones had been cobbled, perhaps indicating that the road construction was incomplete: see Figure 8 below.

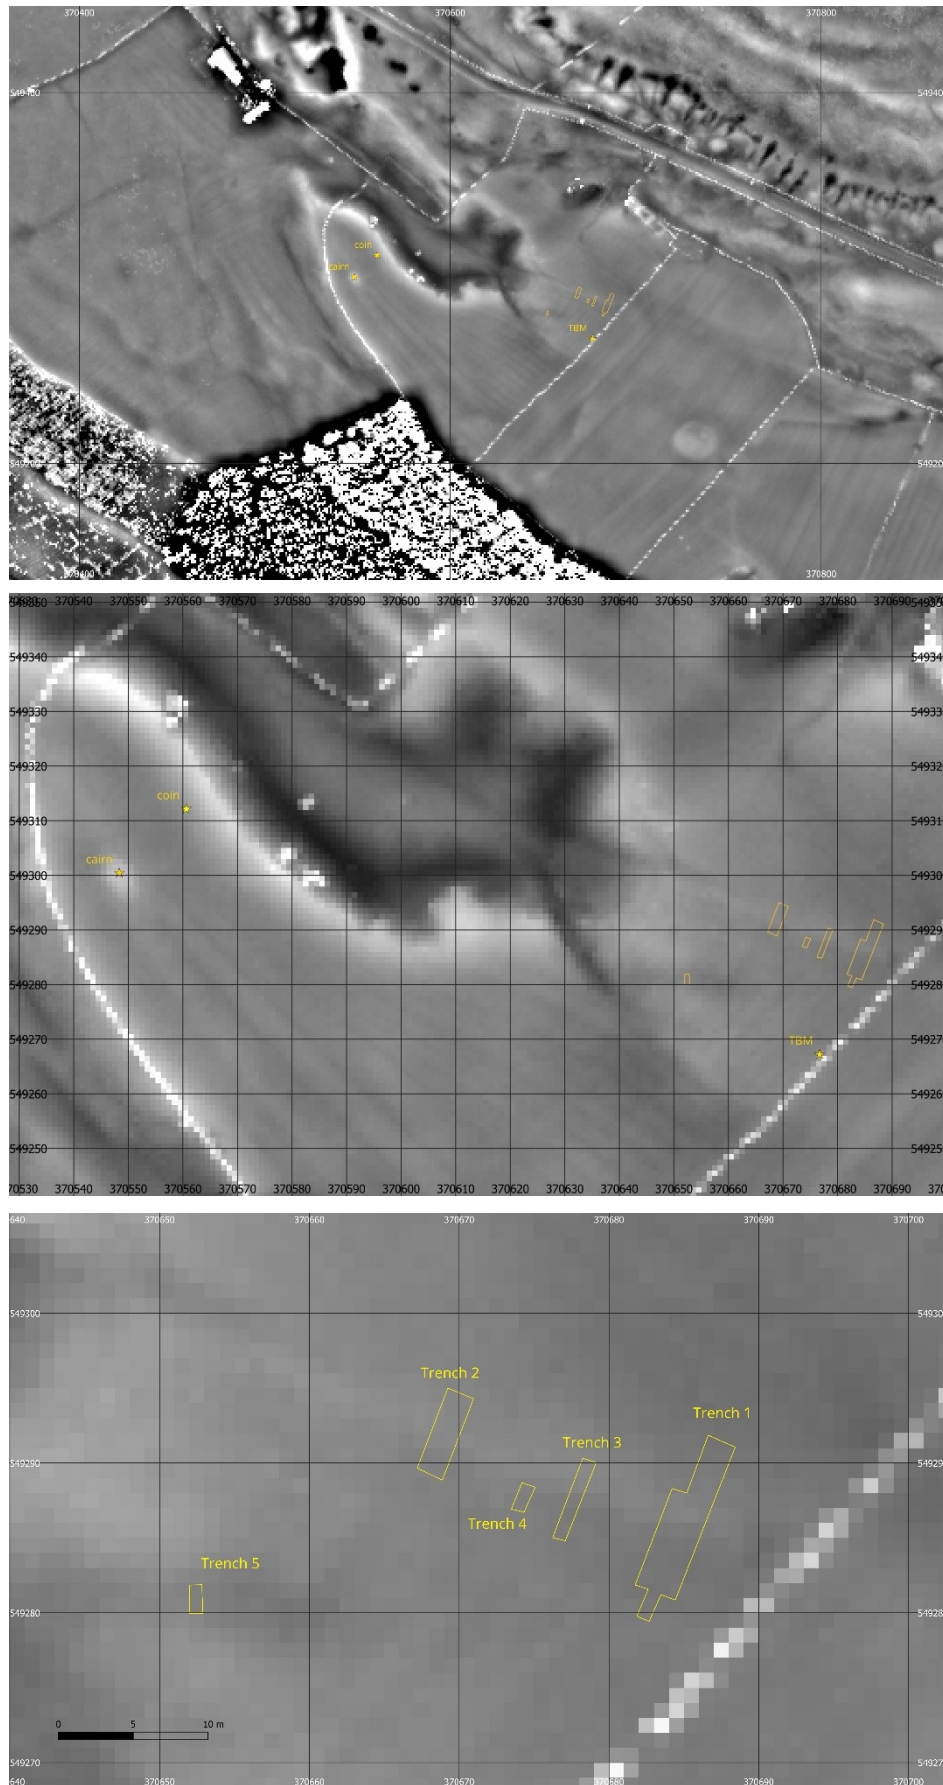
Figure 9: The location of the trenches superimposed on lidar. Successively enlarged views.

Trench 5 was a 2m x 1m test-pit placed across a holloway which ran east-west across the field south of the ridge seen on lidar: see the lowest image in Figure 9. It was excavated to check the possibility that the road had been diverted via this route to make an easier (less steep) descent into the dry valley to the west of the excavation site.

On the lidar image (Figure 9), there is a ridge, a possible agger of a Roman road. Close inspection shows that probably at some time this was a field boundary. On its south side there is a 5m wide blank strip, to the south of which are 30m long cultivation ridges. These are 4m apart and run north-east to south-west (so not at right angles to the “road” ridge). Such narrow straight ridges are normally interpreted as being post-medieval, usually 18th century or later. South of this area of

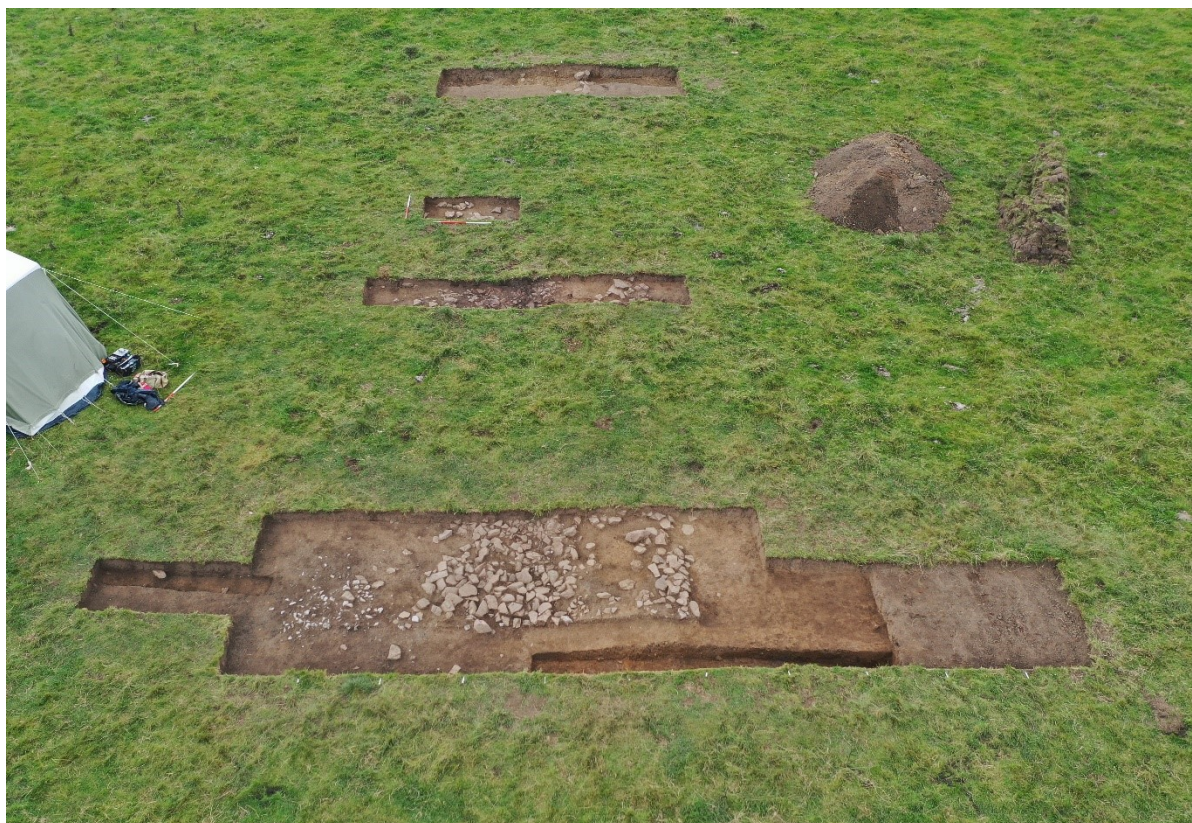
Figure 11: Oblique drone photograph, looking west, of Trenches 1 to 4

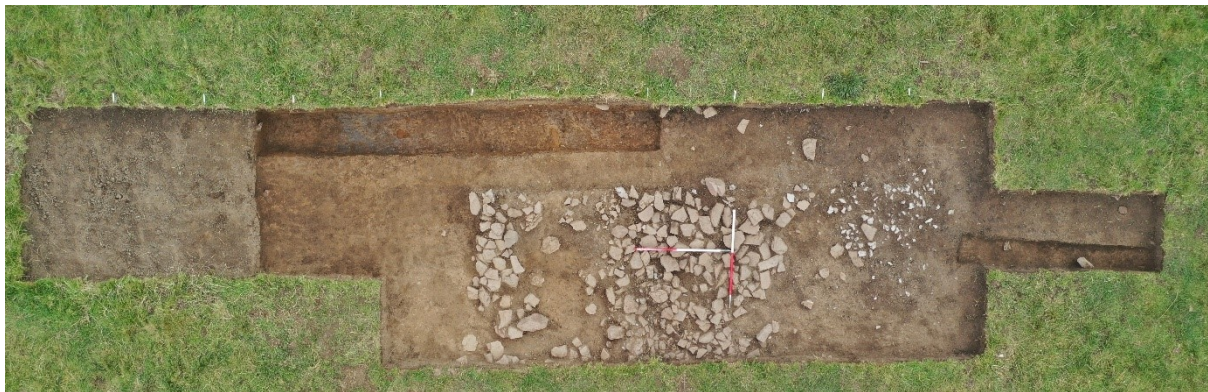
Figure 12: Trench 1 drone photograph on last day of excavation. North is to the left. Stones in the eastern 1m of the trench have already been removed to allow digging of a sondage.

The northern part of the trench was devoid of any features. A sondage was dug on the east side of the trench, crossing the centre line of the lidar ridge. It reached the underlying glacial till natural at about 55cm below the surface. The glacial till 106 was orange clay with small pieces of rotted sandstone and some patches of grey clay.

There was no sign of an agger or any ditches. Another sondage was dug in the southern extension of the trench to determine the thickness of dark layer 105. At the end of the excavation, the stony layer 104 was removed to retrieve any finds and to confirm that there were no underlying features.

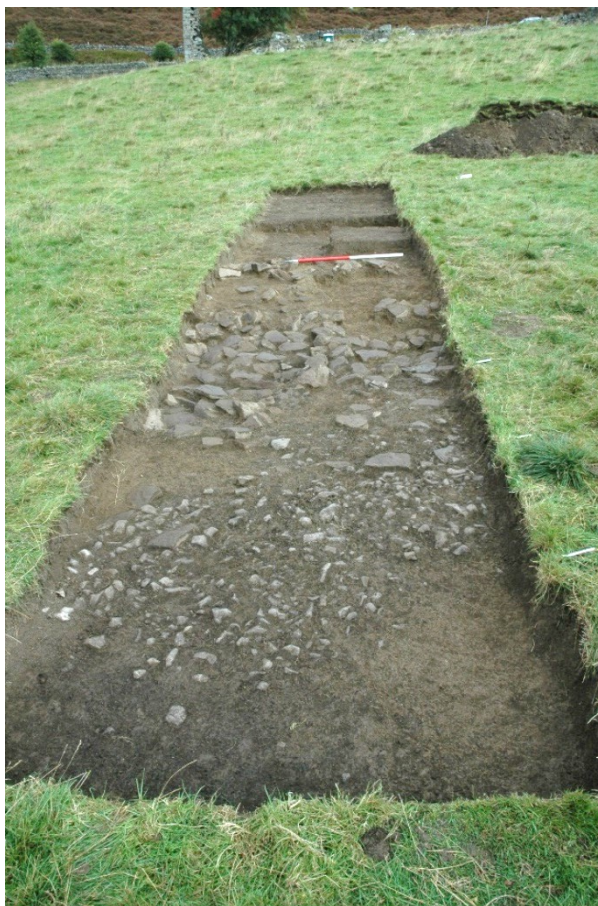
Figure 14: Trench 1, looking north. Photograph was taken before trench was extended westward from 2m to 3m wide, and before southern extension excavated. Nearest the camera is spread of small limestone stones 102. Beyond this is spread of larger sandstone stones 104.

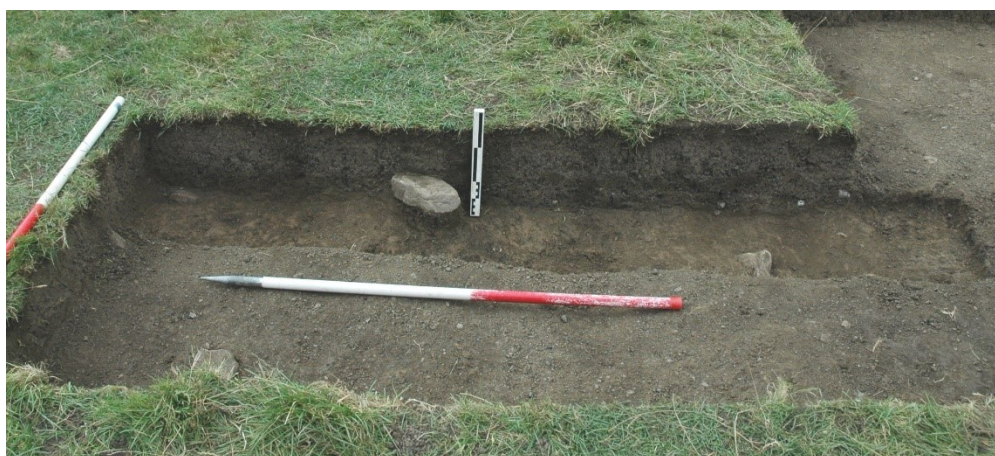
Figure 15: Section along west side of southern extension of Trench 1. The dark coal-rich deposit 105 is seen along the bottom 8cm of the section.

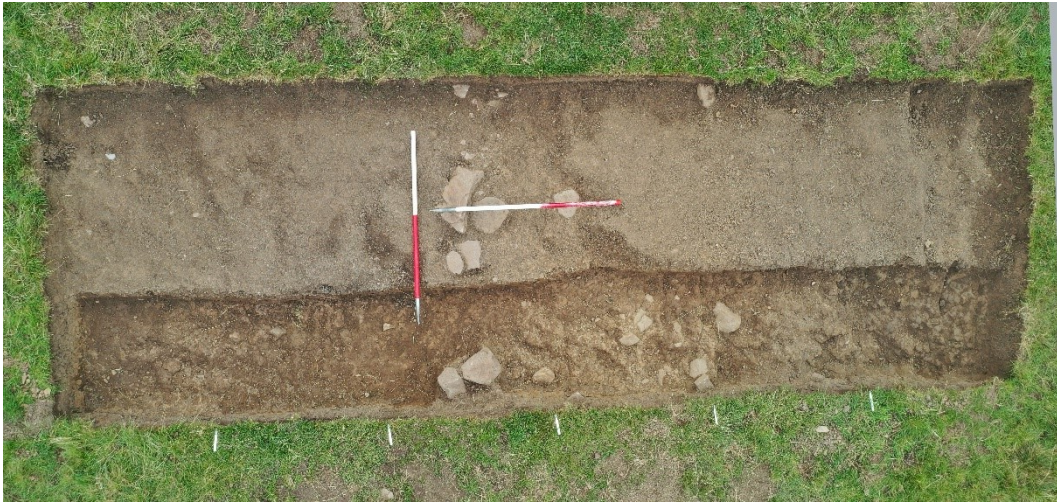
Figure 17: Trench 2 drone photograph on last day of excavation. North is to the left.

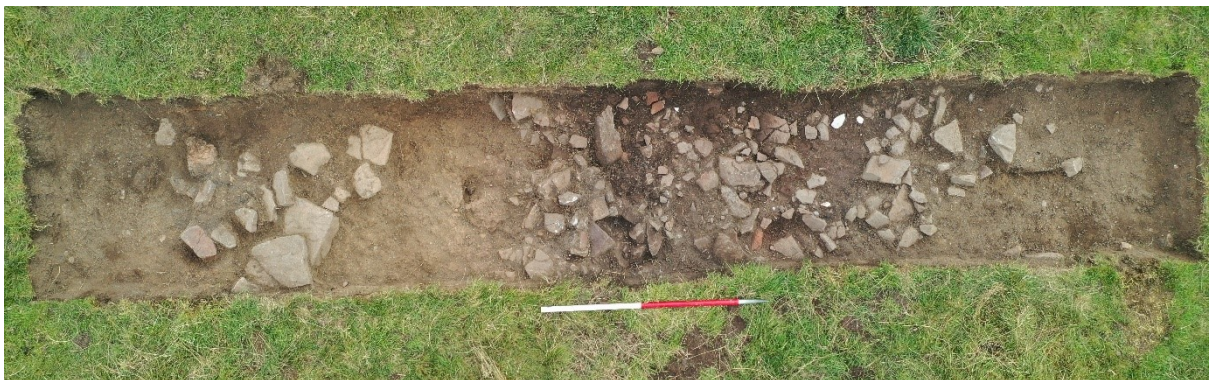
Figure 18: Trench 3 drone photograph on last day of excavation. North is to the left.

Below the topsoil was an irregular band of stones *302*. It was 1m wide across the trench with its northern edge along the centre line of the ridge seen on lidar. The stones were similar to those seen in the spread *104* in Trench 1. South of this was a 1m wide gap, and then a 2.5m wide band of stones *304* across the trench. These were mostly sandstone, up to 25cm in size, but a few were of limestone, and scattered through the context there were pieces of sandstone reddened by heat. The stones were in a matrix of dark sandy soil with frequent pieces of slag and coal. There were no artefacts found.

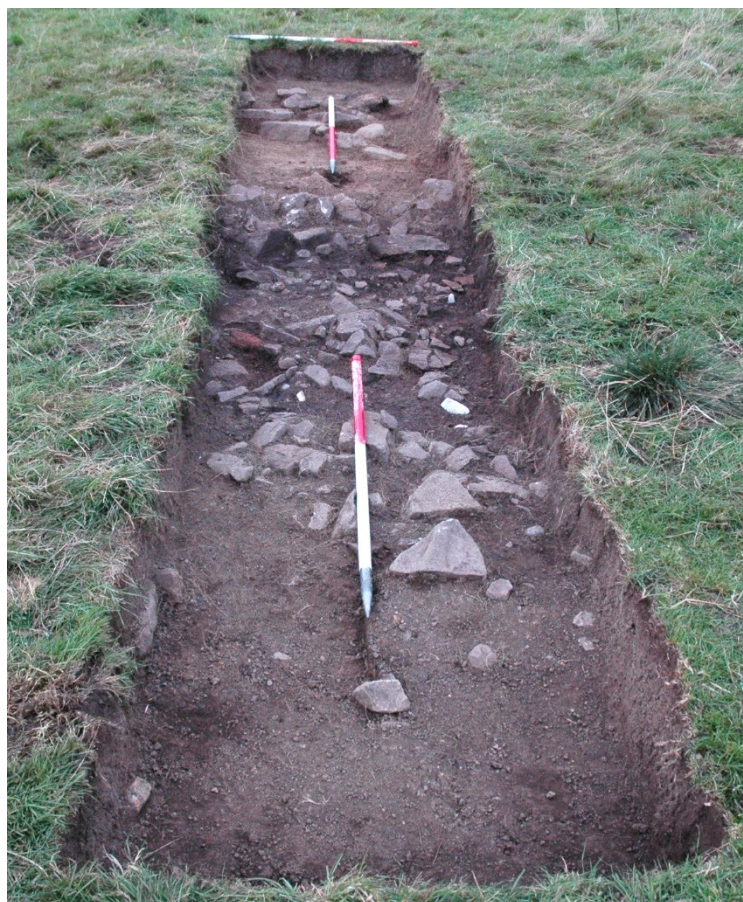
Figure 19: Trench 3 looking north

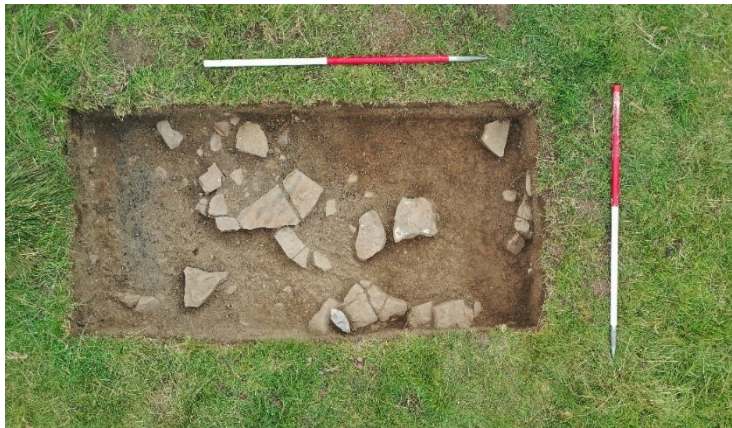
Figure 20: Trench 4 drone photograph. North is to the left

The topsoil 401 contained a fragment of a clay pipe bowl, iron nails, small pieces of slag. Under the topsoil was a sparse spread of stones across most of the trench. These were sandstone and similar to 104 in Trench 1 in size and angularity. The matrix was loamy, with no evidence of coal, burning, or slag, so very different to the deposit 304 in Trench 3 centred only 3m to the east. The deposit contained a lump of charcoal between the stones, but no other finds. At the north and south ends of the trench, stones were very sparse, but there was a thin dark deposit (10cm to 15cm wide and 1cm thick) running across the trench 30cm from its north edge 403. This contained numerous small fragments of coal and ash, appearing similar to deposit 105 in Trench 1.

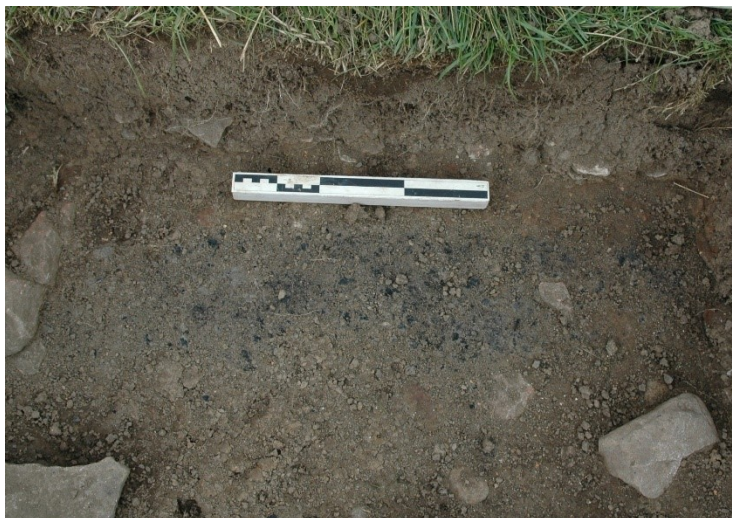
Figure 21: Band of coal-rich deposit 403 at north end of Trench 4

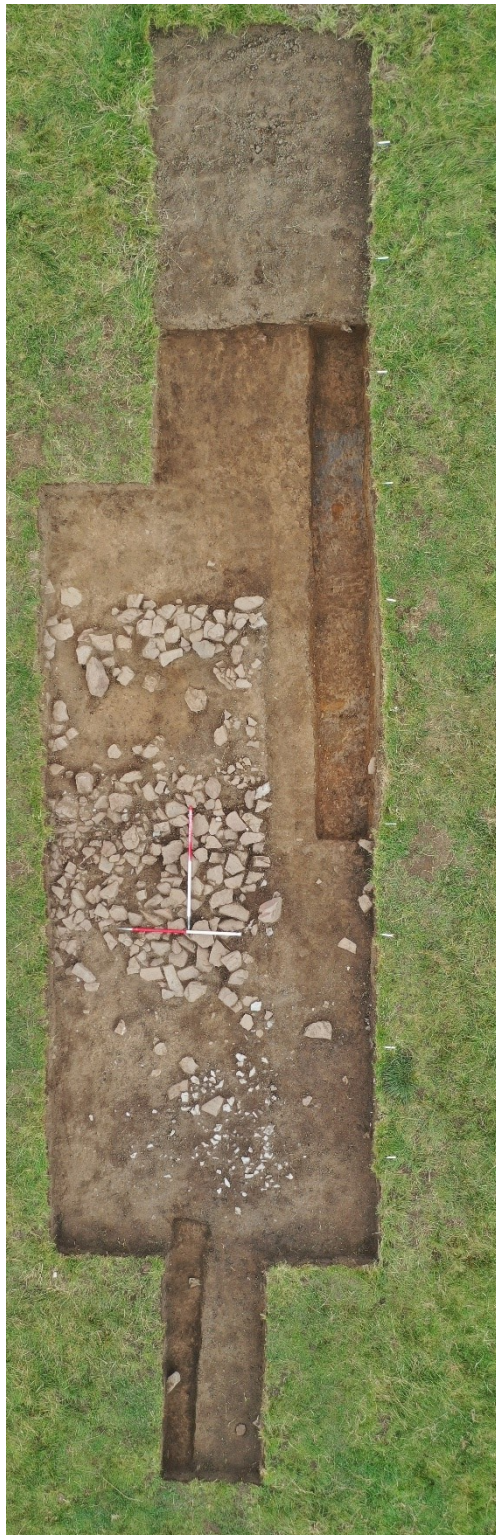
Trench 1. North at top. the stones on the eastern 1m of the trench have been removed and a sondage dug.

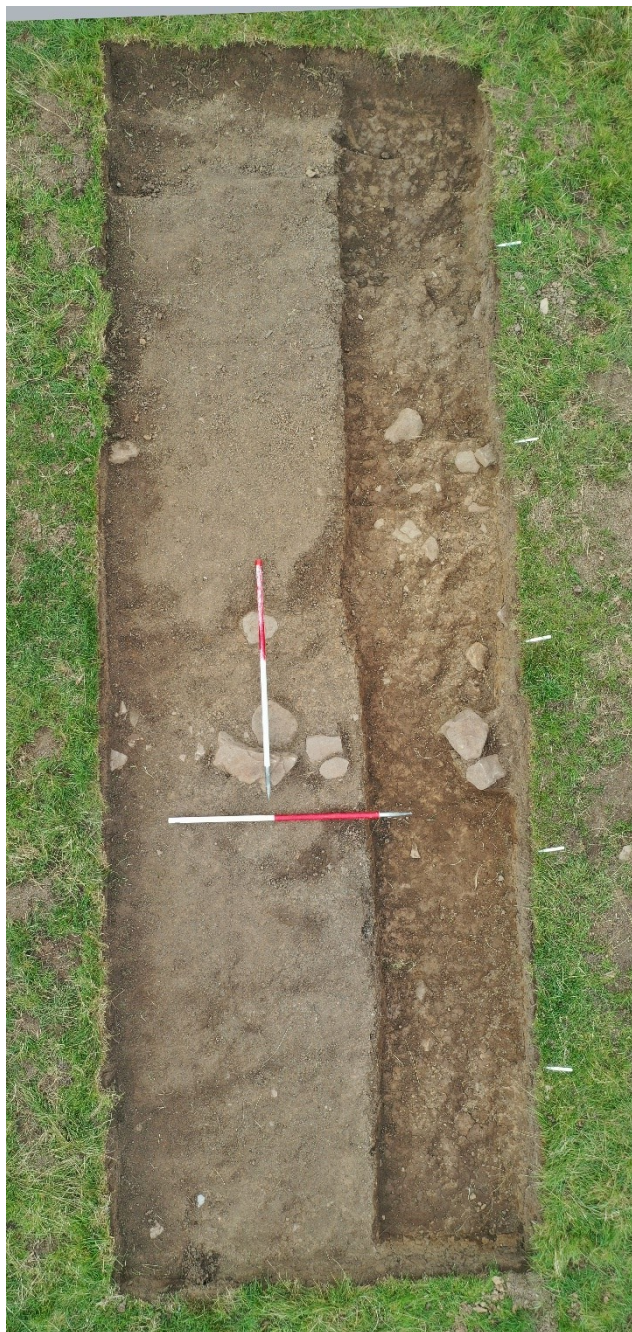
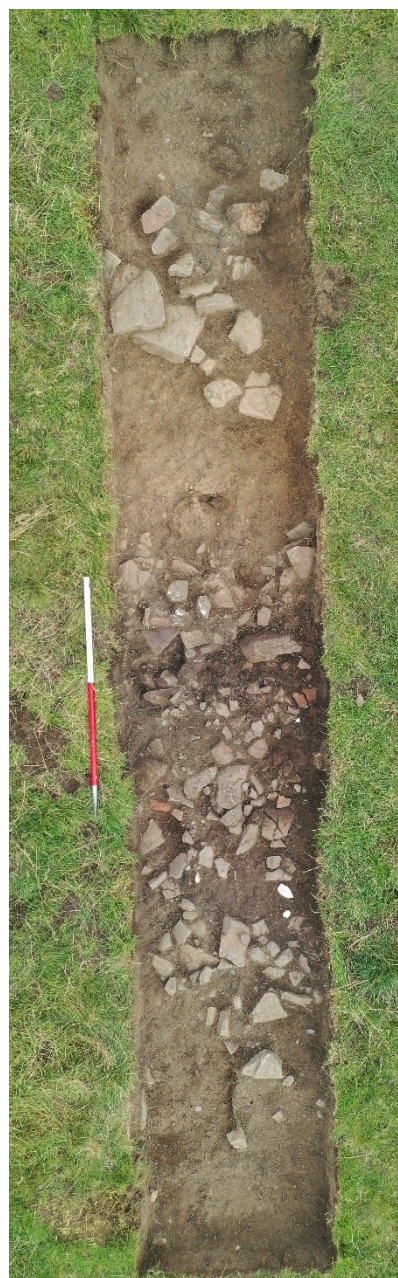
Trench 2 (on left) and Trench 3 (on right).
North at top in both images.

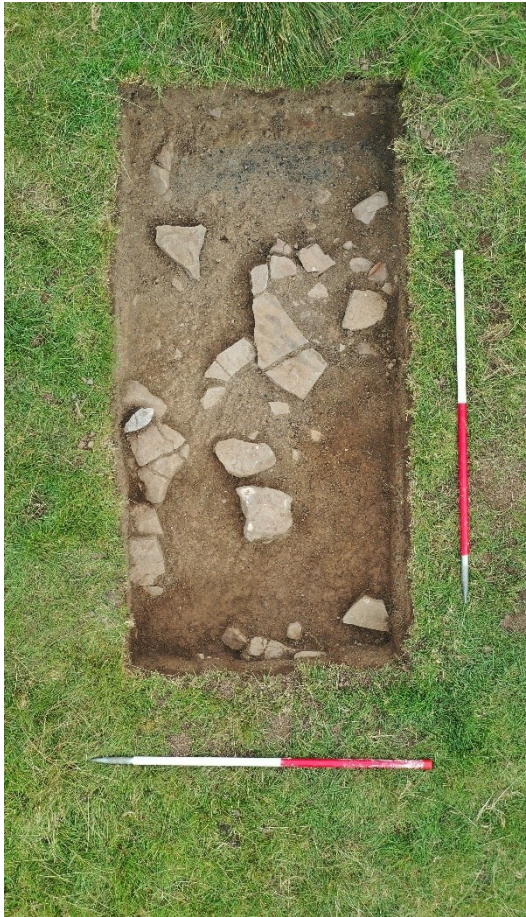
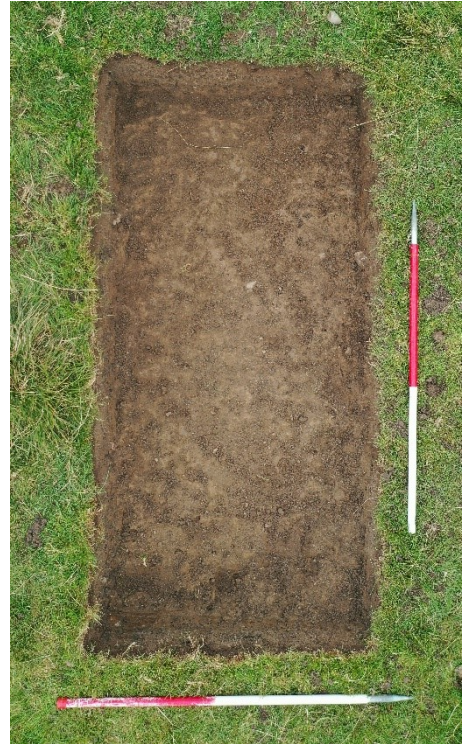
Trench 4 (on left) and Trench 5 (on right).

North at top (Trench 4).
