LOST ROADS ON HEXHAM FELL

Project Report – December 2016

ALTOGETHER ARCHAEOLOGY

Title	Altogether Archaeology 2016 Report HF16: 'Lost Roads on Hexham Fell'
Authors	Martin Green (archaeology), Greg Finch (history)
Derivation	
Origination Date	
Reviser(s)	Martin Green
Last revision	
Version	3.1
Status	Final version, but may be updated when ditch-fill analysis available.
Circulation	
Required Action	For printing and internet publication on www.altogetherarchaeology.org
File/location	
Approval

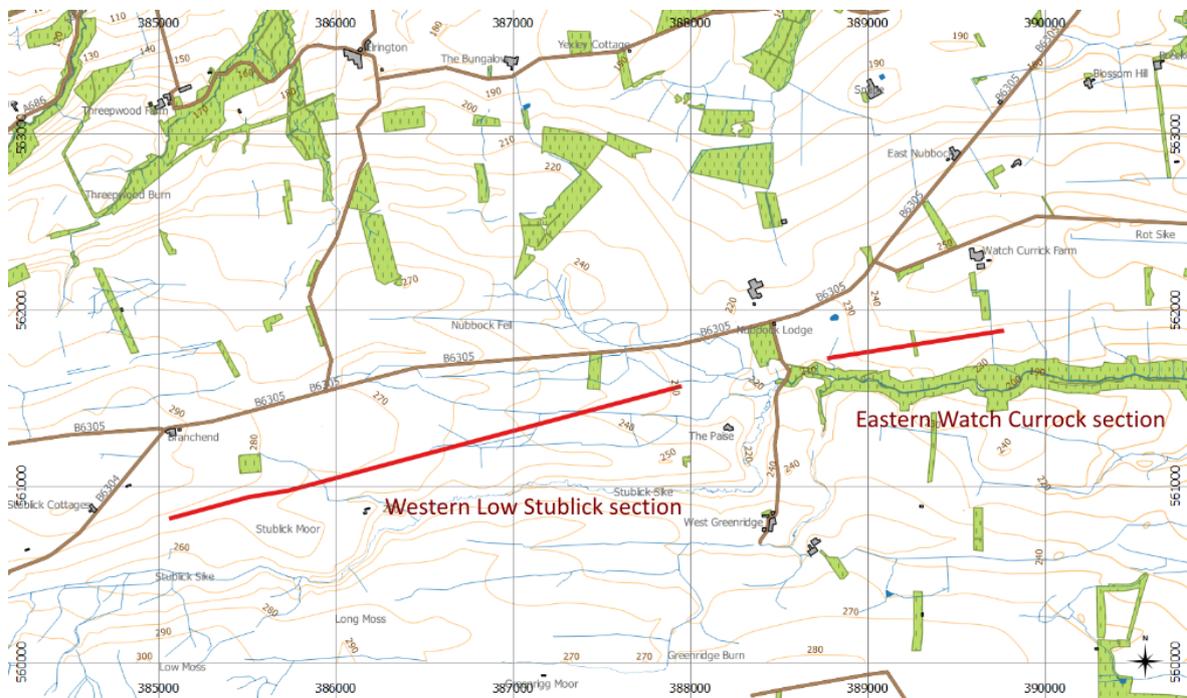
Figure 2: Location of straight linear feature on OS map (not showing uncertain section in Dukeshouse Wood). Feature shown in red. Grid-lines at 1km intervals.

The feature runs across rough pasture at an altitude of 220m to 280m. The west end is lost in the tracks and ground disturbance of Stublick Colliery (see Figure 3), and the east end is lost where agriculture becomes more intensive and there is disturbance caused by the construction of Hexham racecourse (Figure 4). There is also a section missing in the middle around Greenridge, Nubbock and The Paise. Interpolation of the visible sections shows that, if once continuous, the feature would have passed immediately to the north of a sharp bend in the deep ravine of the West Dipton Burn. Although very close to a straight line, there are several subtle changes of direction (e.g. at NY 89076176, NY87756152, and NY86486115) between straight segments.

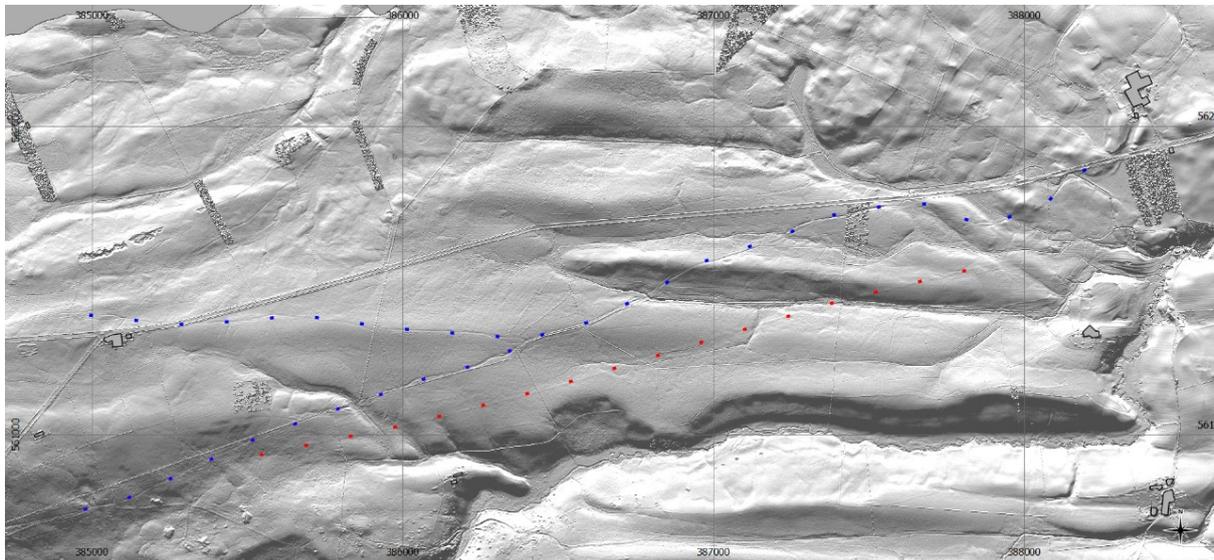
Figure 3: Western section of features on lidar: straight feature red dots, holloway blue dots. Gridlines are at 1km intervals.

Figures 3 and 4 show that this meandering roadway lies on a separate course to the straight road, even where their paths lie very close to each other to the west below Stublick Hill. Figure 17 superimposes on to the lidar image the boundaries of the medieval enclosed ground of The Paise and Greenridge farms (shown in green) and farm encroachments into the waste made by 1770 (shown in yellow). The meandering roadway is shown as a dashed line weaving its way to the north of The Paise grounds, and is also followed by the boundary of one of the post-medieval encroachments on to the common.

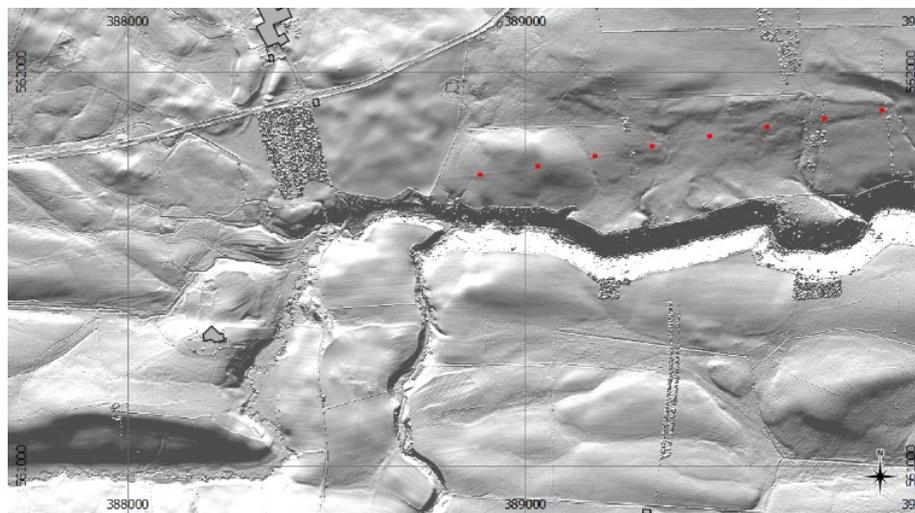
Figure 4: Eastern section of features on lidar, east of The Paize farm: straight feature red dots.

The feature is seen on the lidar hill-shaded images mainly as a slightly raised bank roughly 6m across. In some places, possible flanking ditches are apparent with a total width of about 9m. Discussions with Stewart Ainsworth confirmed that this could be a Roman road, but that other possibilities had to be considered.

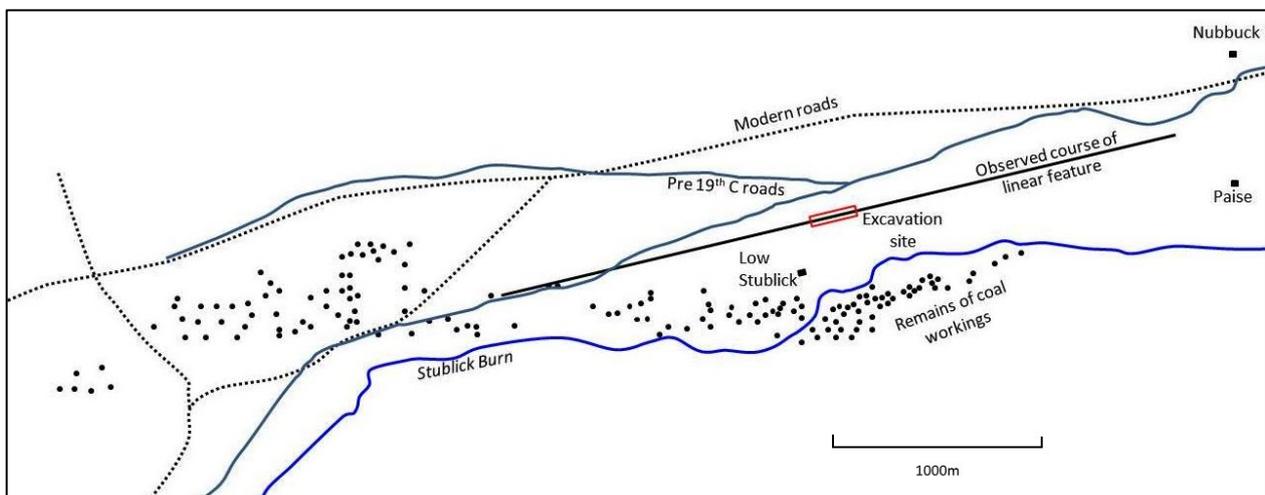
Figure 5: Plan of western section showing relationship to coal workings (black dots).

The features lie on an area covered in glacial till (clay or sandy clay with a variable stone content, mostly local sandstone). The underlying bedrock is sedimentary rock of the carboniferous era, mainly sandstones (Young 2006). To the south and west of the features is an outcrop of coal measures which are cut off at their southern margin by the Stublick fault system. This outcrop has been exploited at Stublick colliery, an extensive area of coal workings lying in a 4km belt between NY872609 and NY831605. Coal mining is documented in the area from as long ago as 1690 and is

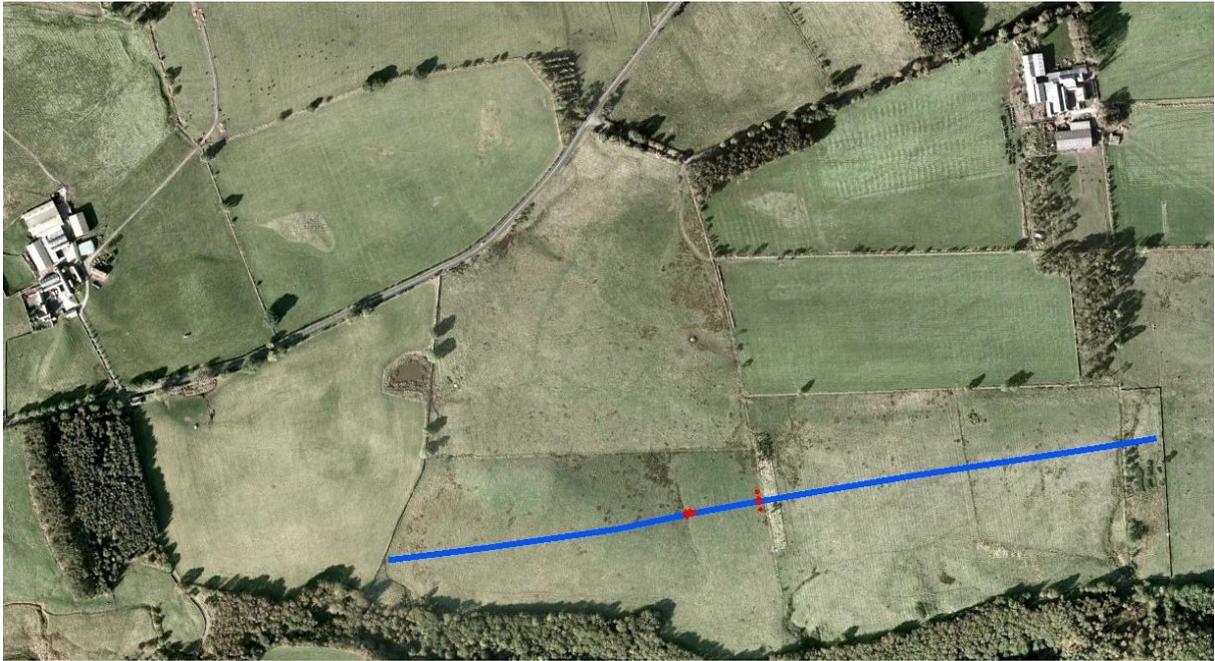
Figure 6: Google Earth image of eastern section of straight feature, with test-pits marked in red.

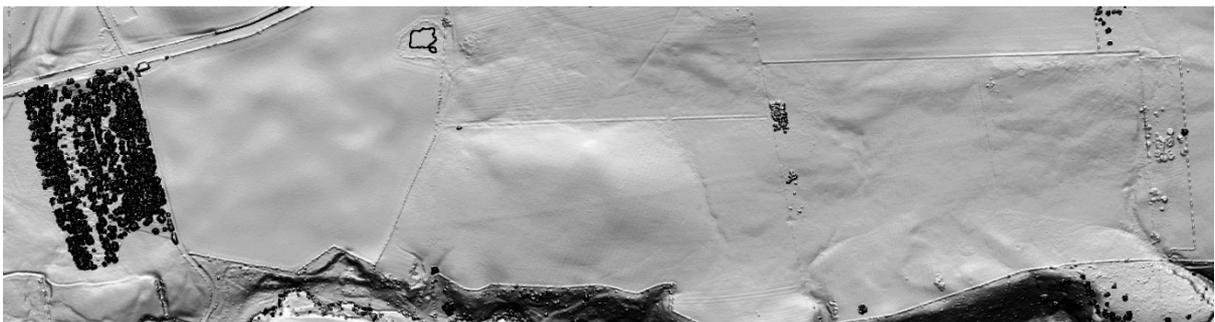
Figure 7: Lidar image of lower half of same area as in previous figure. North is at the top.

The field is currently pasture, but lidar images suggest that there has been post-medieval ploughing across the feature: there is subtle parallel ridging 3m across, on a compass bearing of 169 degrees, seen on lidar images illuminated at right-angles to this direction.

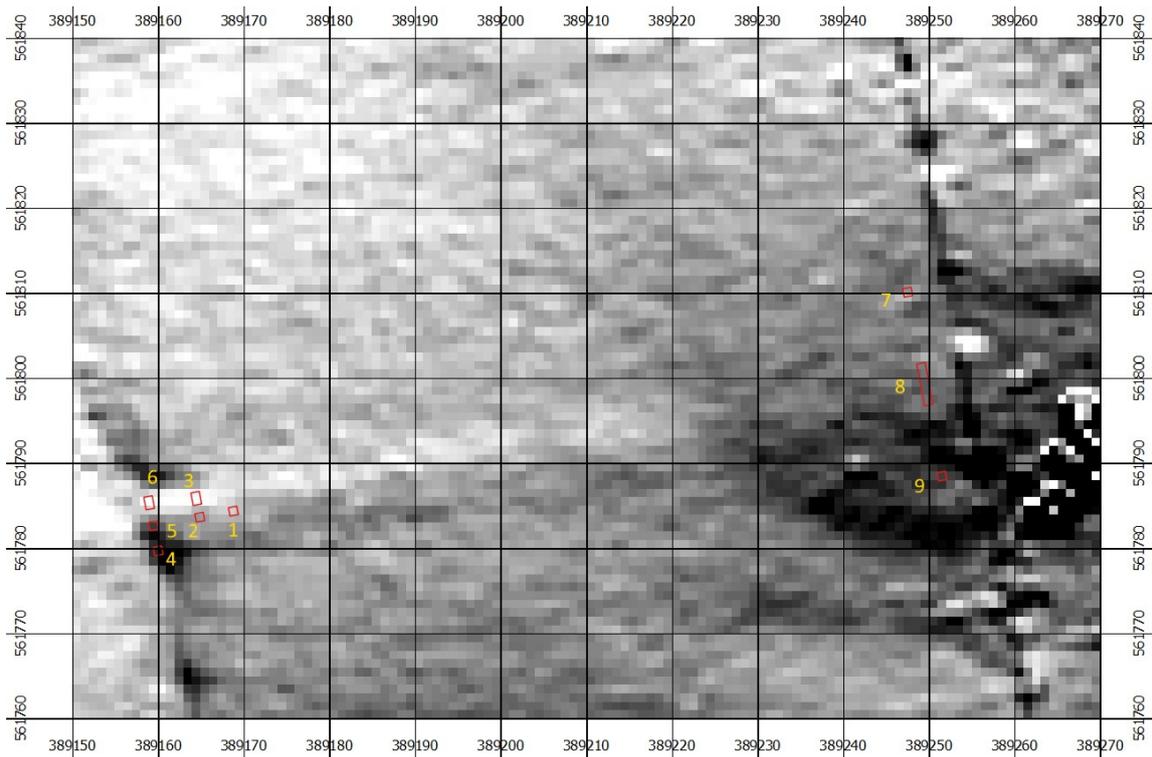
Figure 8: Test-pit locations (red rectangles) marked on a DSM lidar image. The pits are across the straight feature which runs almost E-W. OS grid-lines are at 10 metre intervals.

In all, nine pits were dug. Their locations were established by tape measurement from fixed features visible on the geo-referenced lidar image, checked by reference to handheld navigation-grade GPS units. Test-pits were dug 5m from the eastern boundary of the field (where the feature is invisible on the ground and indistinct on lidar) and 90m further west beside a natural gully (where the feature is clear on lidar and visible on the ground). The test-pit locations are shown in Figure 8, an enlarged view of the centre section of Figure 7.

Of the 6 trenches in the western group, three of these (1,2,5) were on the middle of the feature, two were on the northern edge (3,6), and one on the southern edge (4). In the eastern group, a long trench crossed the centre line of the feature (8) with two trenches well to the north (7) and south (9) of the feature.

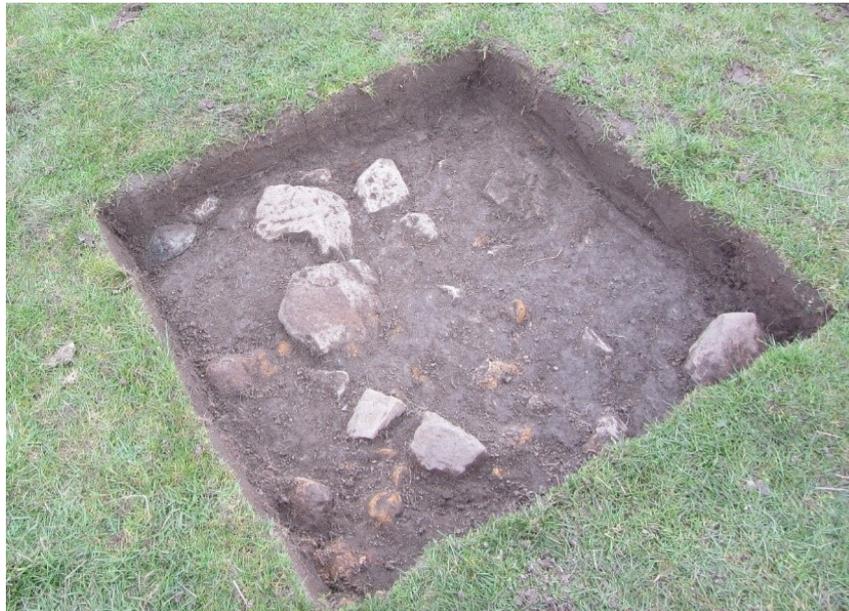
Figure 9: Test-pit 5 (on centre of feature) showing disturbed stony surface.

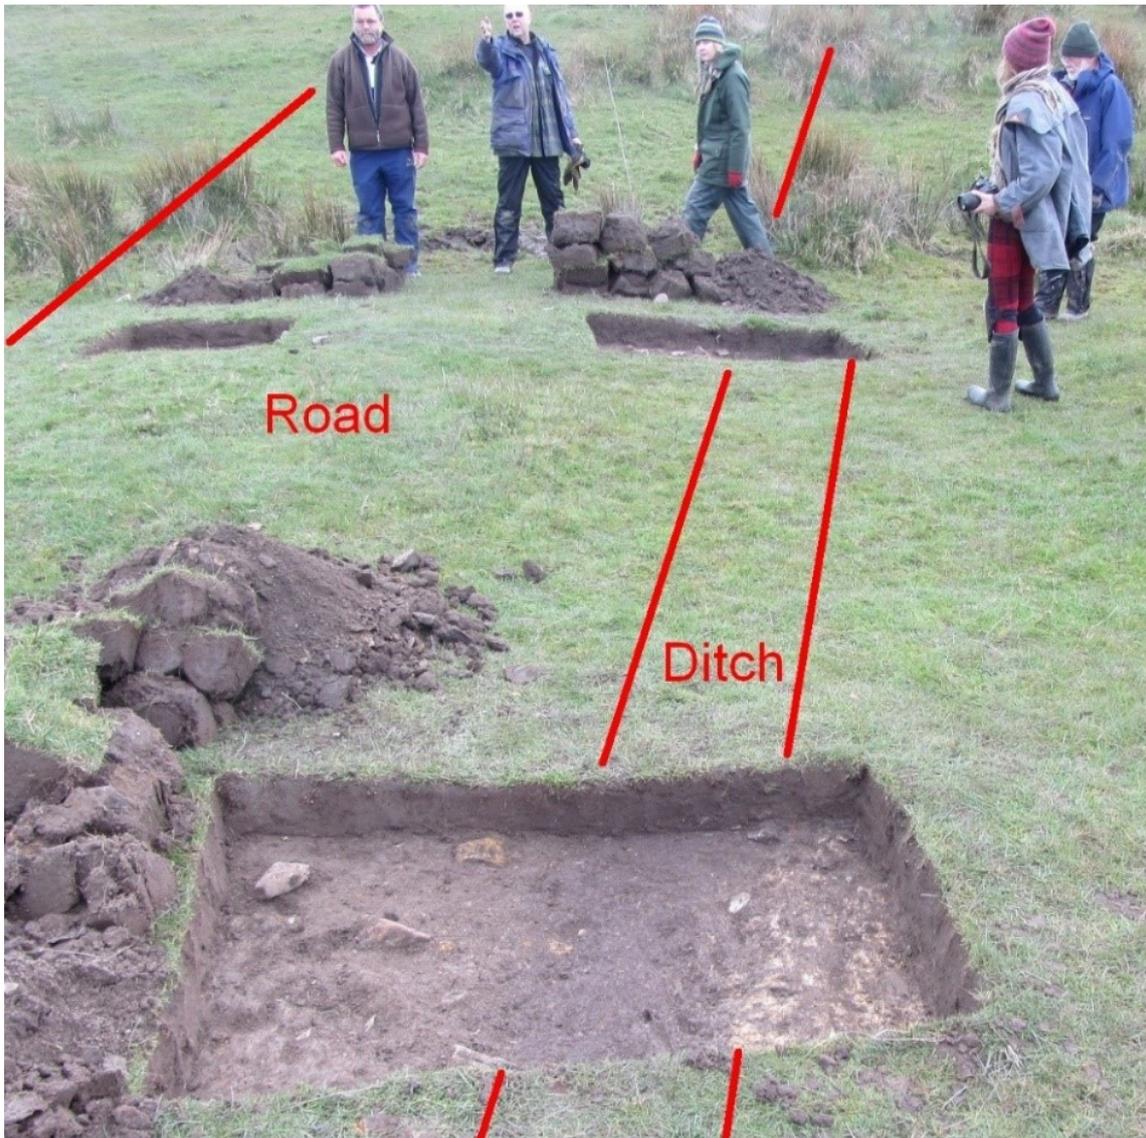
Figure 10: Looking west along the feature. Test-pits 3 (foreground) and 6 (right background) demonstrate the northern edge of the stony surface, with a small ditch in test-pit 3. The road is visible as a raised causeway.

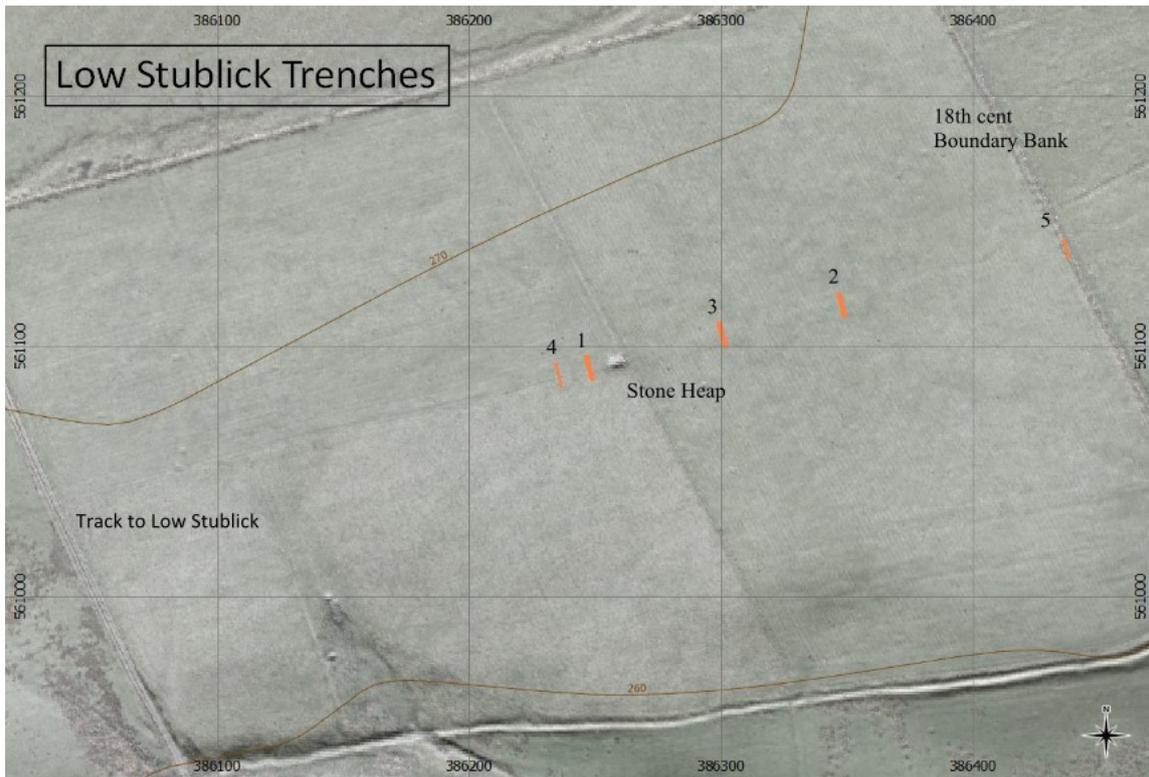
Figure 11: Location of the five trenches at the Low Stublick site. The background is a lidar image and Google Earth aerial photograph superimposed. Contours are in metres, gridlines at 100m intervals.

At Low Stublick, on the western section of the feature, four trenches (1,2,3,4) each 10m long were excavated across the line of the feature. Three were 2m wide, the other trench (4) was 1m wide. They sampled a 120m stretch where the feature is clear on lidar, there is no indication of previous ploughing on lidar, and ground conditions are comparatively dry. The actual positions of these four trenches were chosen to coincide with particularly clear parts of the feature on lidar; the trenches were not evenly spaced over the 120m.

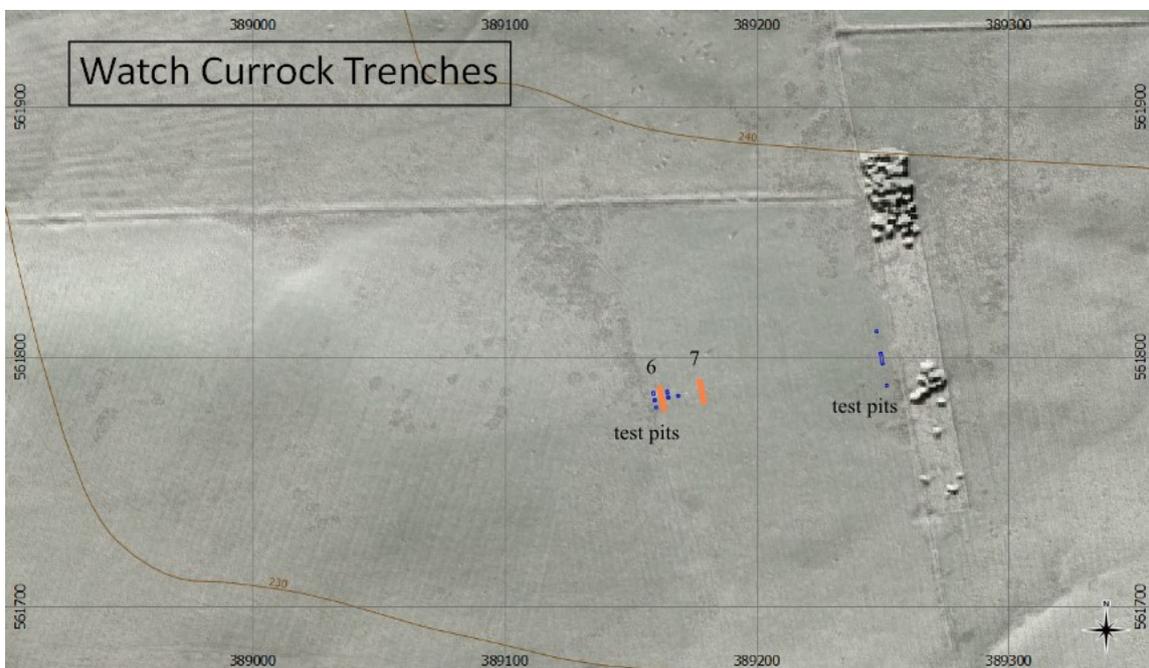
Figure 12: Location of the two trenches at the Watch Currock site. The previous test-pits are shown in blue. Background, contours and gridlines as in previous figure.

The second site, at Watch Currock, was in the same field as the previous test-pits (see Section 2.4). Two trenches (6,7), 10m long and 2m wide, were placed across the feature with their centres 16m apart. The western of the trenches (6) was placed beside a natural gully running through the field, between the location of test-pit 2 and 3 (to its east) and 4,5 and 6 (to its west). This location was chosen to be close to where a suspected road-side ditch had been found in test-pit 3. The eastern trench (7) was located further into the field, where the feature was clear on lidar images.

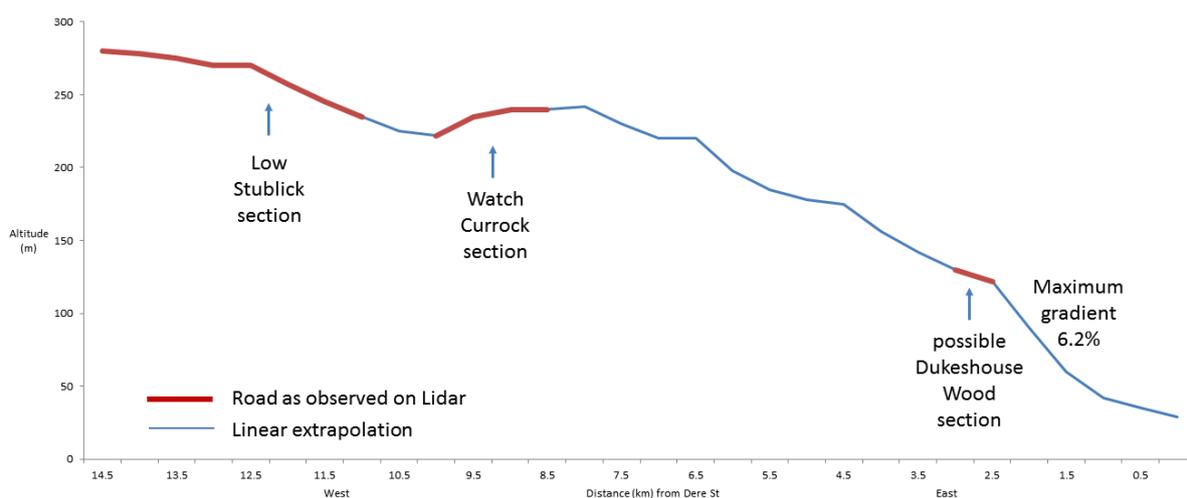
Figure 24: Height profile of the possible Roman road, extrapolating its course to Dere Street at Corbridge.

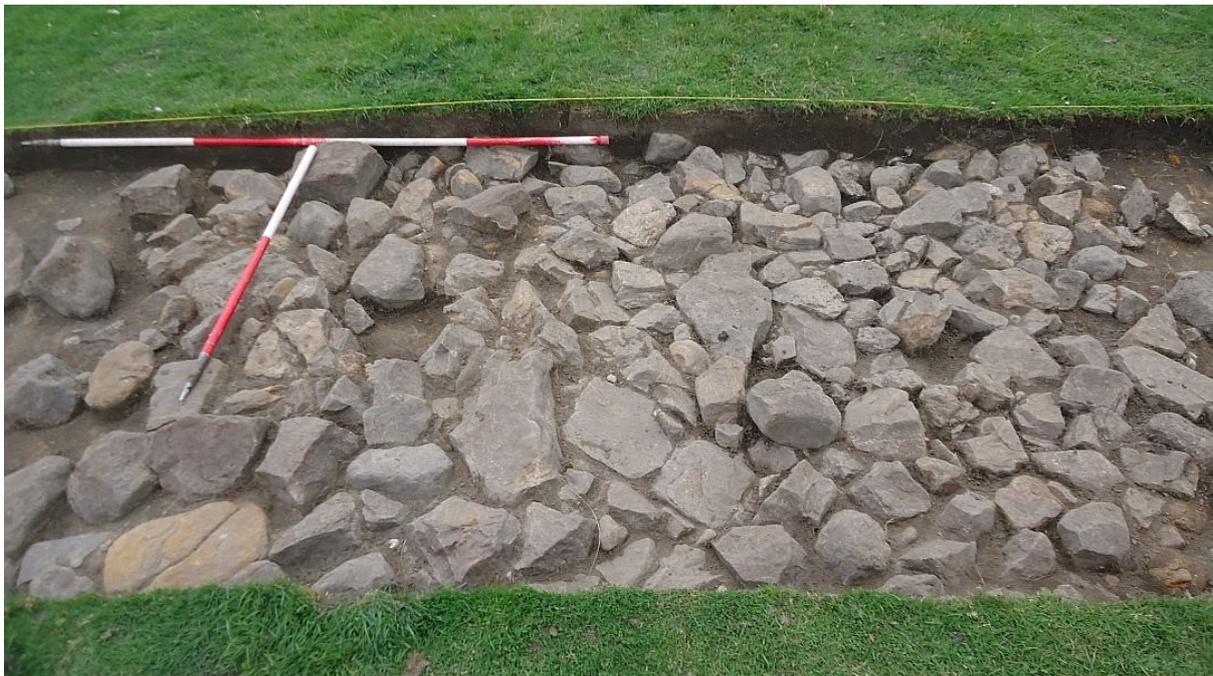
Trench 1. Southern kerb and adjacent road surface. Looking west.

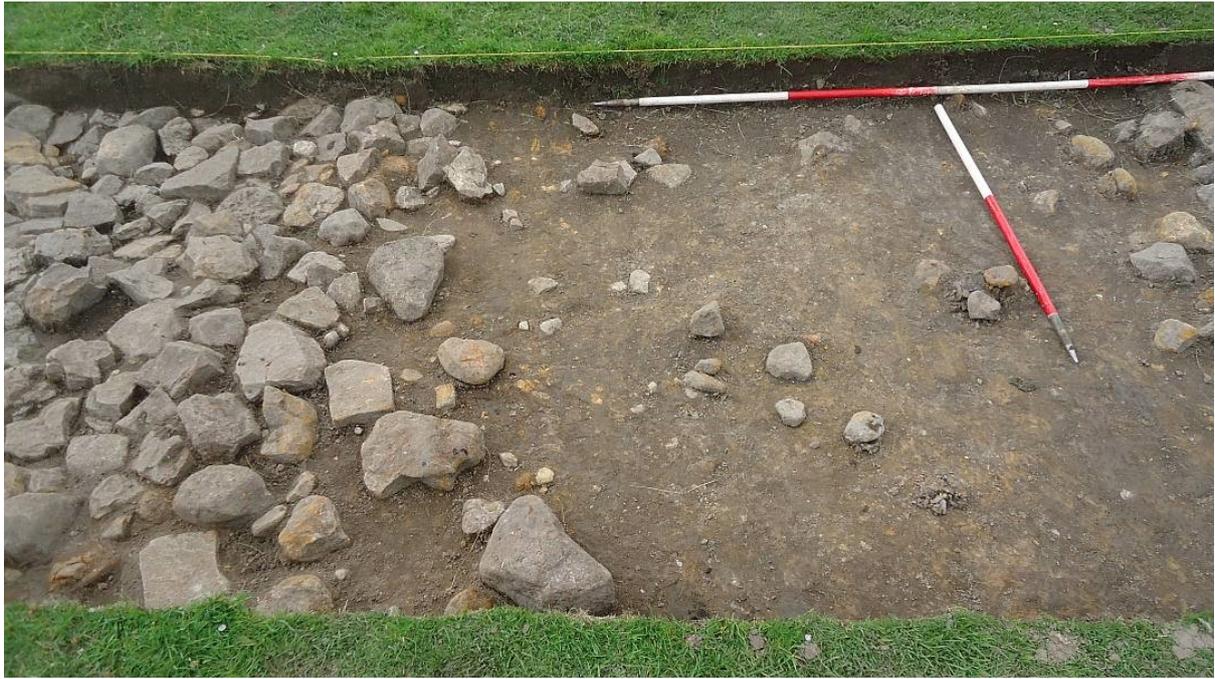
Trench 1. Central road surface. Looking west. Part of the northern kerb can be seen on the extreme right.

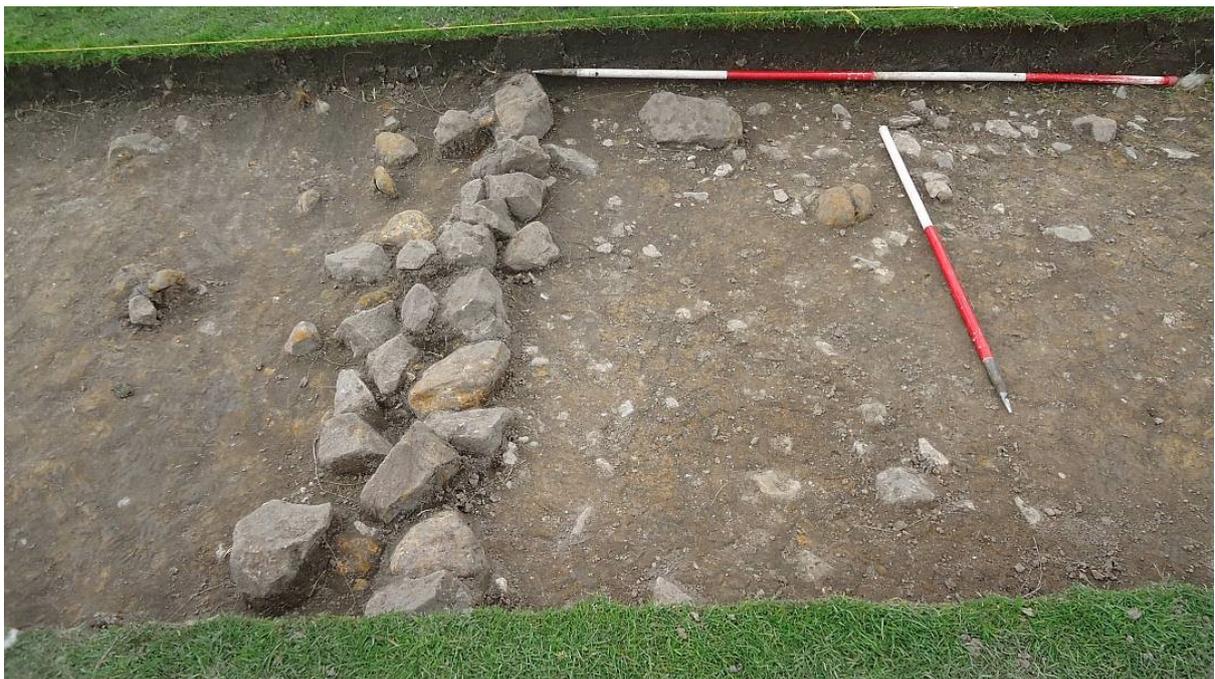
Trench 1 Northern kerb. Looking west.

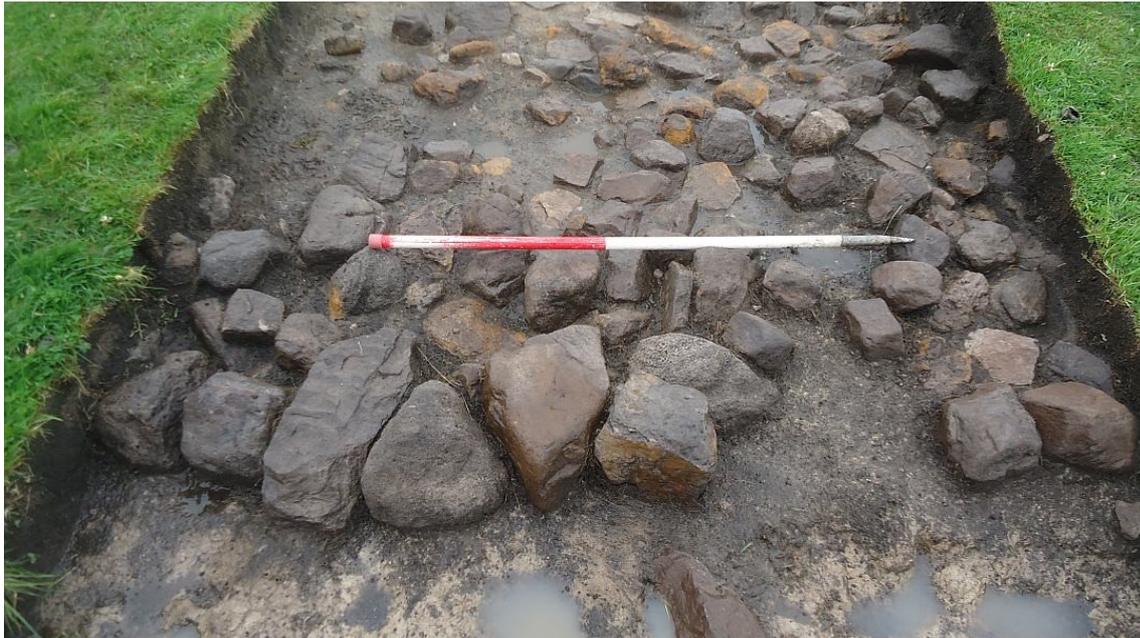
Trench 3. Southern kerb. Looking north.

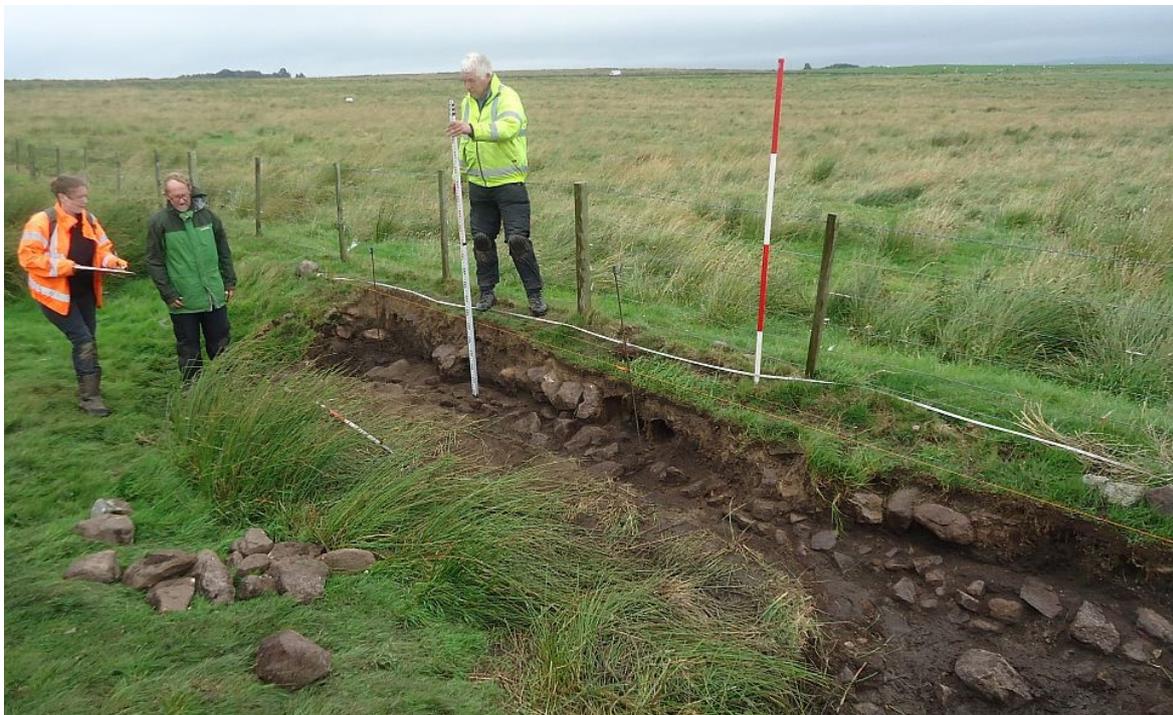
Trench 5. Looking north-east. The staff is placed on the road surface. The surface is exposed in the section along the boundary bank, from the northern kerb (0.8m to the left of the staff) to the right margin of the photo. Loose stones in the bank lie above it.

The bank at this point was found to consist of loose stones (similar to those forming the road surface in the other trenches) in a matrix of topsoil. On cleaning the section, the road surface (F505) of 10cm cobbles was seen to be intact, with kerbstones present (F506, F507). Its width, 6m, and stone size was the same as in other trenches. No road-side ditches were noted. See Appendix 1 for the drawn section.

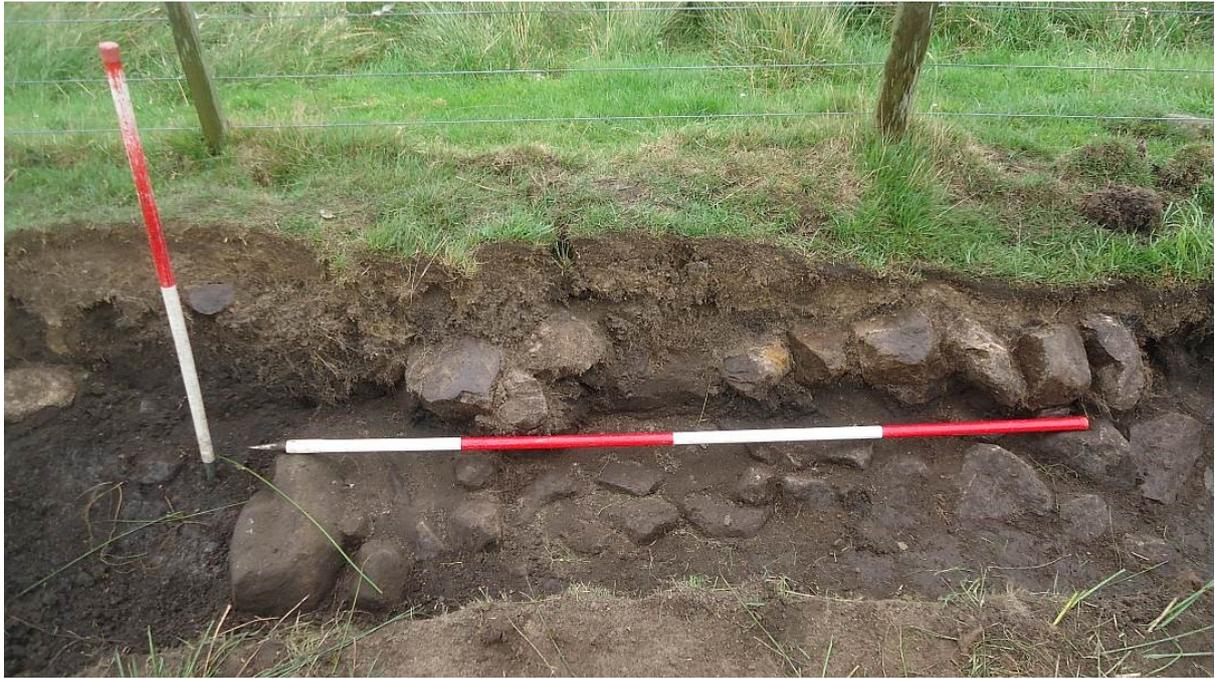
Trench 5. Looking east. Northern kerb and adjacent road surface. The higher stones in the boundary-bank were thrown up on the bank when the adjacent eighteenth-century ditch cut the road surface. The horizontal ranging-pole lies on the road surface.

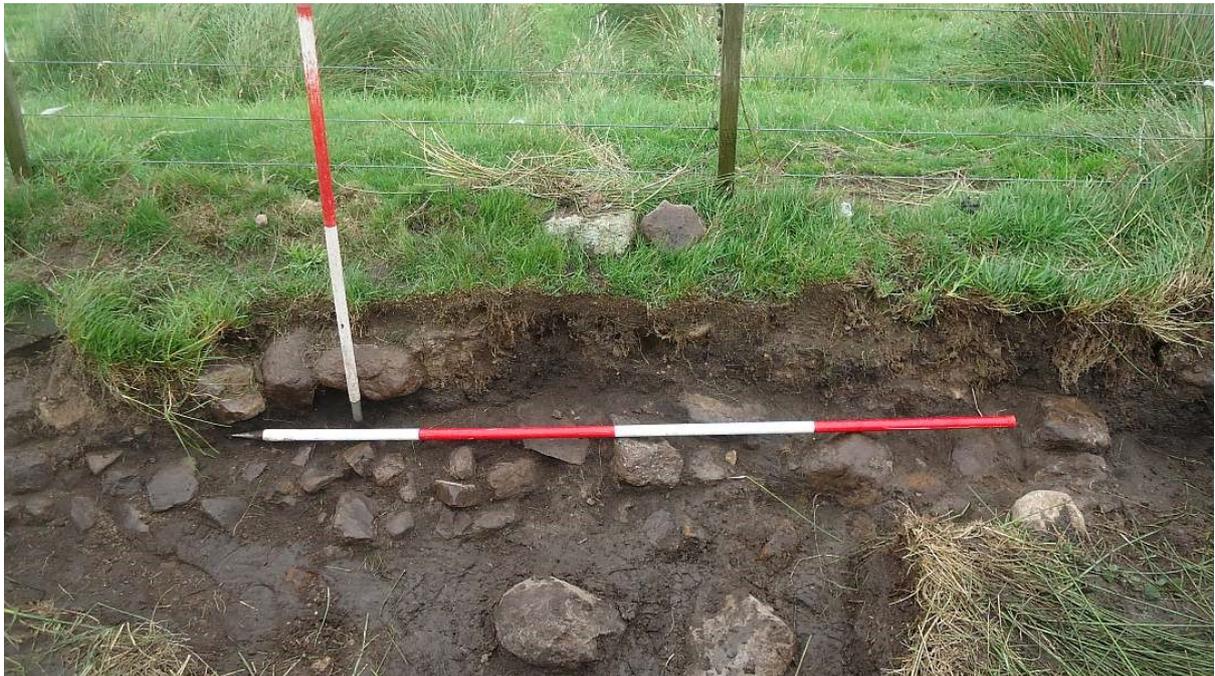
Trench 5. Looking east. Southern kerb (at right of photo) and adjacent road surface. The horizontal ranging-pole lies on the road surface.

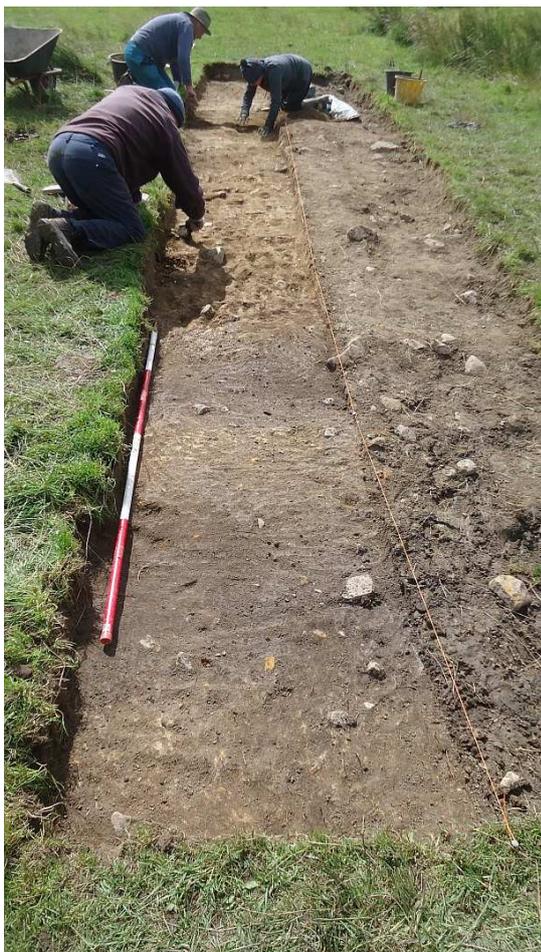
Trench 6. Looking south. The road-side ditches can be seen crossing the trench in the foreground.

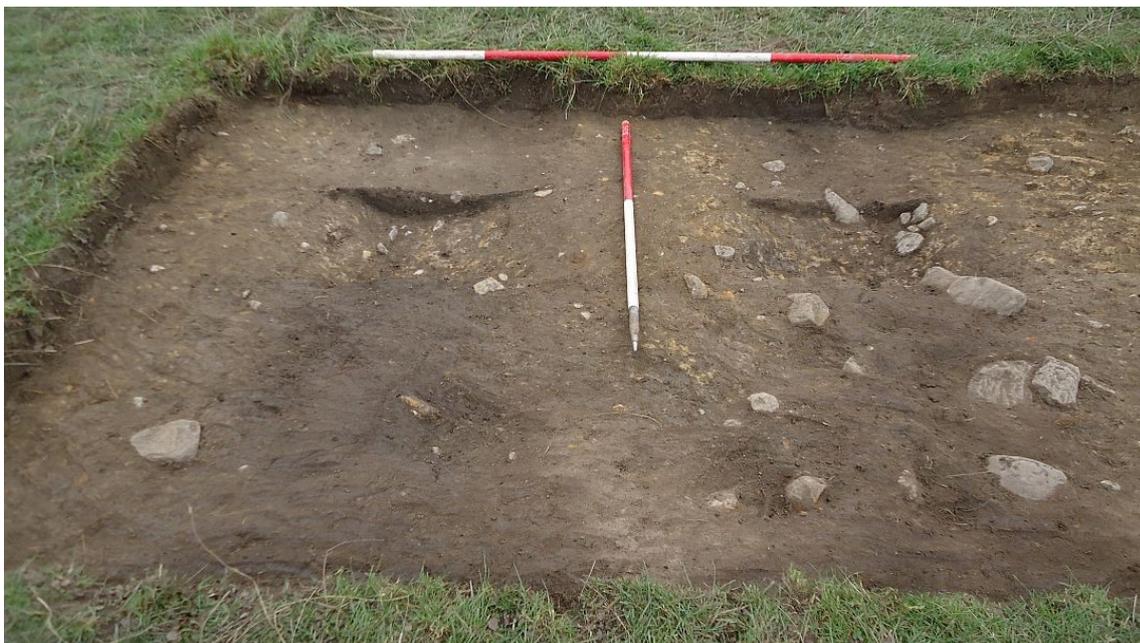
Trench 6 roadside ditches. Looking east. The fill has been excavated from 50cm of each ditch.

As in other trenches, the natural subsoil of glacial till (603) was reached at a shallow depth, 20cm. No road surface of stones was found, nor was a kerb. The section shows evidence that the subsoil had been profiled into a 6m wide low agger, about 10cm to 15cm high. On the northern (uphill side) were two shallow ditches parallel to the line of the road (F604, F606). Both were 0.6m wide at the top, with ditch centres 1.4m apart. The fill of both ditches was a dark silty loam (605, 607), with no discernible variation seen in section. The ditches were very shallow, about 8cm. Samples of the lower fill of both ditches were taken for laboratory assessment.

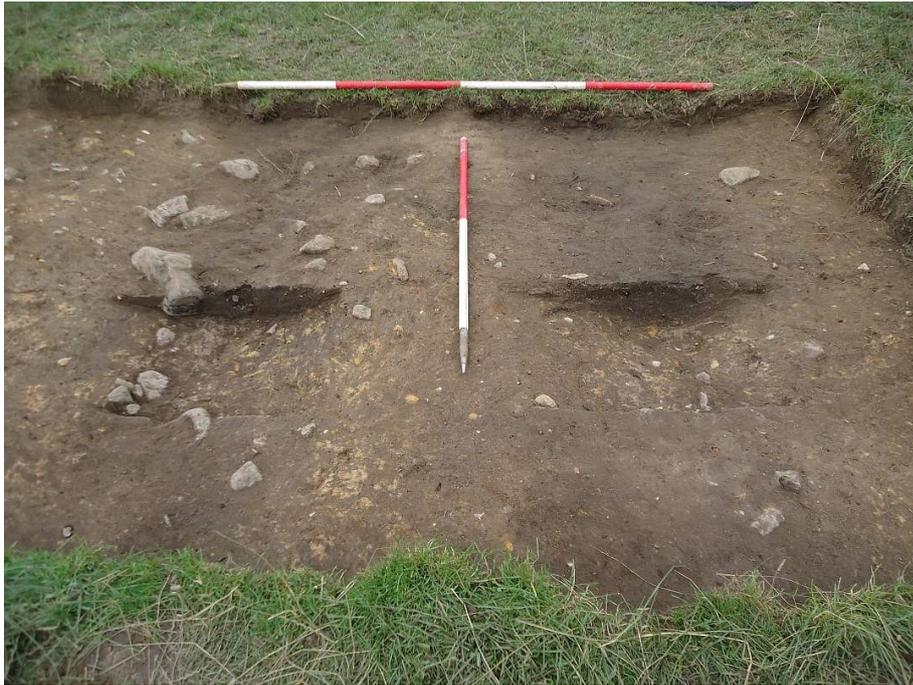
Trench 6 roadside ditches. Looking west.

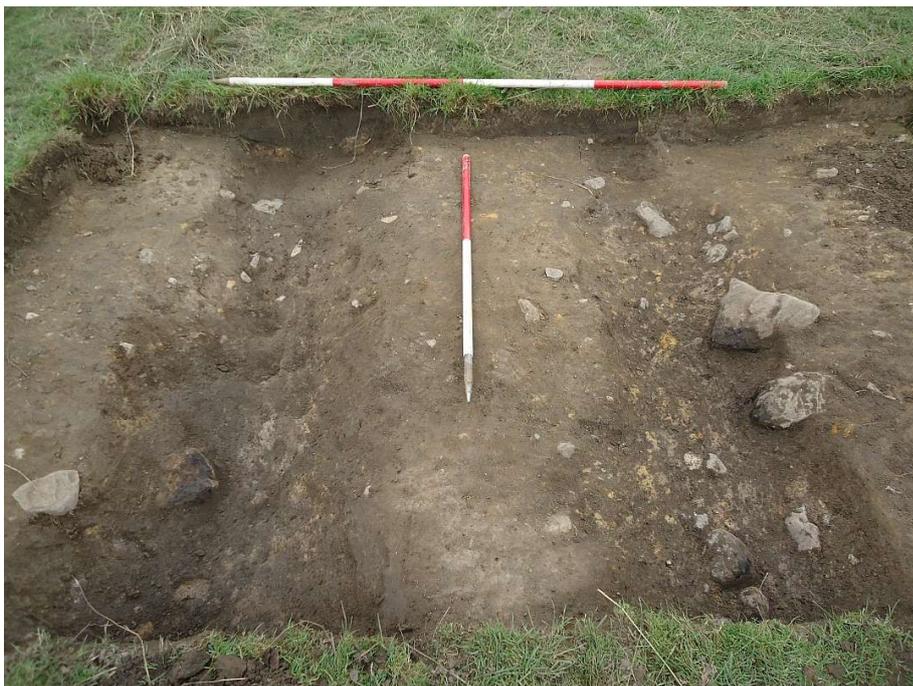
Trench 6 roadside ditches. Looking east. After excavation of fill.

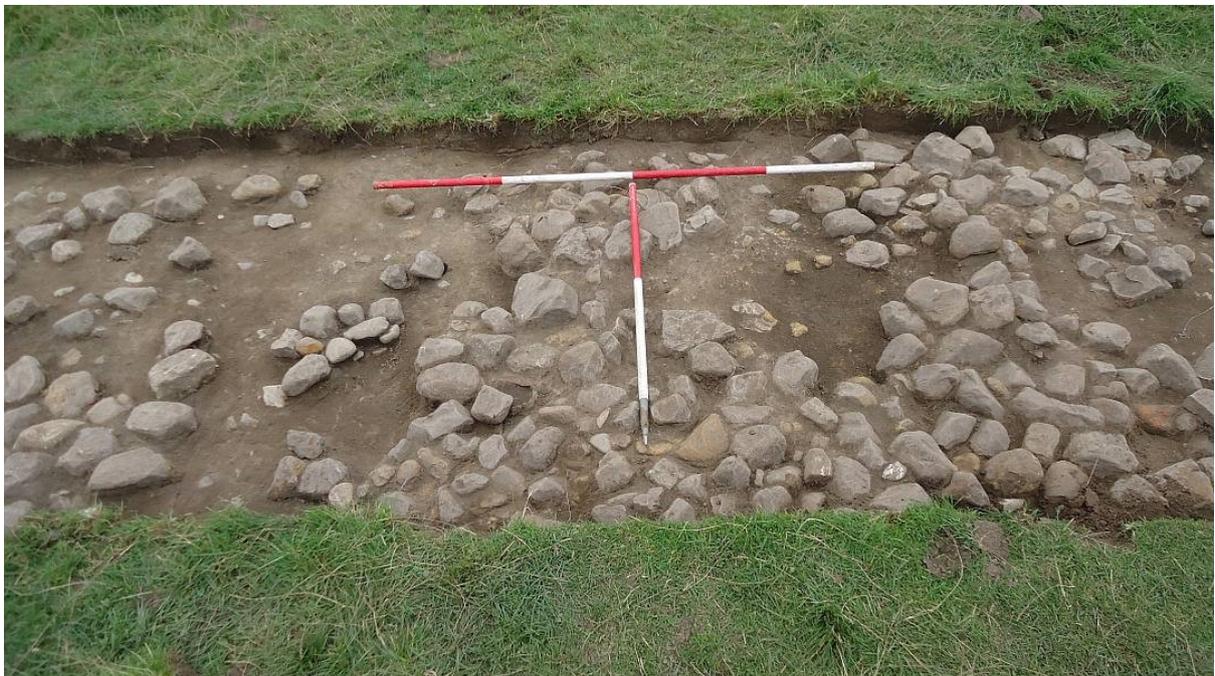
Trench 7 road surface. Looking west.

The damage to the surface is suggestive of plough damage, with loss of stones in an irregular 0.5m wide band running transversely across the road. There are faint parallel plough ridges, 3m apart, seen crossing this area of the field on lidar images (see Section 3.5) at a bearing of 169 degrees and the road feature is aligned on a bearing of 79.5 degrees. The difference between the two bearings gives the angle (about 90 degrees) at which the ploughing crosses the road.
