FIELDWORK AT THE KILLHOPE BUDDLE HOUSE  
KILLHOPE LEAD MINING MUSEUM  
COUNTY DURHAM

REPORT ON AN ARCHAEOLOGICAL EVALUATION  
CARRIED OUT IN NOVEMBER 2012

THE ARCHAEOLOGICAL PRACTICE LTD.

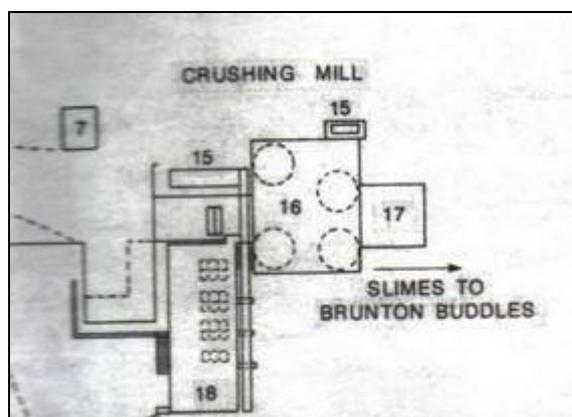
*Illus. 06: Plan of Groverake with four buddles shown in the Buddle House [16] next to the Classifier [17] and Jigger House [18].*

Trench 1, positioned in the west corner of the Buddle House, was sited to investigate the suspected location of original buddle workings suggested by the arrangement shown on a plan of the buddle house at Killhope's sister site, Groverake, near Rookhope in Weardale. The trench was rectangular in plan, aligned south-west to north-east and positioned three metres from and parallel with the west wall of the Buddle House, with its south-west end 0.33m from the south wall.

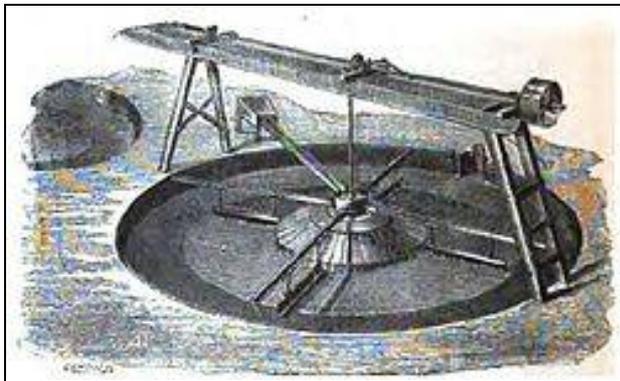
Illus. 07: Diagram of a working round buddle (Davies 1902)

The buddles in use in the North Pennines during the middle and later part of the 19<sup>th</sup> century were of two designs, the earlier and most common type being convex, and the later, less common variant being the concave buddle. The early, convex buddle was designed with a wooden superstructure like a large upturned saucer, onto the high centre of which was fed a slurry of fine bouse, while revolving brushes distributed this evenly around the whole 'saucer'. The heavier ore settled out first, nearer the middle, whilst the lighter waste was carried towards the edge. After a time the machine was stopped and the different bands, of increasing purity towards the centre, were dug out. The water used in all the processes was led to the settling tanks where any remaining solids held in suspension were settled out. The late, concave variant operated more like the Classifier described above, with slurry entering at a point on the upper edge and solids settling on the sides and at the bottom of the apparatus, the water draining away through a central drain.

and gangue, if blende is present, or of galena and gangue, if it is absent. Two qualities of the mixed ores are formed. Rings are formed around the deposit on the buddle to indicate the division lines. The rich heads are taken out and reworked once in another buddle, when they will be rich enough to be sent to the dolly tub. The middles are likewise re-treated, the ores of approximately the same percentage being treated in the same machine until all the mineral is abstracted, and the waste contains not more than  $\frac{1}{2}$  per cent. of lead, and 1 to  $1\frac{1}{2}$  per cent. of zinc. By successive re-treatment the minerals may thus be enriched up to 50 to 60 per cent. Pb., and when blende is present, to about 42 per cent. Zn. These concentrates may either be sold as they are, or further enriched in a dolly tub.

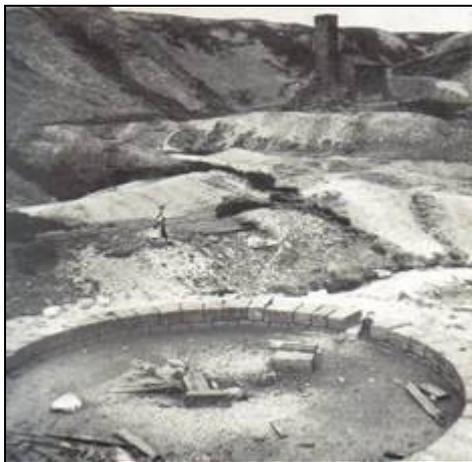
*Illus. 13: An abandoned buddle with apparent traces of removed machinery and signs of a possible central hub support.*

Prior to the current excavation it was not known which type of buddle was in operation at Killhope, nor if remains sufficient to determine that information could be uncovered and successfully recorded. A possible guide to the likely state of surviving remains was provided by illustrations of abandoned buddles elsewhere, such as in the illustration below shows an abandoned buddle with apparent traces of its removed machinery visible as pieces of wood, with signs of a possible central hub support.

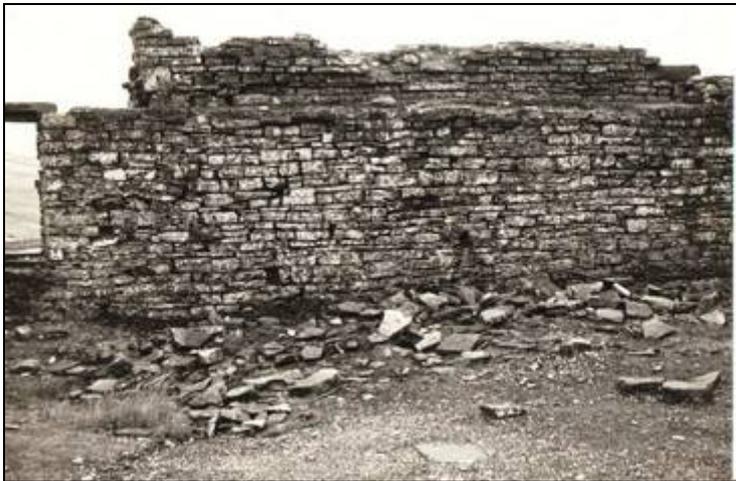
*Illus. 14: Interior view of the north wall of the Buddle House prior to repair and reconstruction in the 1980s.*

A number of photographs are available showing the condition of the buddle house following almost a century of abandonment (Illus. 14, below) and during major re-building works in the 1980s (Illus. 15).

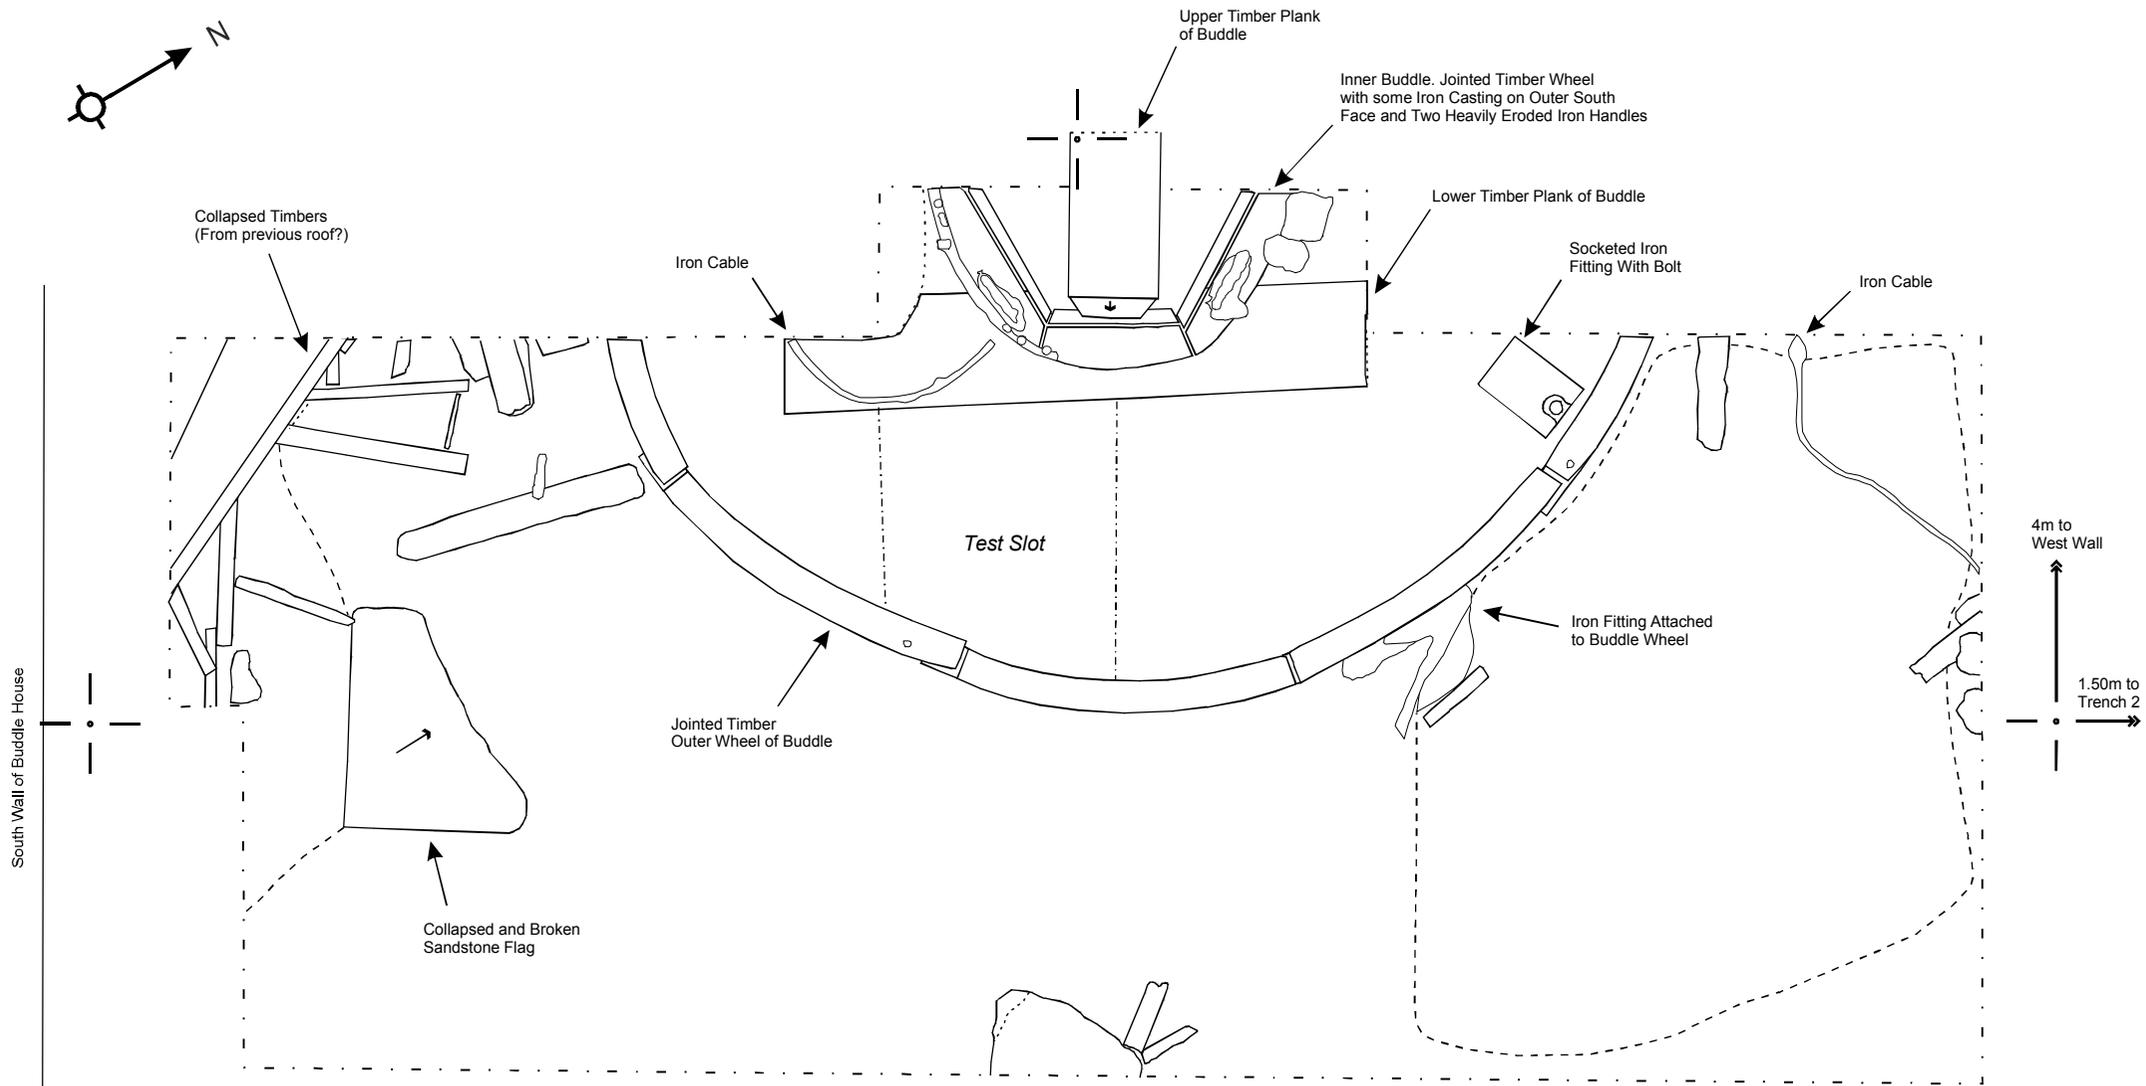
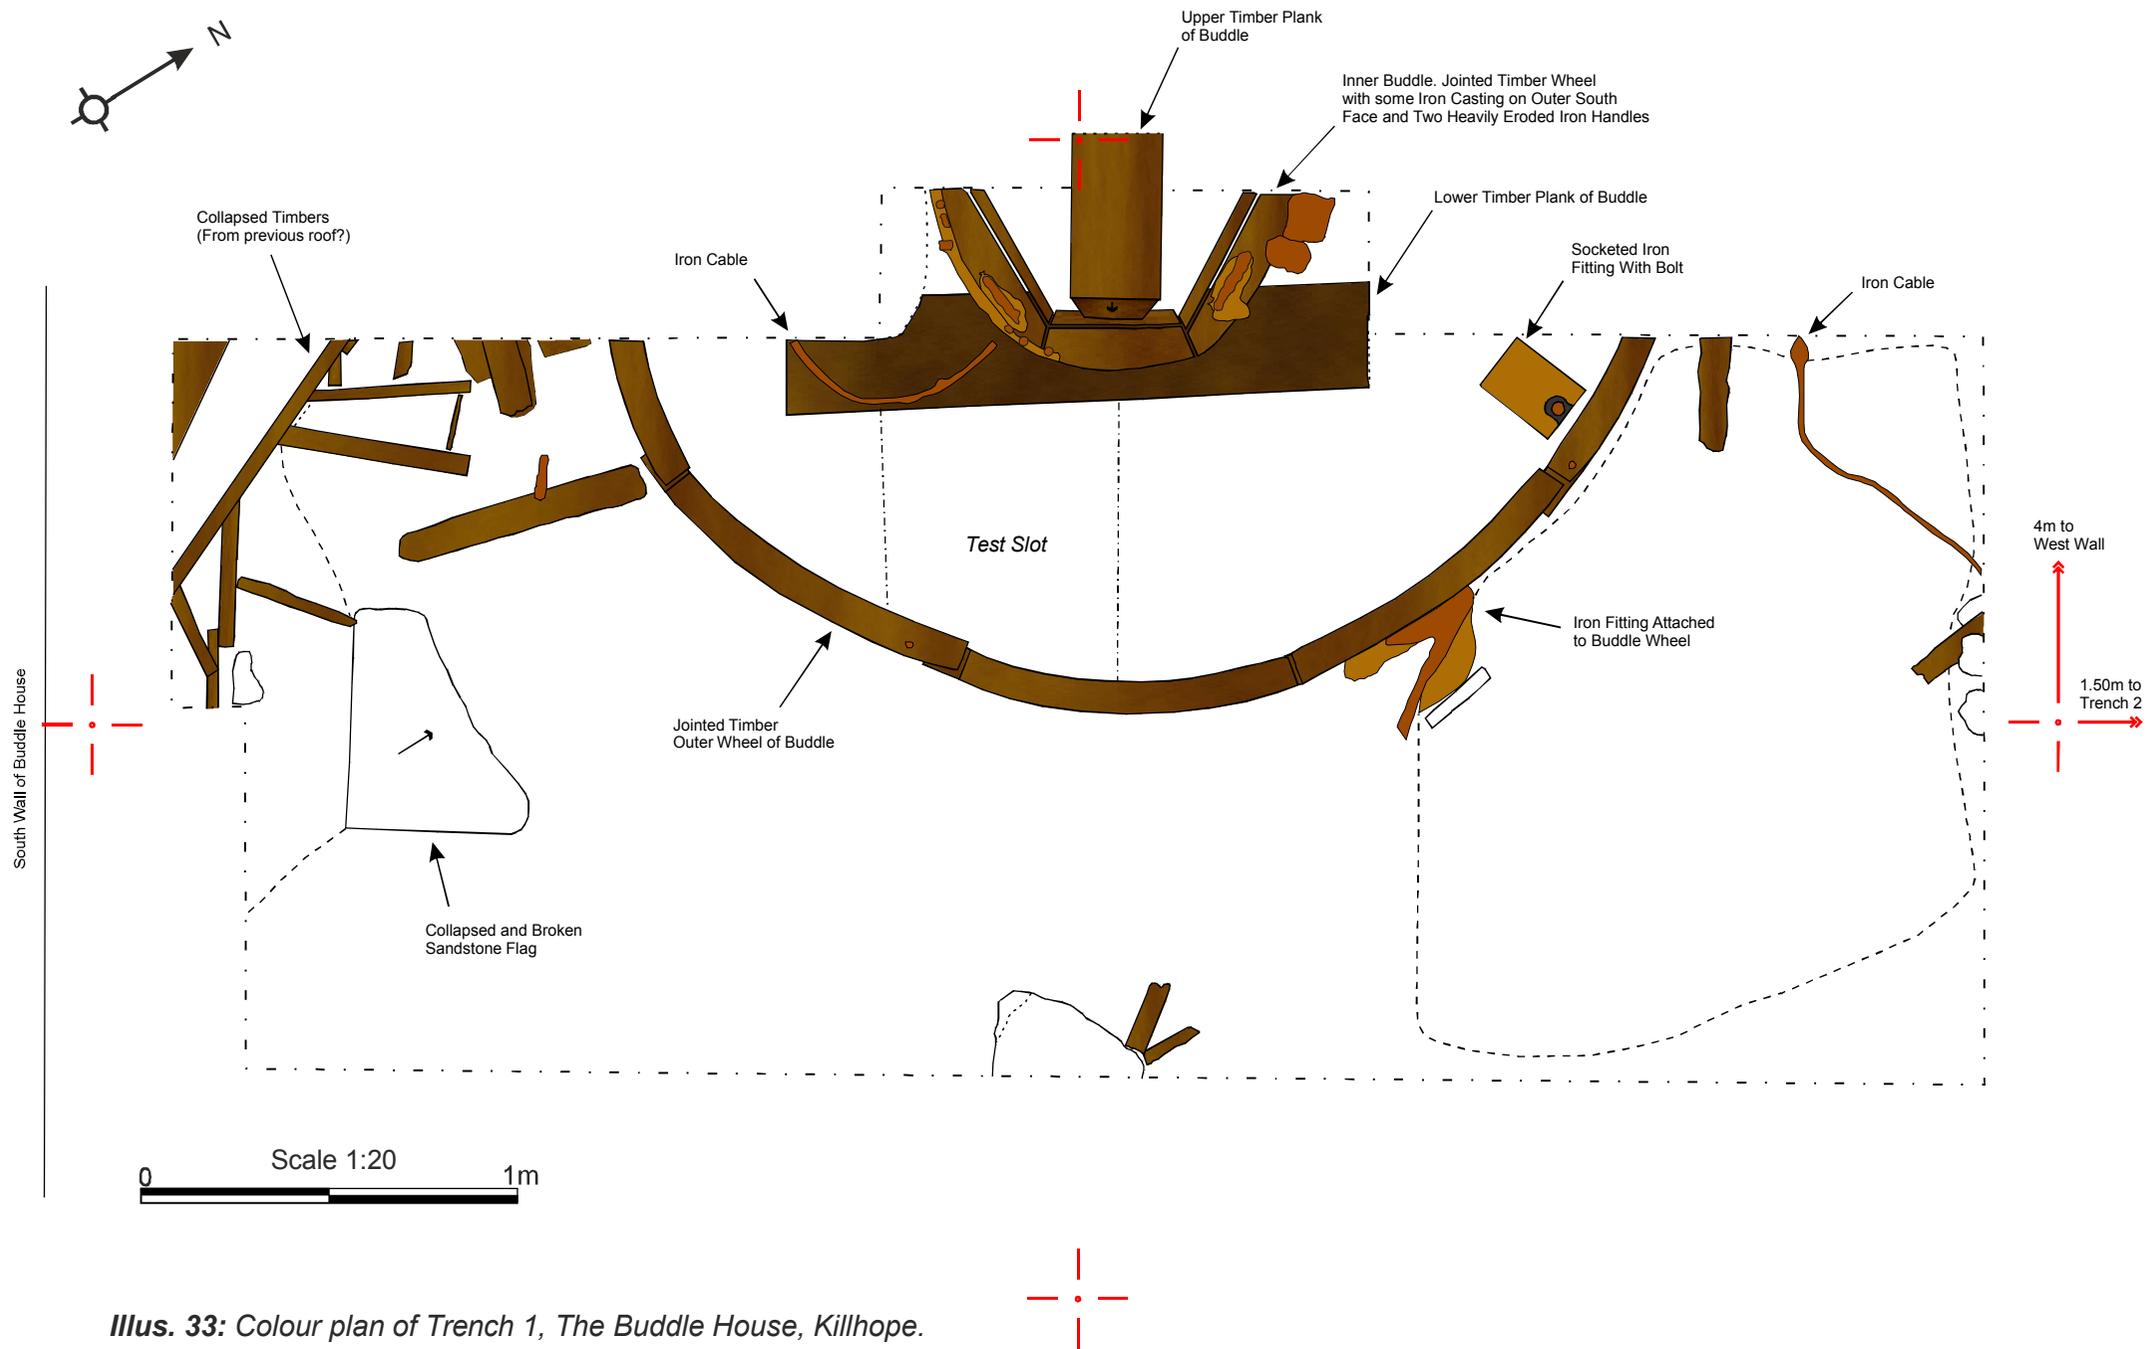
**Illus. 32:** Line drawing plan of Trench 1, The Buddle House.

Initial excavations revealed a very shallow layer of apparent mortar forming a rough surface just beneath the present ground level, and extending throughout the trench. Beneath this layer, a substantial deposit of collapsed roof timbers and associated roofing slates (02), were encountered throughout the trench, concentrated towards the south-west end. The most substantial deposit encountered throughout Trench 1 was a firm but friable, dark grey, shale-gravel mixed with loam (03) observed below the modern collapse and probably associated with made ground from the original construction of the building. A large broken sandstone flag (04) observed at the southwest end of the trench and sitting upon (03) may represent fragmentary remains of an original flagged floor, documented in historic documents but subsequently robbed out.

Cutting into (03) and visible in the north-western side of the trench, were the substantial remains of presumed buddle workings (05). This feature comprised of two distinct elements; the first took the form of a partial ring of timber, segmentally formed by five curved timber batons rather like a timber wheel. Each baton measured around 0.90m (length) x 0.08m (width) and had overlapping joints secured with broad iron nails. Heavily corroded iron fittings seemed to be attached to the exterior of the most easterly of these timber batons, and a socketed iron fitting containing a large bolt appeared just inside the north-eastern part of the suspected buddle. Just under half of this circular structure was exposed within the trench, with an estimated diameter of 3.05m (exactly 10 feet). It was calculated that the north-western edge of the buddle probably lies 0.94m south-east of the west wall of the building.

Within the parameters of the original trench dimensions, the second element of the suspected buddle feature (the cone or hub-support, labelled as the 'inner buddle') was only just visible in the south-east facing trench section, but was regarded of sufficient archaeological importance to explore in further detail by extending the trench a further 1.30m (length) x 0.40m (width) from a point 1.87m north-eastwards from the west corner of the trench. This feature constituted three further components. The first was a lower platform/foundation constructed from a substantial timber plank on which the buddle apparatus sat, measuring 1.55m (length) x 0.30m (width). Second was an elevated 'inner' wheel, measuring about 1m in diameter, constructed with two jointed skins of timber batons. The first skin of timber was curved on the outside and strengthened with sheet metal casing (now only partially visible on the southern side), and squared off on the inside from where a second skin of narrower timber batons was joined to it. Two heavily eroded, linear, cast iron fittings resembling handles, were observed to project vertically from the centre of two batons

from the first outer skin of the inner buddle wheel, along with other possible iron fittings observed at the edge of the northern baton. This 'inner wheel' had been propped up on the north-east side by the insertion of thin wooden wedges between it and the underlying wooden platform (an observation consistent with actions designed to counteract the subsidence documented in the building, probably caused by settling of the infilled floor deposits, in early 1880). The third component of the buddle inner wheel, comprised of an upper timber plank, positioned upon the top of the timber wheel and almost at 90° to the lower foundation plank. This plank measured 0.50m (maximum length within parameters of trench) x 0.24m (width) and had a bevelled south-eastern face.

It is recommended that the remains of the convex buddle uncovered in Trench 1 should be fully exposed by excavation in order to determine its full size and the nature of all its components, and that consideration is made to their preservation and display – perhaps mounted on a wall of the building or in another suitable location - alongside interpretive material presented on a panel or in the form of a reconstructed model.

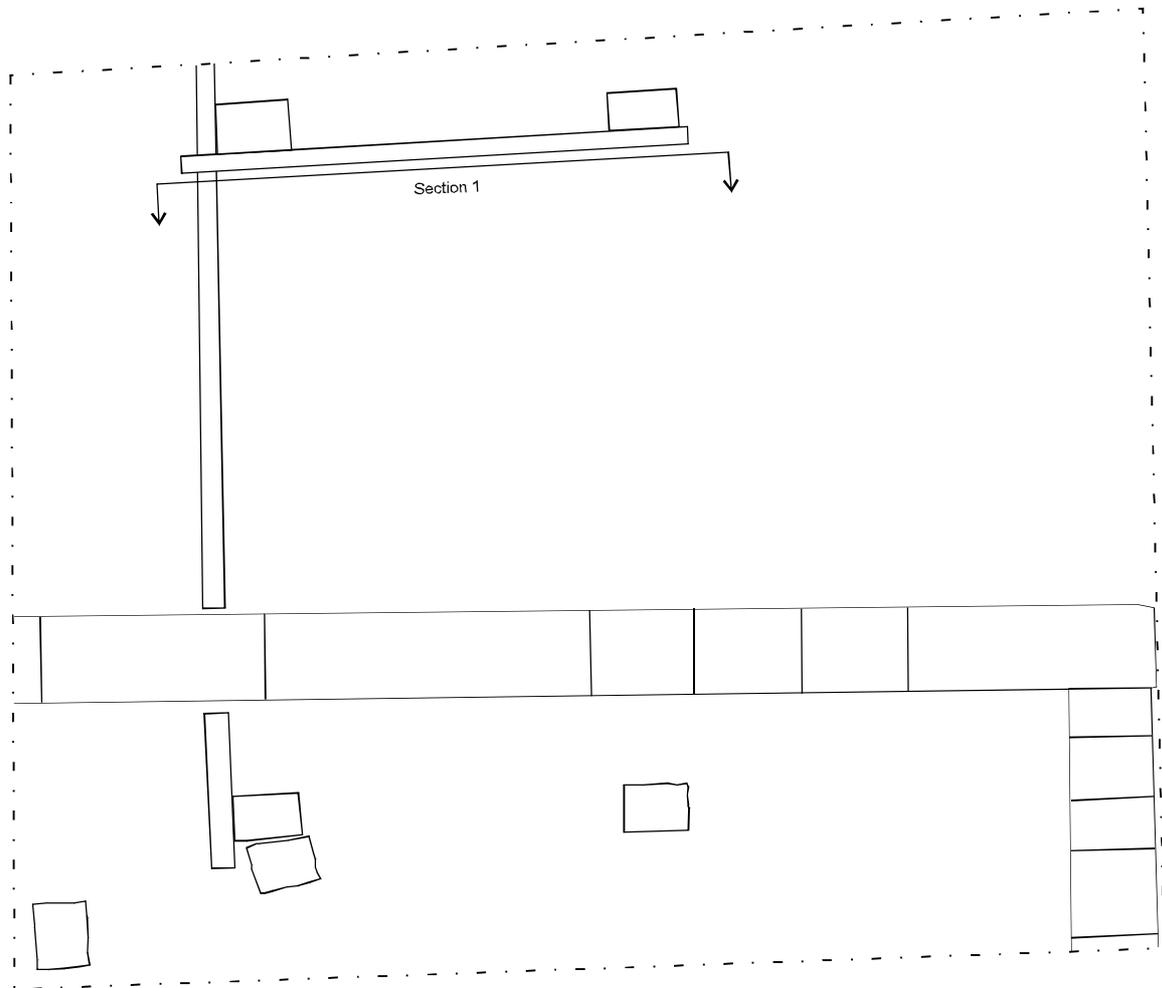
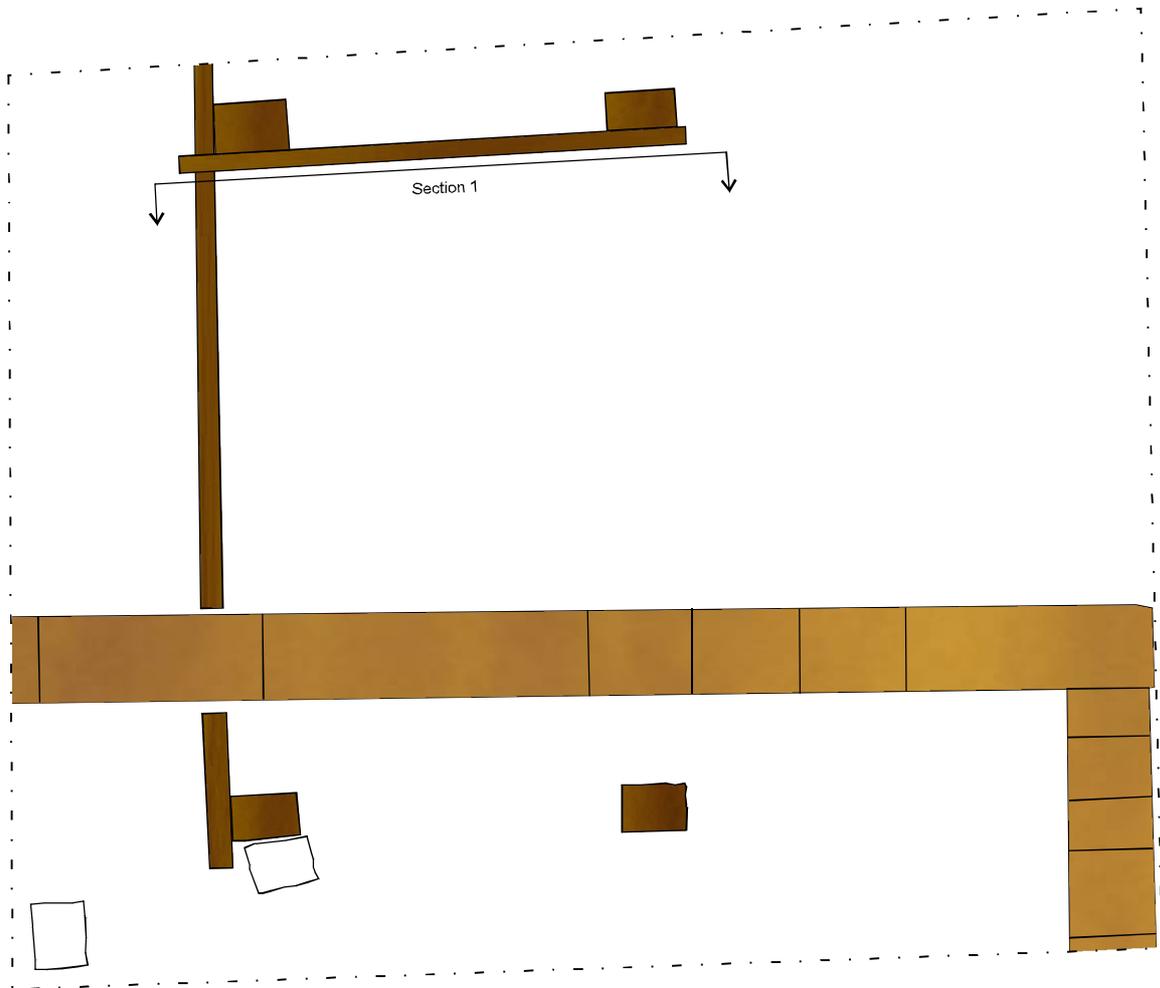
*Illus. 40a: Plan of Trench 2, The Buddle House.*

Trench 2 was strategically positioned to investigate the remains of four surviving timber uprights, now somewhat weathered but projecting out of the ground on the north-east side of a path leading from the centre of the buddle house to its door in the north-west side. The trench was located 1.70m north-east of Trench 1 and 1.0m south-east of, and parallel to, the north-west wall of the Buddle House. The trench was rectangular in plan and aligned south-east to north-west.

Excavations revealed a very shallow layer of mortar (01) forming a rough surface just beneath the present ground level, and extending throughout the trench. Below this, a firm but

friable, dark grey, shale-gravel mixed with loam (02), as also recorded in Trench 1, was thought likely to be associated with made-up ground from the original construction of the building.

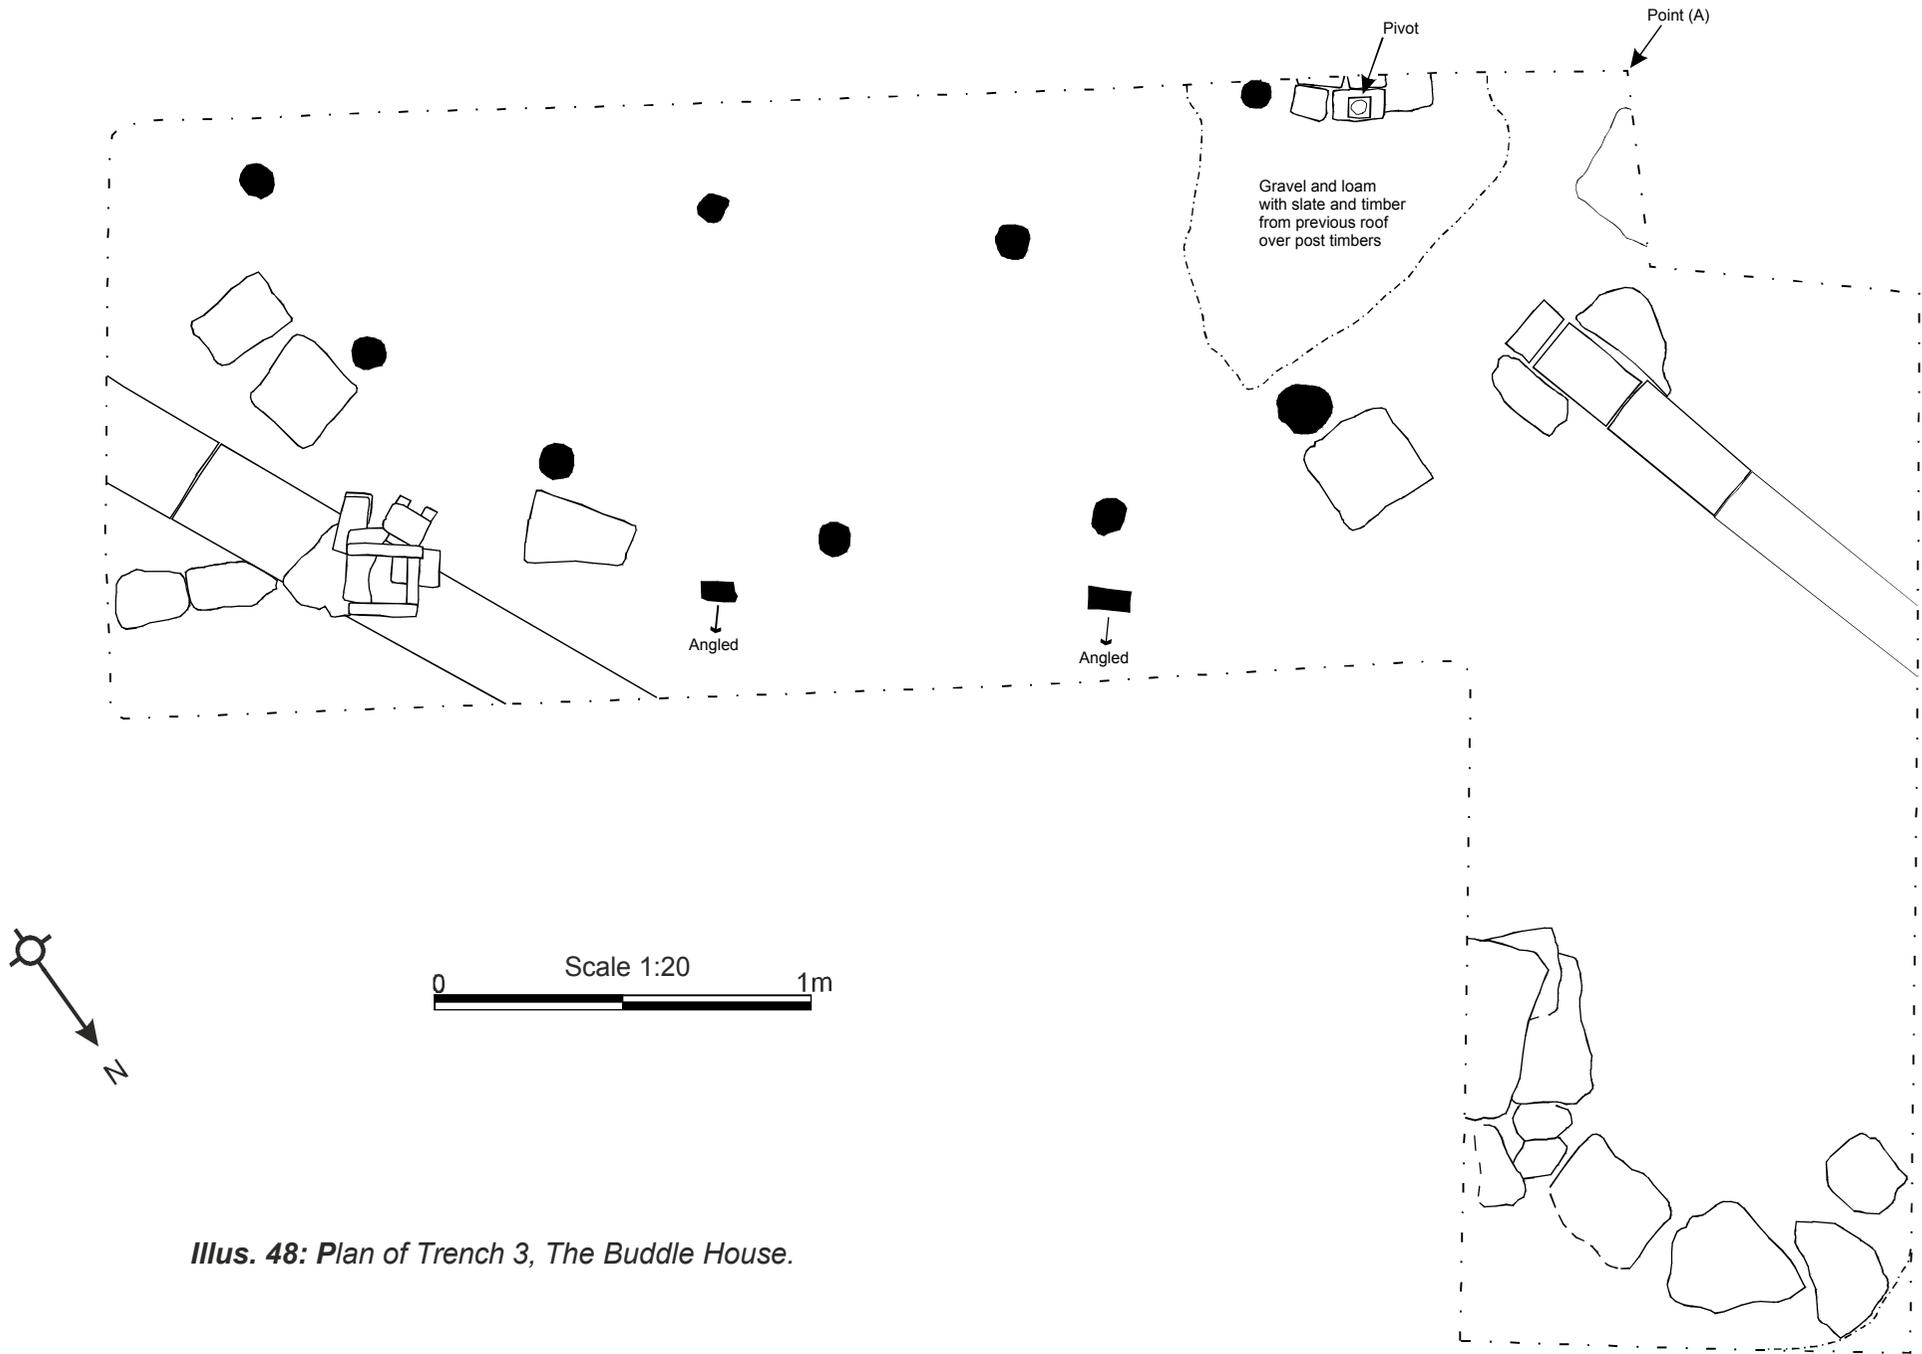
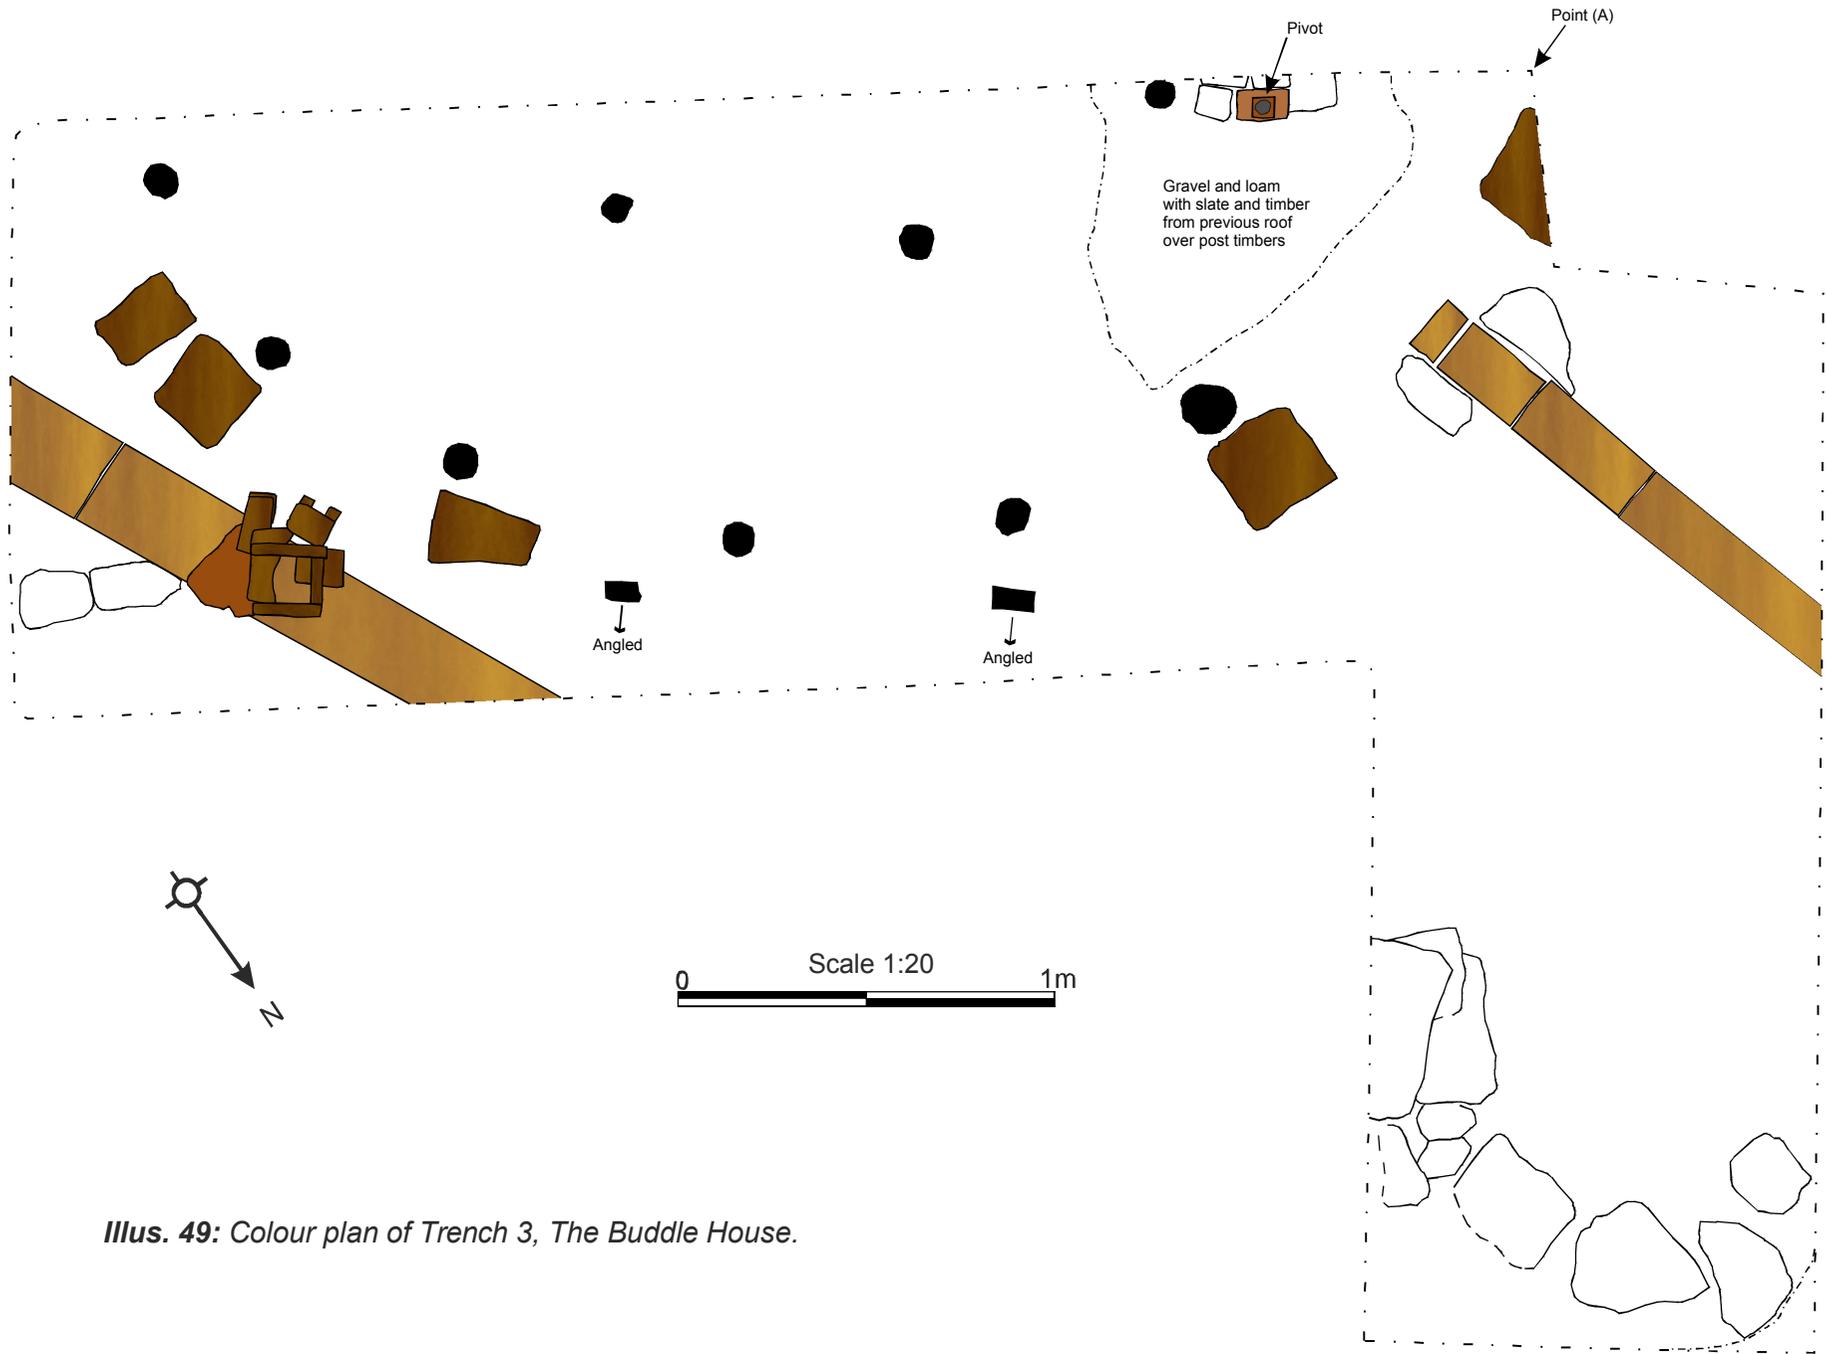
*Illus. 48: Plan of Trench 3, The Buddle House.*

Excavations revealed a very shallow layer of a mortar-rich deposit (01), as seen across the entirety of the Buddle House, forming a rough surface just beneath the present ground level. Beneath this layer, fragmentary deposits of collapsed roof timbers and associated roofing slates (02) were observed throughout much of the trench. Below this was a firm but friable, dark grey deposit of shale gravel (03), probably representing made ground when the area was levelled before and after the original construction of the building.

A boxed segmented timber drain (04b) aligned roughly north-south, virtually identical to that observed in Trench 2, was uncovered at the west end of the trench. The projected alignment of this drain beyond the south-western edge of the trench, meets exactly with the centre point of the proposed inner ring (04a), and would appear therefore to have been an instrument of water supply or, much more likely, drainage associated with the buddle workings.

A second concentric ring of post stubs (04c) (with some simply being postholes), numbering six in total within the trench, was observed at 0.70m beyond (4a) to the east and north, with a wider projected diameter of 3.80m (12.50ft). Individually, these postholes were slightly more substantial than those of the inner ring, measuring on average 0.10m in diameter, and some were set closer together – varying between 0.45m – 0.68m.

Associated with these pads and observed within the same concentric band at the centre of the north-eastern end, were two rectangular stubs of timber posts (04e). These posts measured 0.10m x 0.05m, were set 0.93m apart, and were both angled downwards in a north-easterly direction, evidently to lean on and thus provide further support for the main structural frame of the proposed buddle.

Immediately adjacent to the eastern side of the outer perimeter of the proposed buddle, a further boxed timber segmented drain (04f) was observed running (roughly) on a north-south alignment. This drain was slightly broader than the first, measuring 0.21m in width. A small collection of timber and iron workings, including a small open topped timber box and a timber baton bolted to the centre of a flat iron blade, were observed sitting upon and spilling over the drain. It is unclear whether some of these features were associated with the buddle itself

It is recommended that the remains of the putative concave buddle uncovered in Trench 3 should be further exposed and recorded if significant ground disturbance is proposed in that area, or if it is considered that drainage works will change the sub-surface hydrological conditions enough to threaten the survival of sub-surface timber remains. While of considerable archaeological and interpretive value, however, the condition of these remains is not good enough to merit their permanent display, so any excavated remains should then be back-filled without an attempt to preserve them for display. The position of this buddle would, however, lend itself to a reconstructed buddle placed above it.

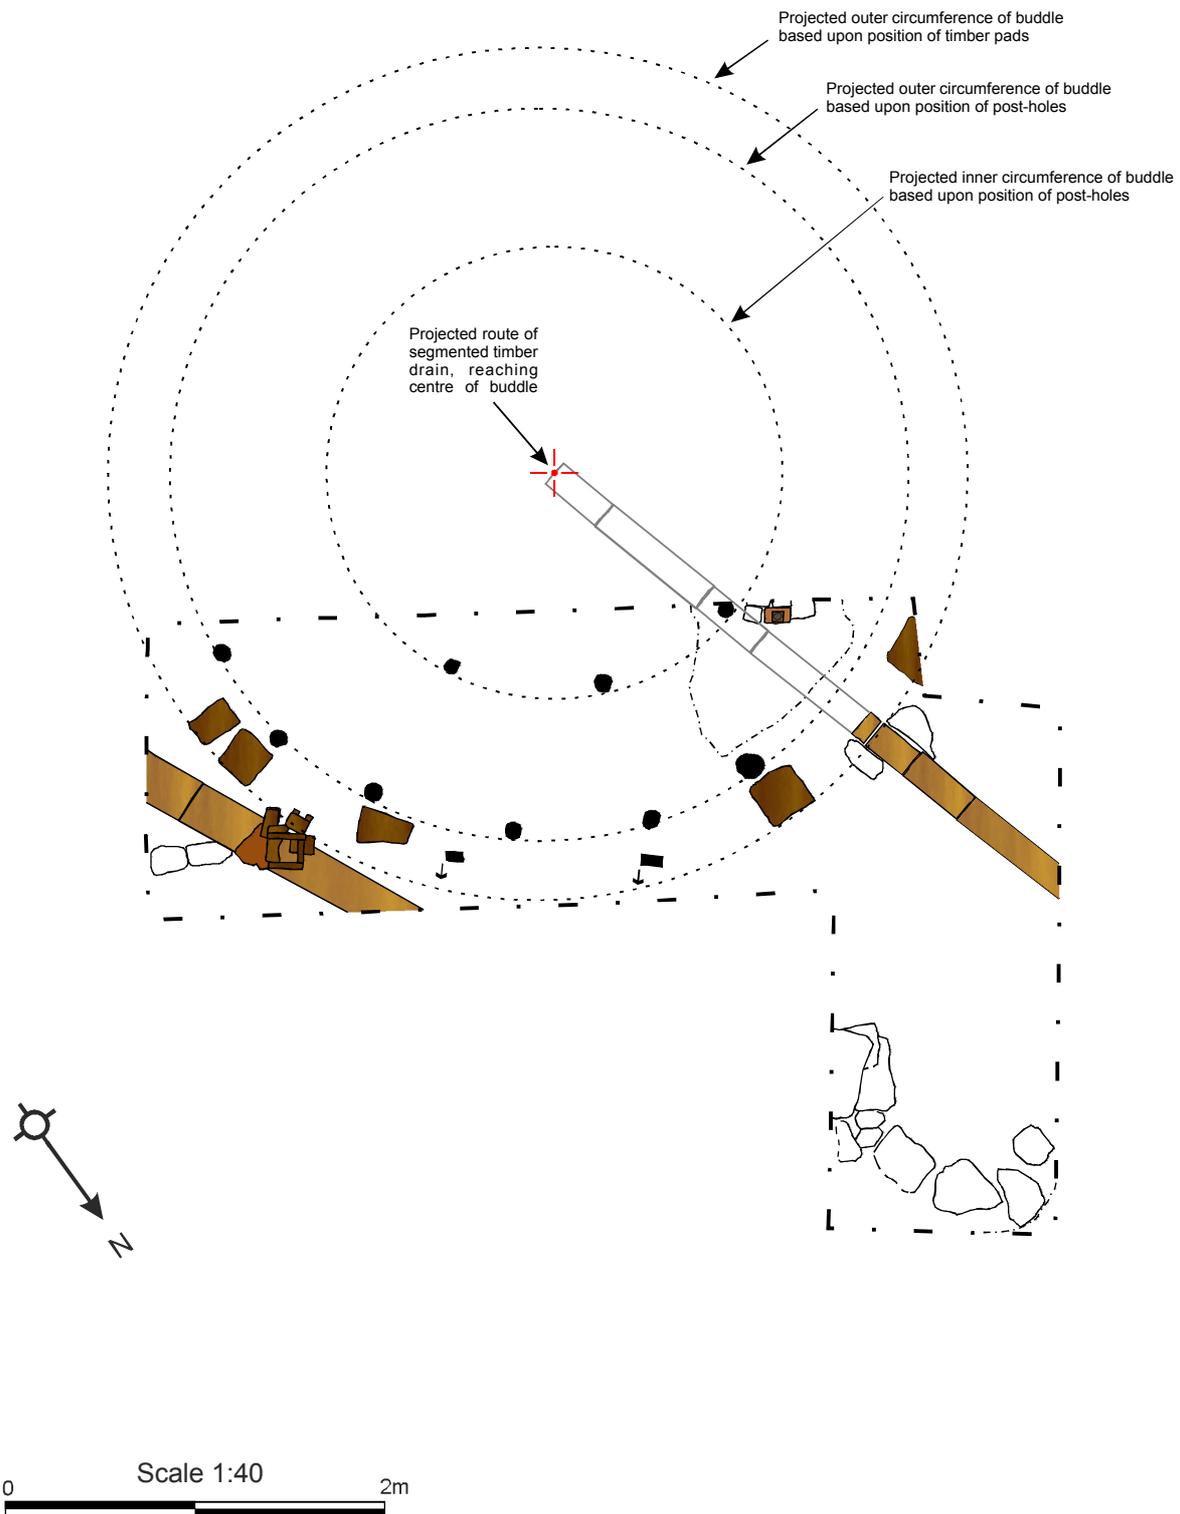
*Illus. 50: Colour plan of Trench 3, showing projected circumference of suspected buddle.*

The remains excavated in Trench 3 are best interpreted as those of a convex buddle, with the two concentric rings of posts providing support for the convex, saucer-like wooden buddle. Some of the loose timbers and iron fittings found strewn within Trench 3 may relate to the super-structure of the buddle, but some could equally be part of the roof structure of adjacent waterwheel. One of the box drains found in Trench 3 is clearly positioned to drain the centre of the buddle – as would be expected for a convex buddle structure – but the other, running NW-SE in the east corner of the trench, is of unknown function.

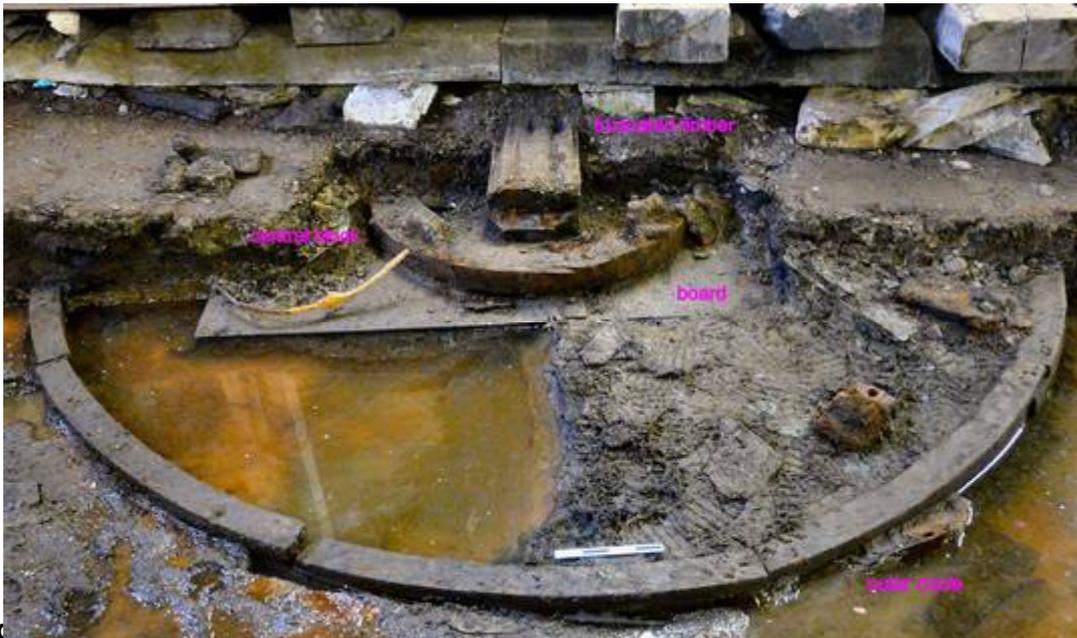
Fig

The 'buddle' comprises an outer (presumed) circle c2680mm in diameter, made up of a series of curved, half-jointed timbers c78 x 78mm in section. Occasional surviving nails/staples and localised iron staining on the top surface of the wood suggest nailing was the original means of affixing the half joints. In the presumed centre of the outer circle is a wooden board c80mm thick and at least 1530mm long, its width concealed under the unexcavated portion of the 'buddle'. Along its front edge, this board appears to rest on a small, squared off length of timber, now broken at its visible end.

On top of the board, pieces of timber (each c70mm wide max x 90mm thick) have been cut and joined to form a circular block of wood c930mm diameter. It is not clear how the pieces were fixed together. Staining around the outer rim of the block suggests there was an original encircling iron band, now lost. The corroded remains of two unidentified iron fittings survive on the surface of the block. On top of the block lies part of a large timber 250mm wide x 160mm thick. This timber has been cut off – possibly fairly recently – and only some 540mm visible length survives. Two large nail heads protrude from the top surface,

As examined, the base of the outer timber circle and part of the central board were under water. The small central block and large, truncated timber were exposed to the air, though currently still damp. The outer circle, board and central block appear to be in very good condition, with traces of tool marks still visible on the outer circle and no signs of wear to most of the components. The wood is extremely hard and almost completely resistant to puncture with a steel awl. Part of the edge of the central block has been damaged, possibly during truncation of the large timber which lies over it, and it was possible to remove a sliver of damaged wood for species identification. This was identified microscopically as pine, though the exact sub-species could not be determined; pitch pine is a possibility. The top surface of the large timber is worn and abraded, in contrast to the condition of the rest of the 'buddle' structure, and the wood can be punctured to a depth of c3mm, suggesting some degradation of the timber.

Taking into account the relatively recent date of the structure (19<sup>th</sup> century) and its (mainly) excellent condition, it is likely to survive lifting and controlled air drying without significant damage or distortion.

Very hard, non-degraded timbers do not benefit from the pre-treatment and freeze-drying process which is applied to archaeological wood, as the treatment solutions will not penetrate the still-solid wood structure. Controlled air drying is the preferred method for drying solid, historical timbers.

To control the drying process, to minimise timber distortion, the wood should be loosely covered (**but not wrapped**) in polythene sheeting.
