Muggleswick Grange

Priory Farm, Muggleswick, Co. Durham

Historic building survey and community archaeology projects
(October 2009 - September 2011)

Data Structure Report (March 2011)

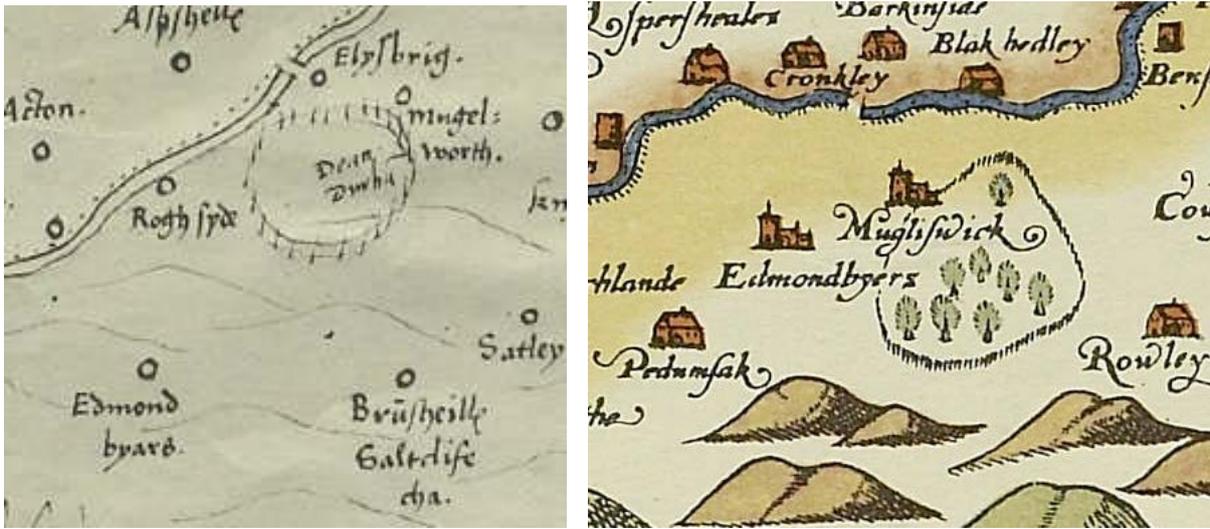
Figure 2.1 detail of Burghley's map of 1569 (courtesy of Paul Frodsham)

Figure 2.2 detail of Saxton's map of 1576 (courtesy of Paul Frodsham)

The earliest maps to show Muggleswick include Burghley's map of 1569, figure 2.1, which shows it as 'Mugelsworth', and Saxton's of 1576, figure 2.2. Both show the settlement and the park, but give no indication of the form of the grange or settlement. The earliest map to give an indication of the form of Muggleswick is Greenwood's of 1820, figure 2.3, which shows a few buildings (presumably Lane End, Priory Farm, and Grange Farm) along the line of the Muggleswick Burn, but gives no indication of the grange ruins.

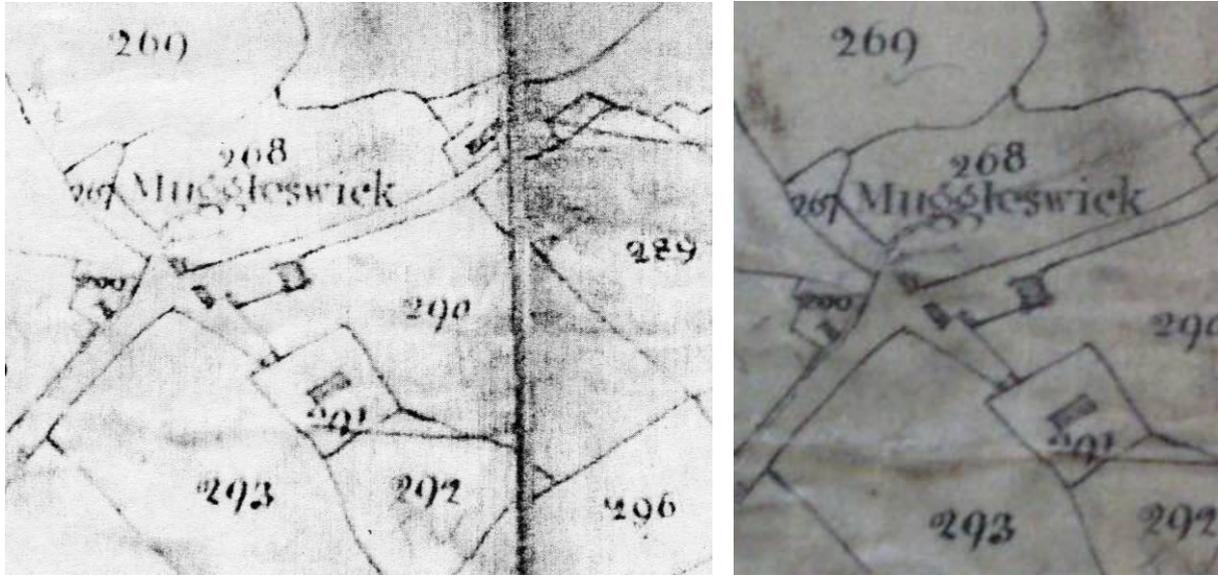
Figure 2.4 estate map of 1800 (Durham University Library)

An estate map of 1800 shows, if somewhat sketchily, the first detailed plan of the site, *figure 2.4*.²² While this may not show all of the buildings within the complex then extant, the structures that do appear seem to be in recognisably correct positions. Of particular note is the east end of the chapel, which is represented as a roofed structure at that date; however it is possible that this may have been a lean-to structure erected within the earlier walls.

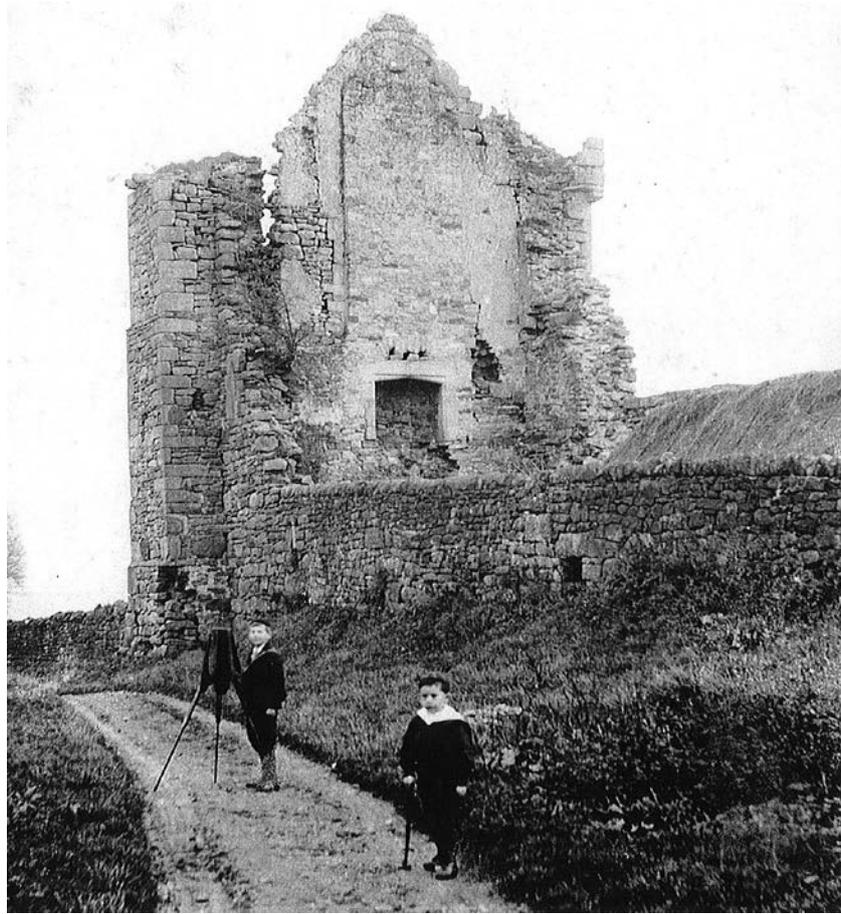
Plate 2.1 Later 19th century view of the ruined gable wall from the WN. Image provided courtesy of Castleside Local History Society.

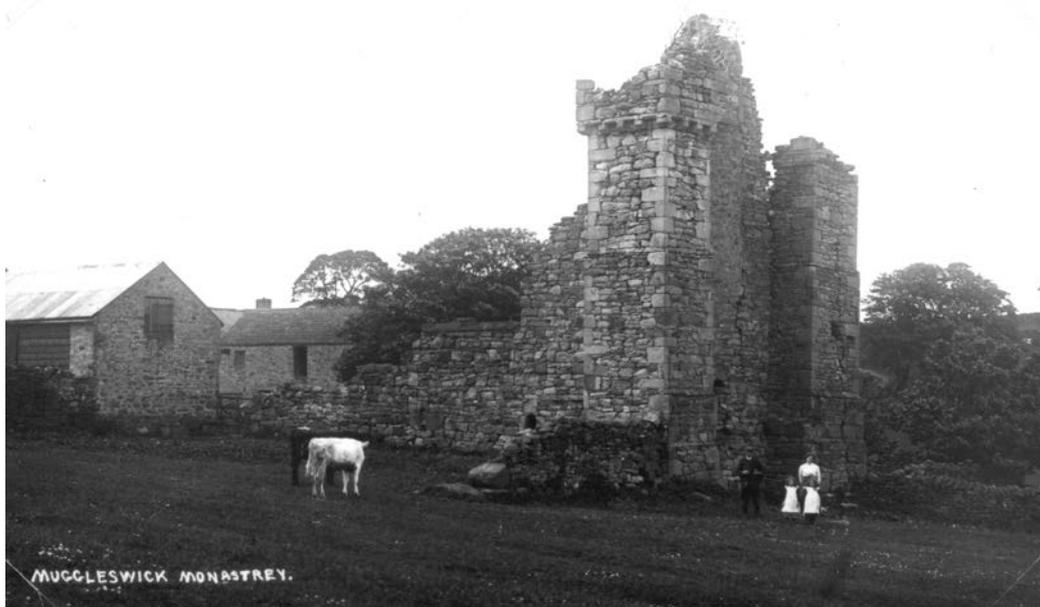
Plate 2.2 Later 19th century view of the ruined gable wall and farm buildings further west, taken from the SE. Image provided courtesy of Castleside Local History Society.

This interpretation appears to be confirmed by the delineation of the ruin on the 1st Edition Ordnance Survey, whose east end appears to be enclosed, possibly roofed, *Figure 2.5*. It also shows the south side of the Muggleswick complex in some detail. The outline of the ruinous early range can be identified within a series of small enclosures in that area. Within the western part of the range is an existing farm building. The latter also appears on the 2nd Edition Ordnance Survey of 1894, by which stage it is accompanied by a second farm building further east. This second structure also appears in a late 19th century photograph of the site seen from the SE, *plate 2.2*.

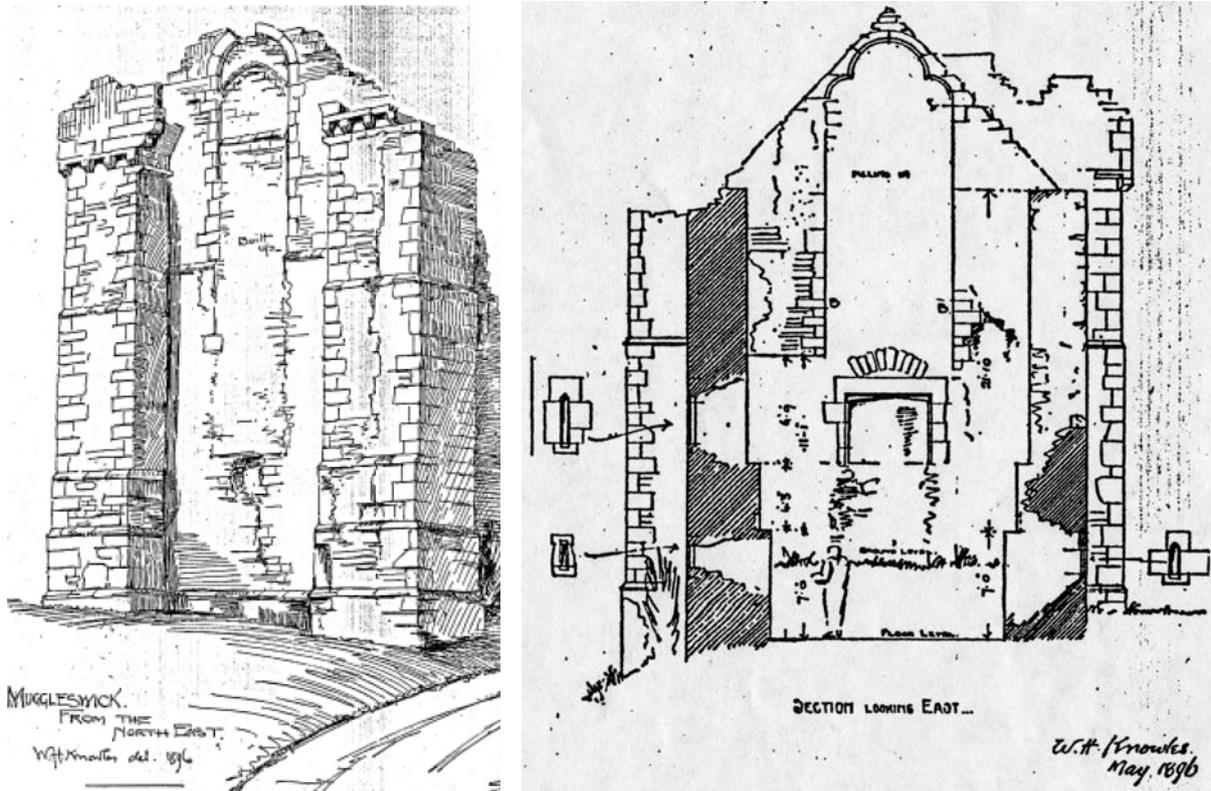
Figures 2.8 and 2.9 Greenwell and Knowles' sketch and internal elevation of the east gable wall of the chapel of 1896

In extent the ruined chapel remains very much as it had been in the 1890s, with the exception of the entrance towards the west end of its south wall described as a *shoulder headed door*, 3 foot 7 inches wide, and five foot 3 inches high. This is shown in the elevation drawing, *Figure 2.7*. Their published view of the east gable shows the upper part of the east window still to be walled up at that date.

The standing ruin had seen significant repair; this evidently occurred after the taking of the two detailed early photographic views presented in *section 2*, and also after Greenwell and Knowles' sketched views of 1896, *figures 2.8-9*, all of which show the ruin in an un-restored state. Greenwell and Knowles also noted the condition of the standing remains,

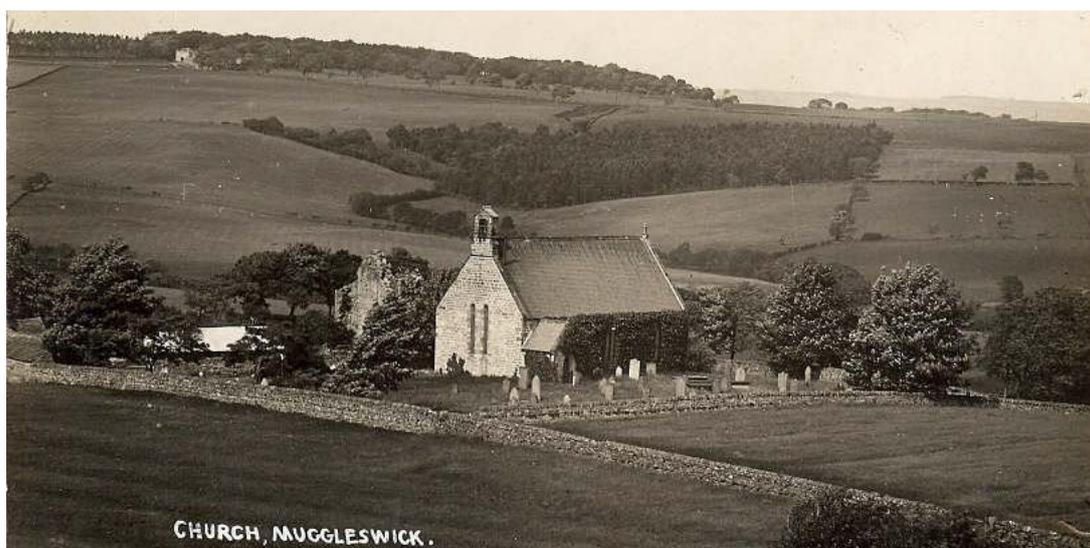
Plate 2.3 Early twentieth-century view of Muggleswick Church from the south-west, with the grange ruins visible behind. (Source: M Sobo archive).

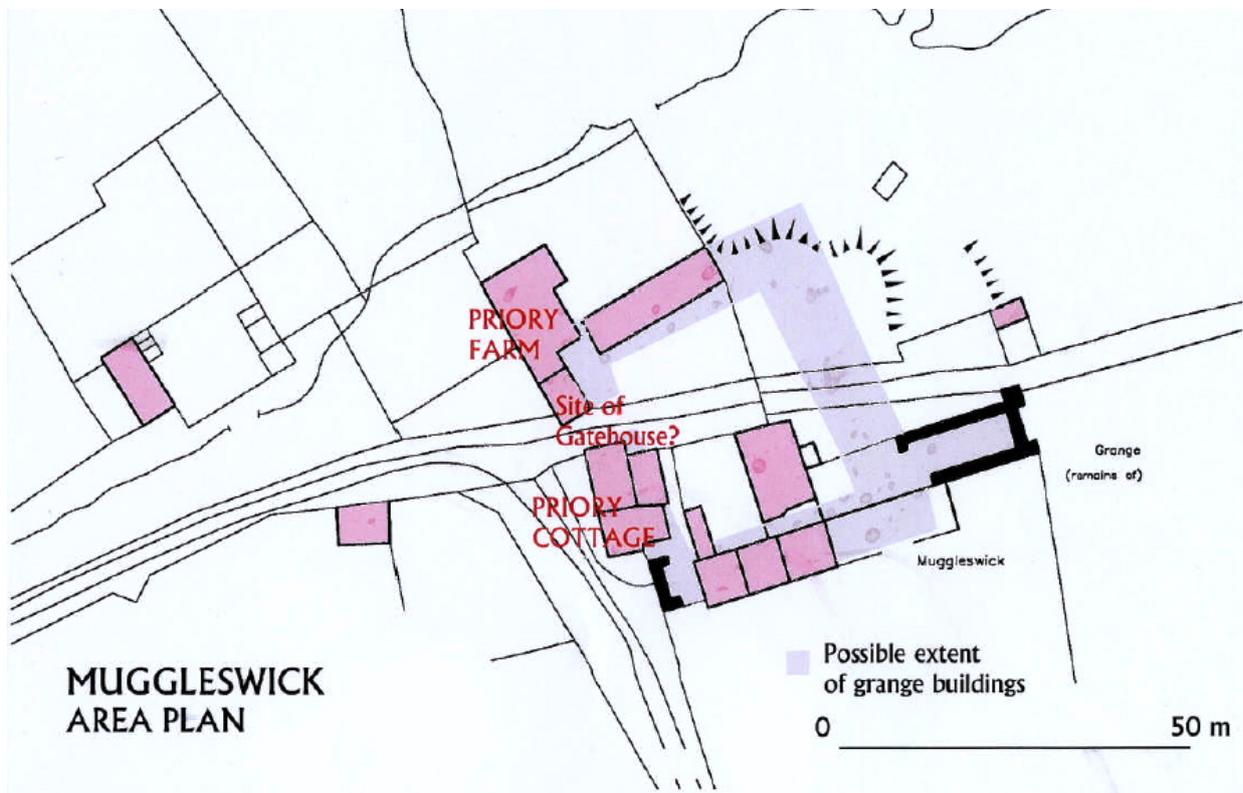
Figure 2.10 General site plan of Priory Farm showing location of upstanding medieval walling (black) and suggested extent of the medieval complex – P Ryder, 2006

Peter Ryder described the chapel ruin and provided observations on the nature of the wider site and, in particular, suggested the grange buildings themselves had formed a large quadrangular enclosure bisected by the existing farm road running through Priory Farm, *Figure 2.10*. These were incorporated into Johnston and Wright's *Conservation Statement* for the site, see *Appendix B.ii*.

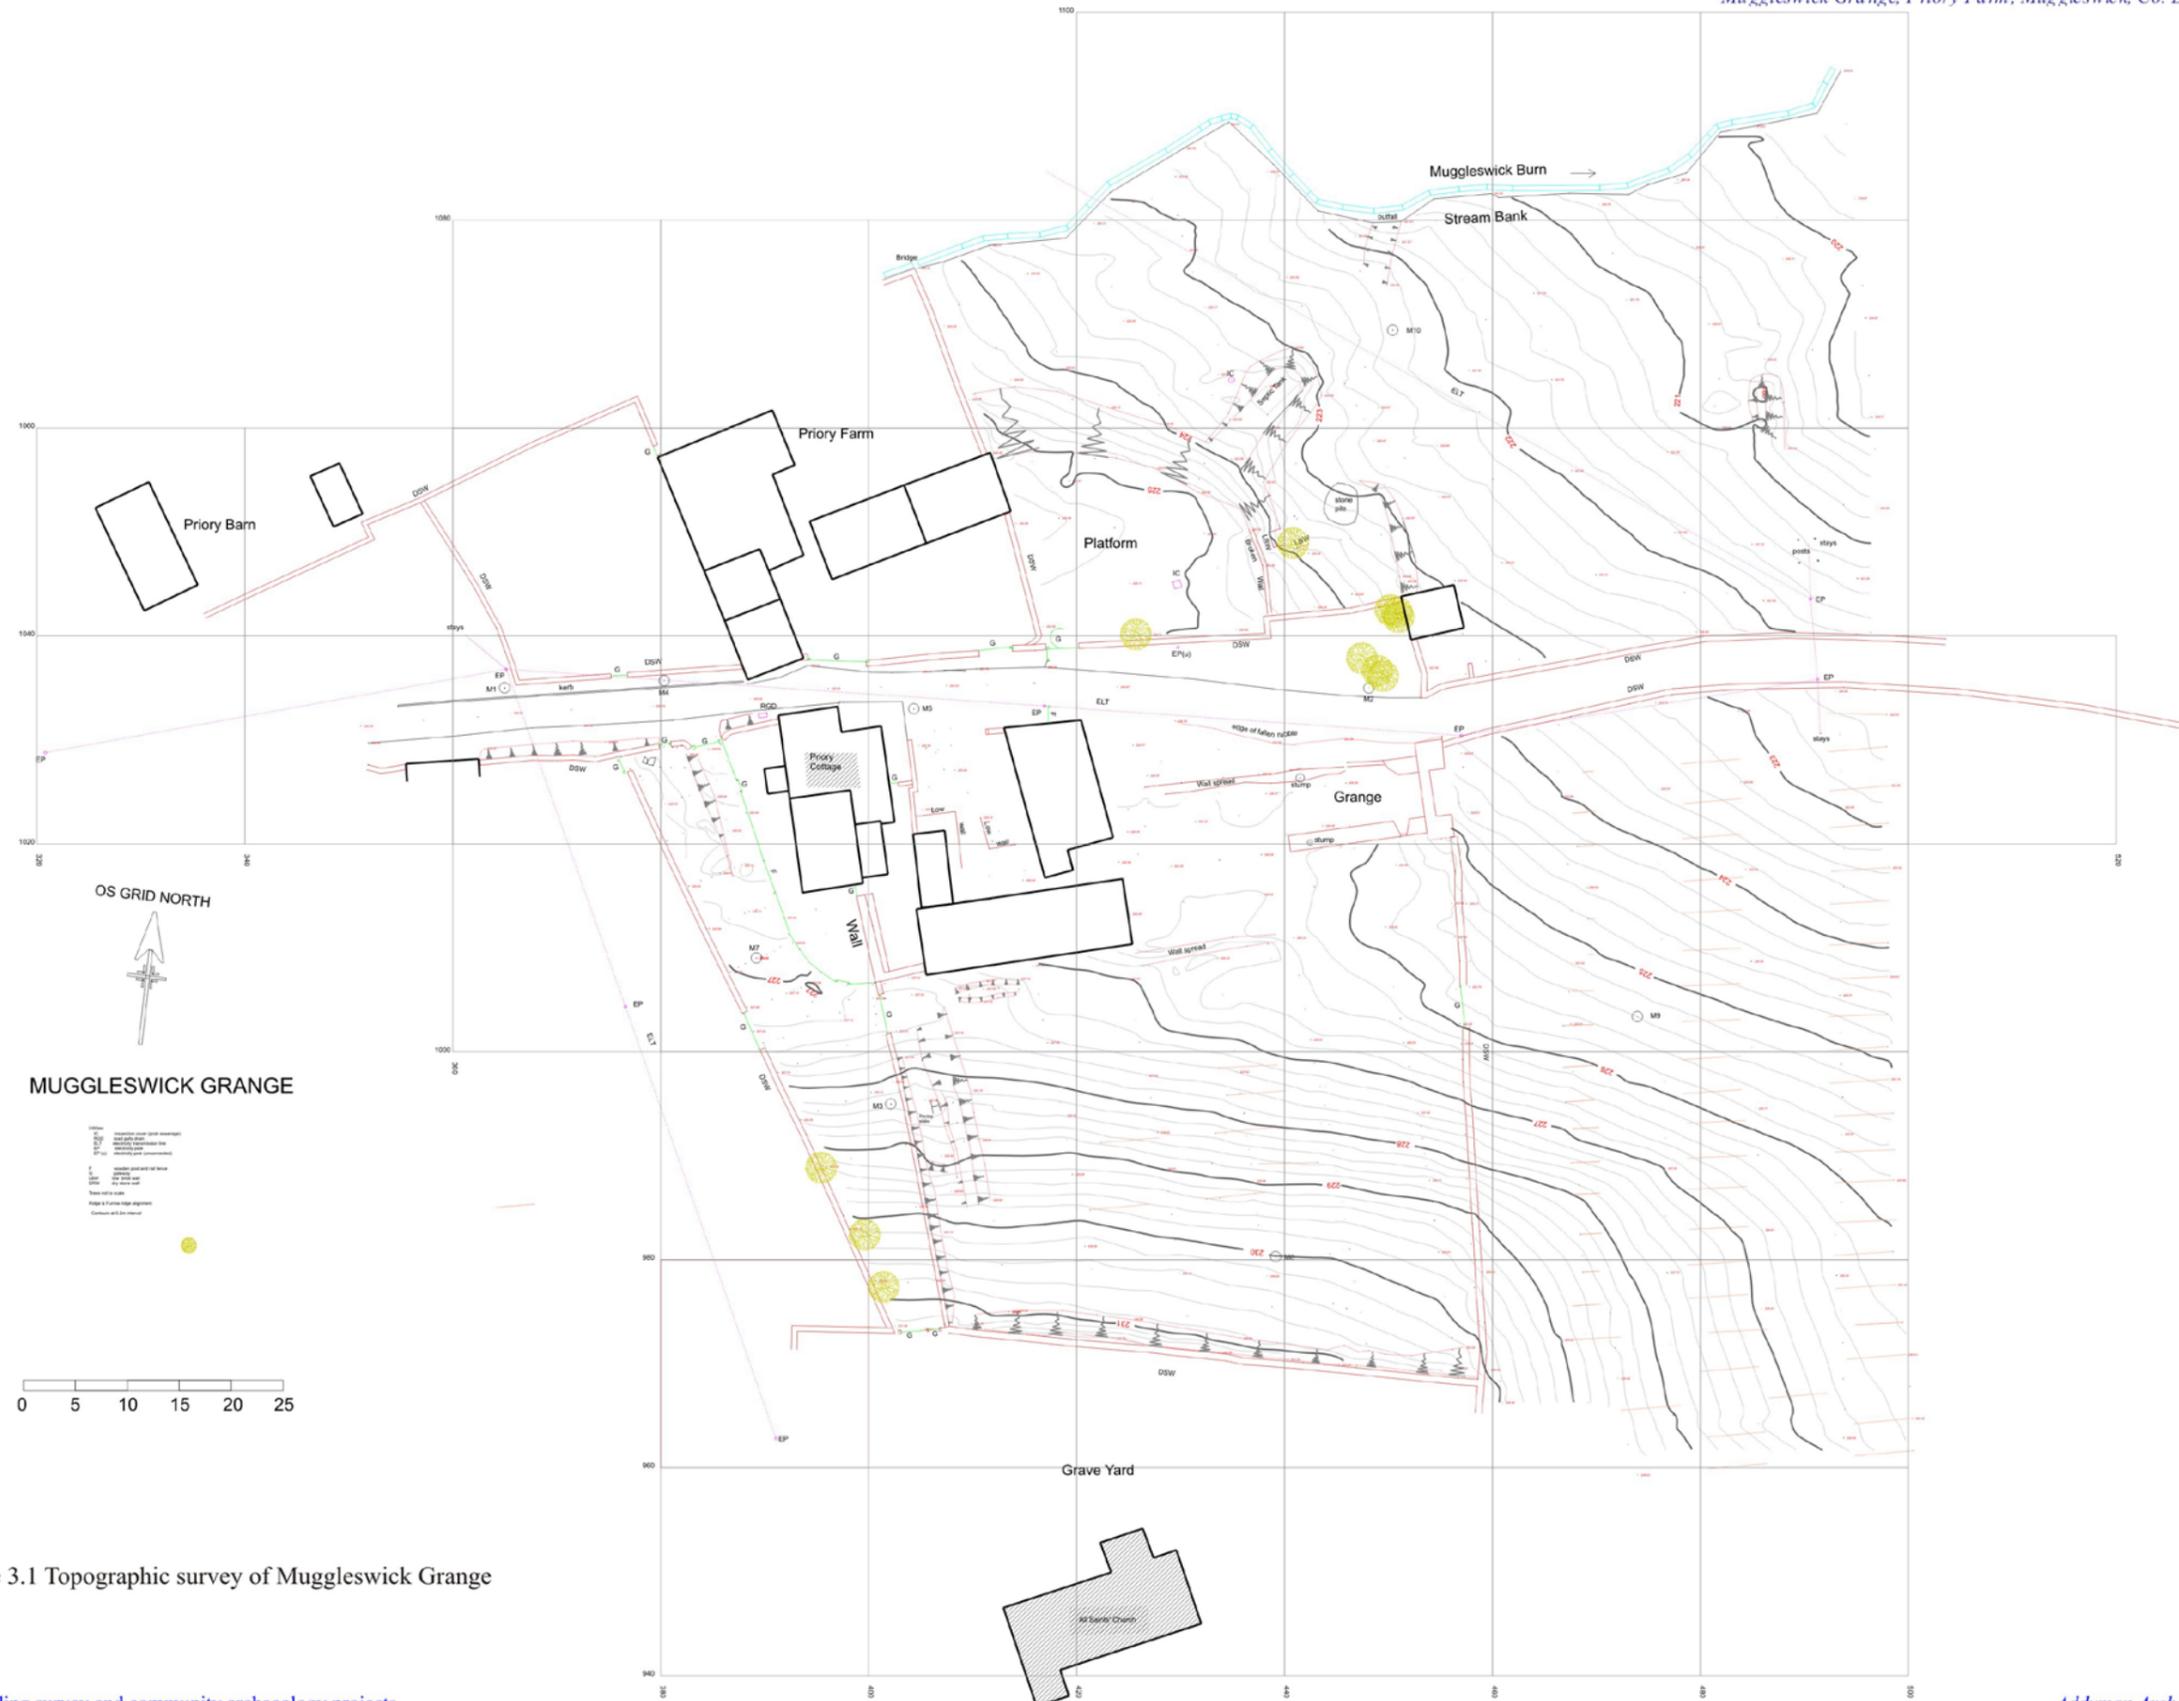
Figure 3.1 Topographic survey of Muggleswick Grange

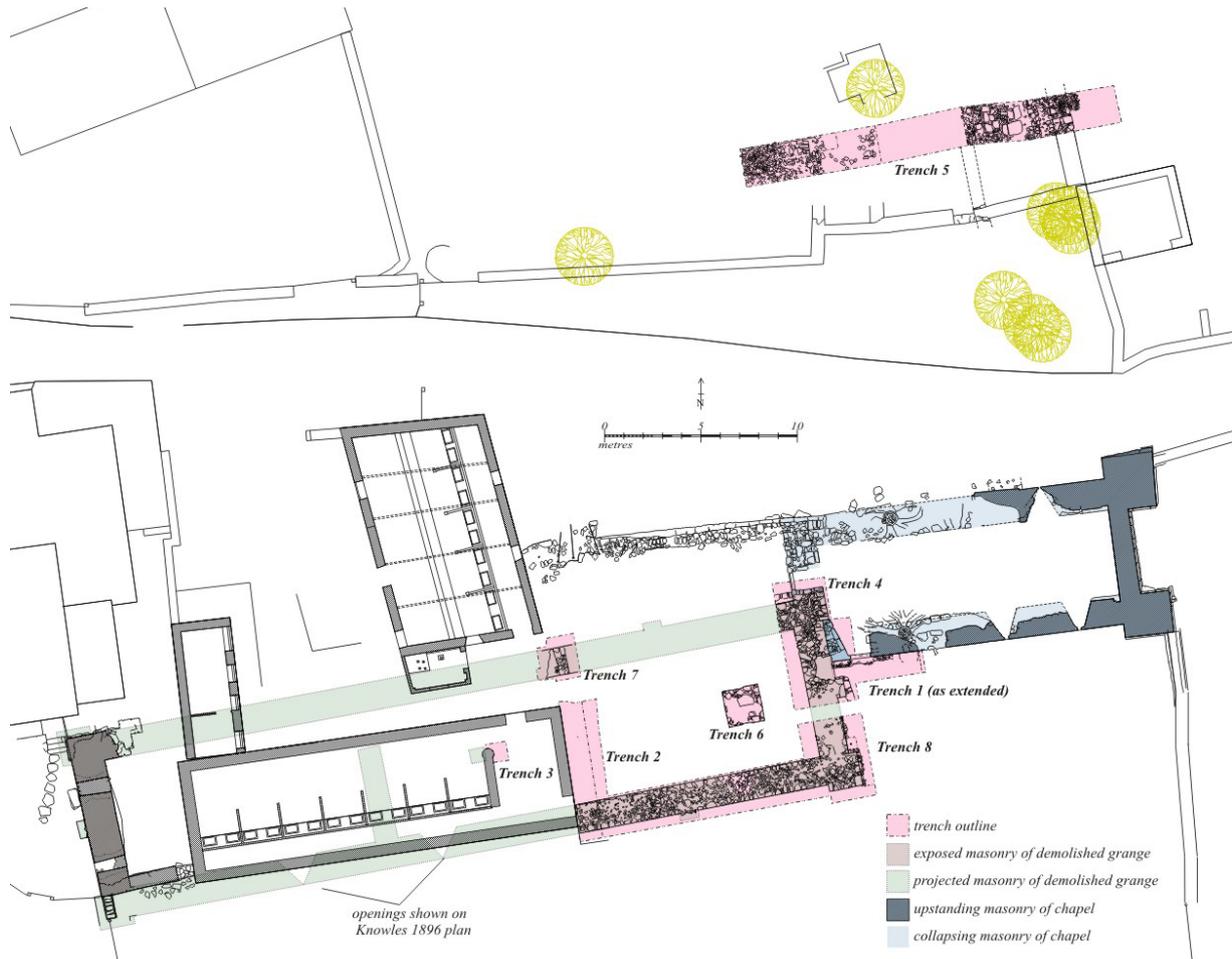
Figure 3.2 Site plan showing the locations of Trenches 1-4 (May-June 2010), and trench locations for the Altogether Archaeology project – Trenches 5-8 (November 2010).

Trench 5, measuring 20.0m by 2.0m, was laid in east/west alignment across the eastern side of the large earthwork platform visible within the field to the north of the farm access road. The field wall bounding the north side of the road incorporated evidence for earlier structures; as can be seen from *figure 3.2*, Trench 5 extended over the line of a number of apparent wall returns.

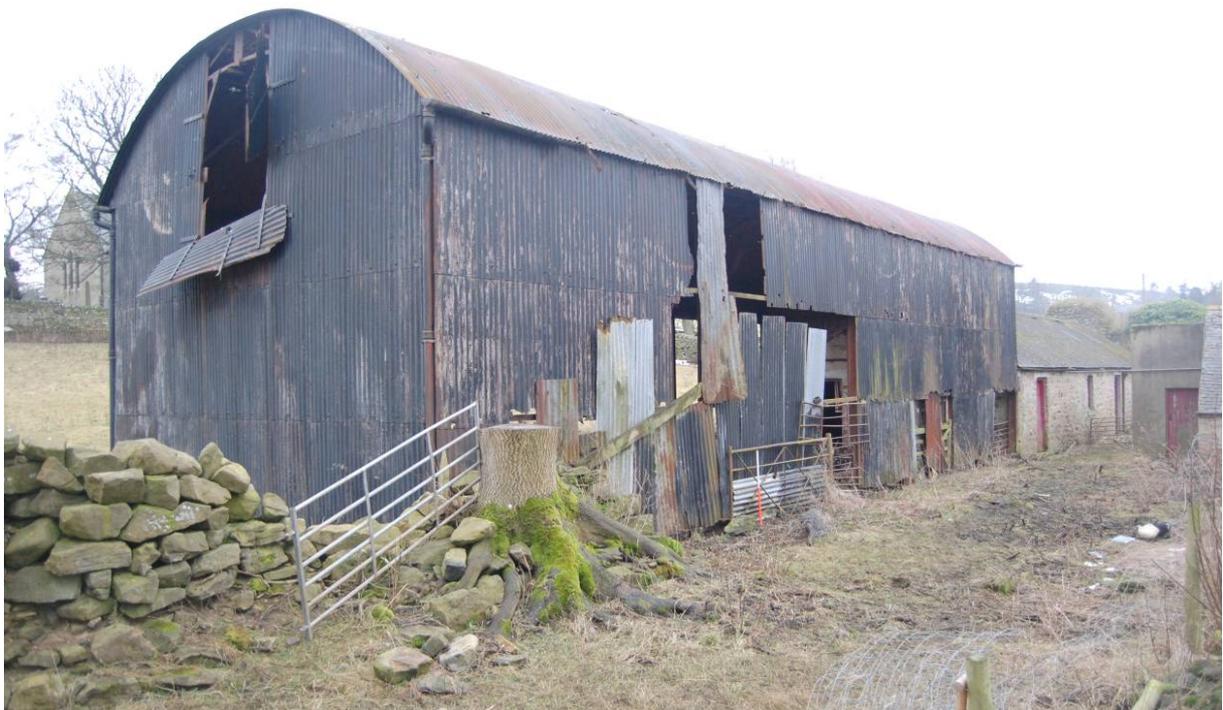
Plate 4.1 General view of the Dutch barn from the NE

Dating to c1900 the existing Dutch barn (*plates 4.1-4.7*) extended eastwards from the east gable wall of the long byre that bounds the south side of the wider Priory Farm complex. Towards its eastern end the north side of the barn had been erected against the external wall face of the chapel ruin (the western end of its south wall).

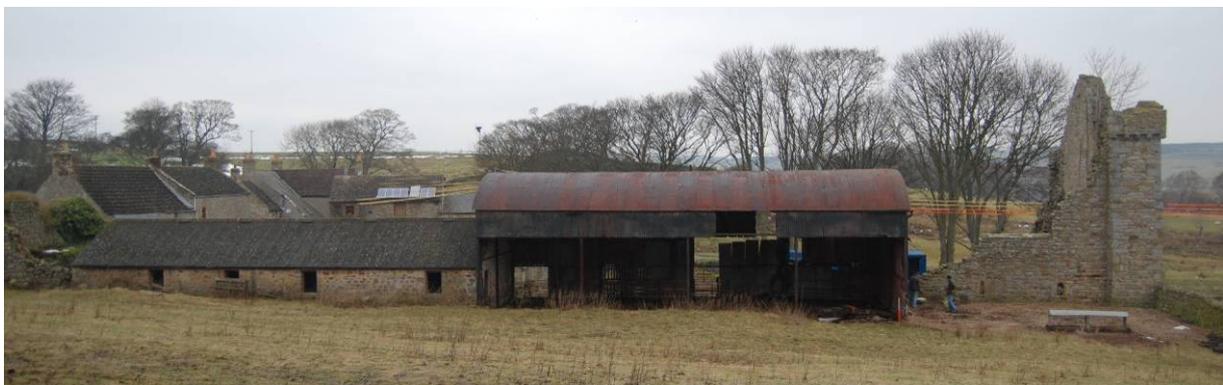
Plate 4.2 General view of the barn and adjacent structures from the south

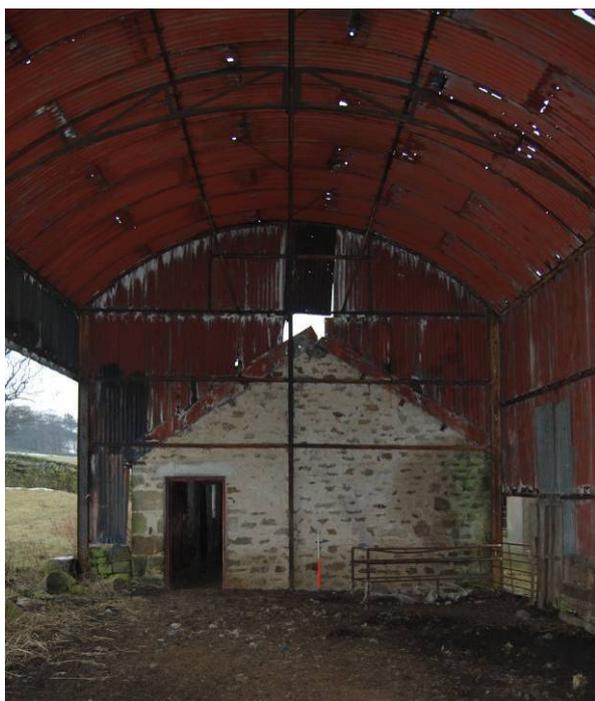
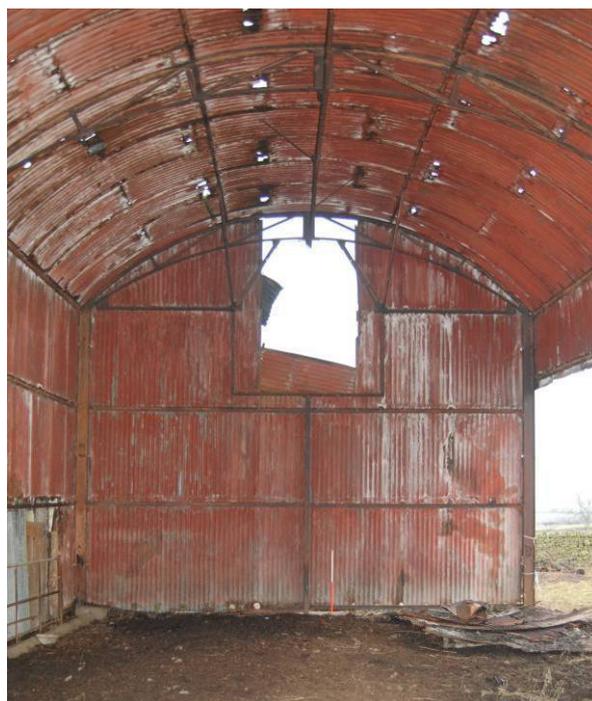
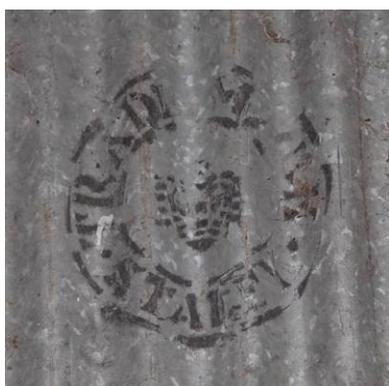
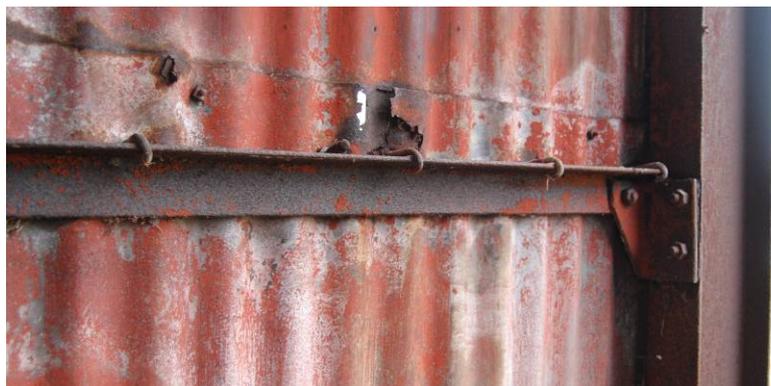
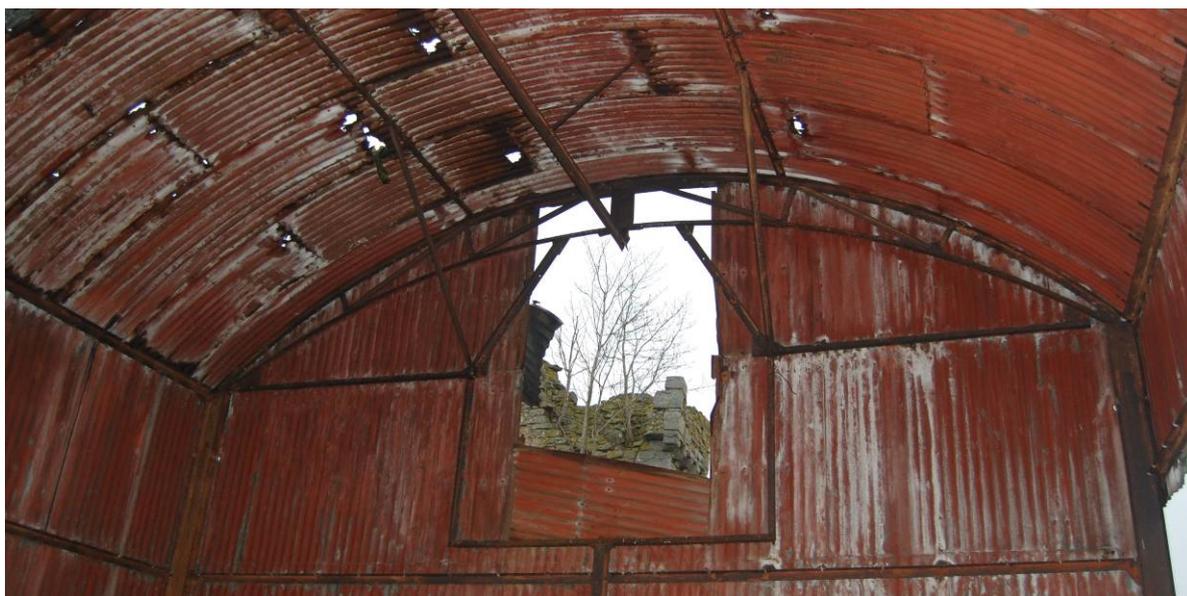
Plates 4.3 – 4.7 Dutch barn – internal views and constructional details

Overall the Dutch barn measured 60'0" by 24'0" (18.30m by 7.32m). Five piers to each side divided the structure into 4 equal bays of 5'0"; less substantial piers were positioned centrally at either end giving the structure a nominal 2 bays depth, each of 12'0". Each pier consisted of an I-section rsj; these had been set within substantial post-pits to a depth of about 0.75m and then in-filled with rubble stone and concrete.

The structure's roof was supported upon a series of five curved cross-frames with iron 'purlins' over (*plates 4.3, 4.4 and 4.7*). On its N, E and W sides, and roof, the structure is clad with corrugated iron, this painted red internally and black externally. The barn was open-sided to the south. As shown in *plate 4.7*, a first floor level opening containing paired hinged doors was set in the eastern end wall.

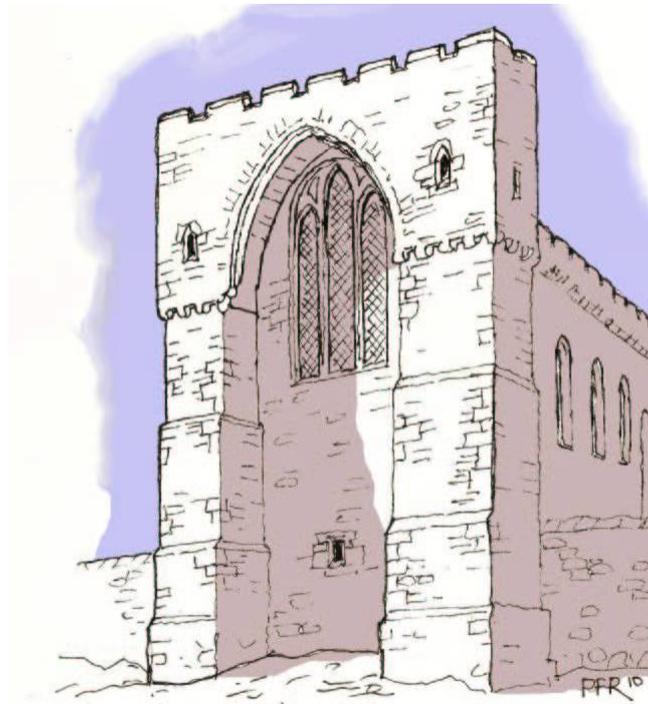
Figure 4.1 Speculative reconstruction of the surviving grange ruins by Peter Ryder, based on detailed recording work during the 2010 conservation project and knowledge of contemporary sites elsewhere.

The wall-tops were recorded in plan, *figure 4.8*. Very little upstanding masonry survived above the level of the corbelled-out upper stage of the angle towers. However the SE angle tower preserved a low section of upper level walling on its east side, enough to determine the presence of an internal wall face. This can either be interpreted as part of an upper stage of the tower containing a chamber, or as part of a parapeted wall head. Perhaps the former is the more likely; such an arrangement forms the basis of Peter Ryder's sketch reconstruction, see *figure 4.1*, above.

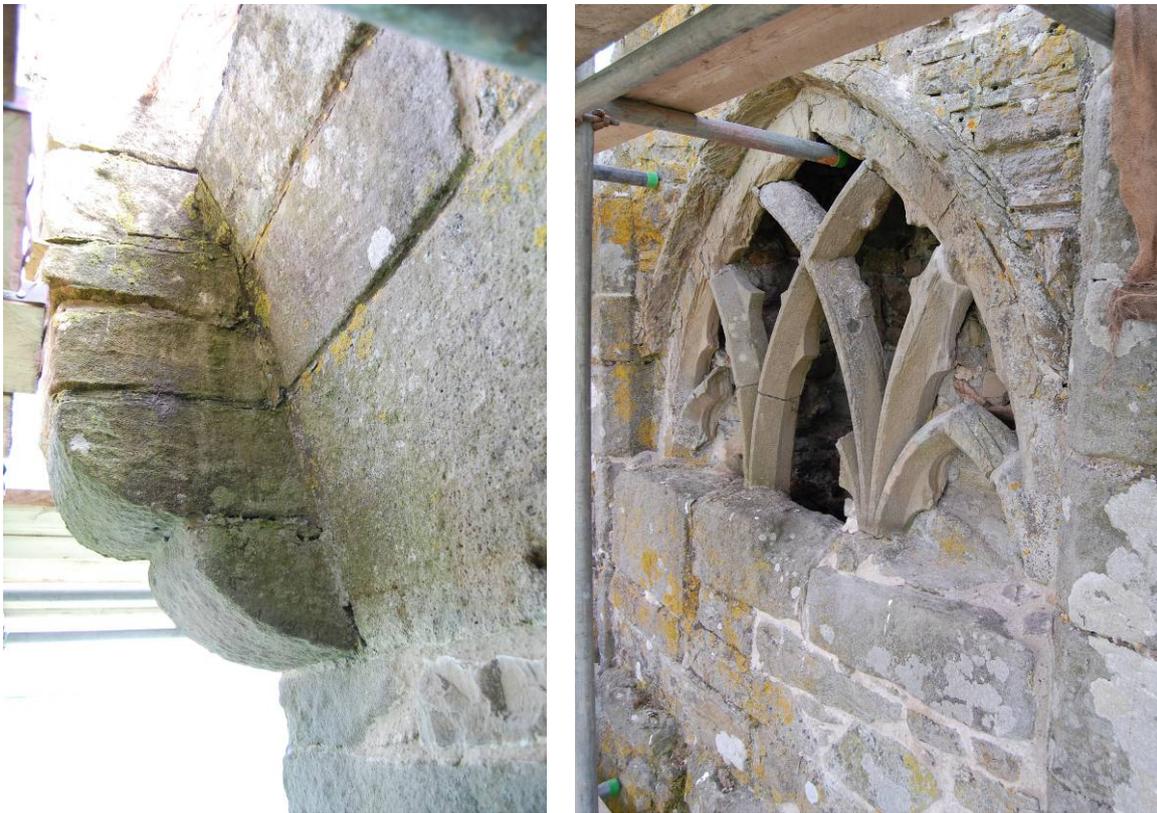
Plate 4.8 The SE angle tower of the chapel, upper parts showing arch springing on its north side
Plate 4.9 Traceried head of secondary window within the east gable wall

The original three-light east window of the chapel was removed and a new traceried window inserted in its stead, *plate 4.9* and *figures 4.2* and *4.9*. The head of the new window was set at a lower level than its predecessor and mortared rubble infill inserted above. All that now remains of the secondary window is its head whose surviving tracery demonstrates it to have been of three lights and of 14th century date. The window mullions were removed when the opening was in-filled to form a flue; a single reused mullion section was noted within the southern side of the flue behind the surviving window head.

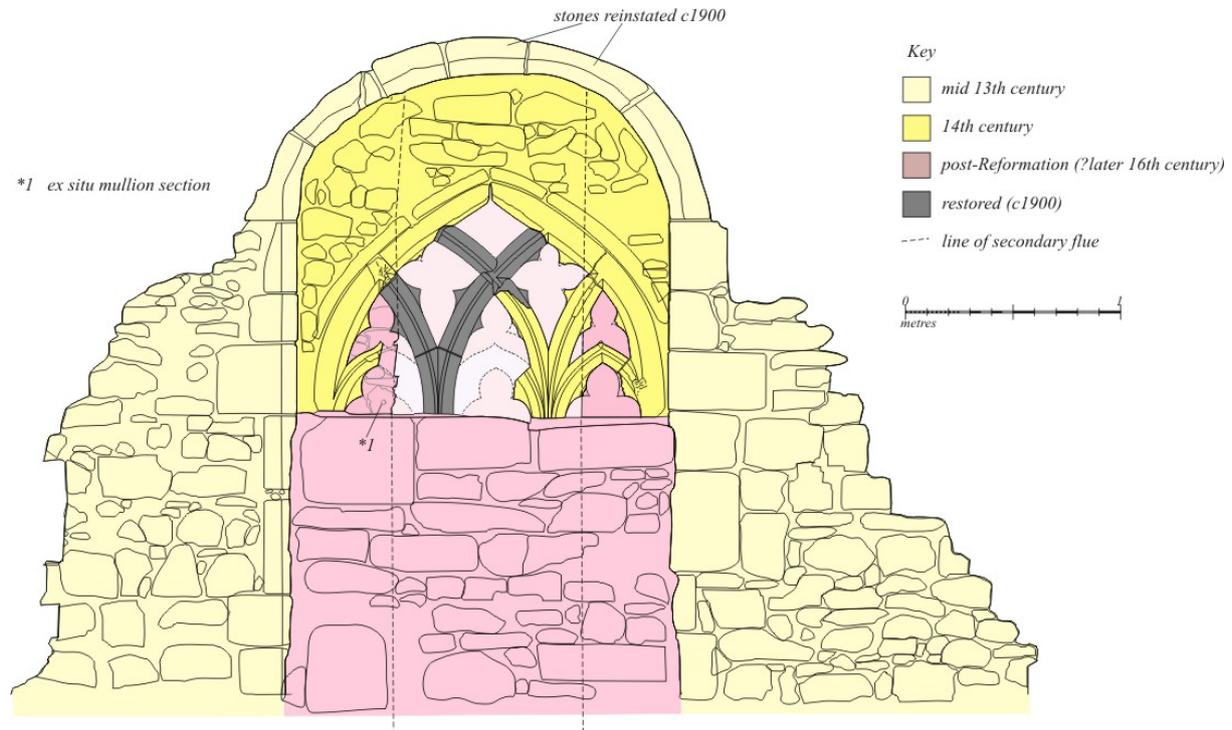
Figure 4.9 Detail of the upper parts of the east window and gable, exterior

Close inspection of the window head revealed it to have been fashioned from a single large slab of sandstone and not made up of individual elements. The tracery had simply been pierced (*figure 4.9*). This comparatively unusual detail does have precedent within the region.²⁴

A fireplace was inserted, set centrally within the east wall at first floor level, *figure 4.4*. The formation of the associated flue involved removing the walling immediately above, up through the sill of the early east window. The window mullions were removed and the window opening in-filled with mortared rubble masonry within which the flue was formed (*figures 4.2 and 4.4*); at one point a section of mullion had been built in, see *figure 4.9*. The traceried head of the east window, being cut from a single stone, remained in place and its apertures simply walled up. The flue was broken through the apex of the east window's arched head to a new chimney immediately above, the latter now gone, see *figure 4.9*.

The works of this period also involved the unblocking of the upper parts of the secondary east window thereby revealing its traceried head, *figure 4.2*. The tracery was clearly sufficiently damaged to warrant insertion of new pieces; evidently once discovered the restorer elected to preserve the window head and leave it on view, *figure 4.9*.

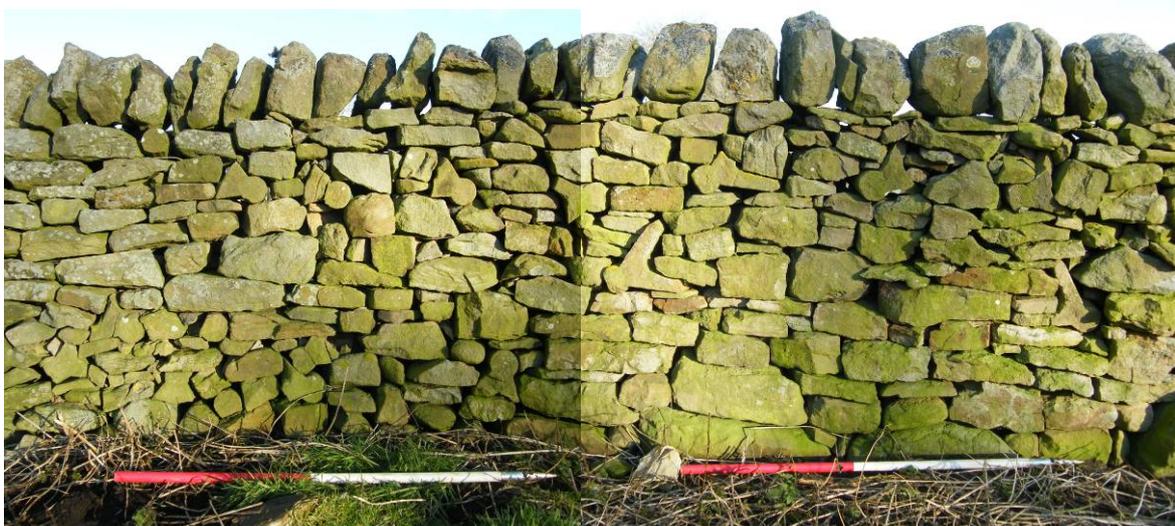
Plate 4.12 Field wall running south from the SE angle of the chapel range, west side. Note the medieval ridge stones incorporated within the wall

A general inspection of field walls in the vicinity of the grange ruins identified a remarkable group of reused carved stones incorporated into the first section of field wall running southwards from the SE angle tower of the chapel range. As seen in *plate 4.12*, these consisted, almost exclusively, of finely tooled ridge stones from an early, probably medieval, roof apex. Each was detailed with an upper roll. About 35 of these stones, both partial and whole, were identified (*plate 4.13*).

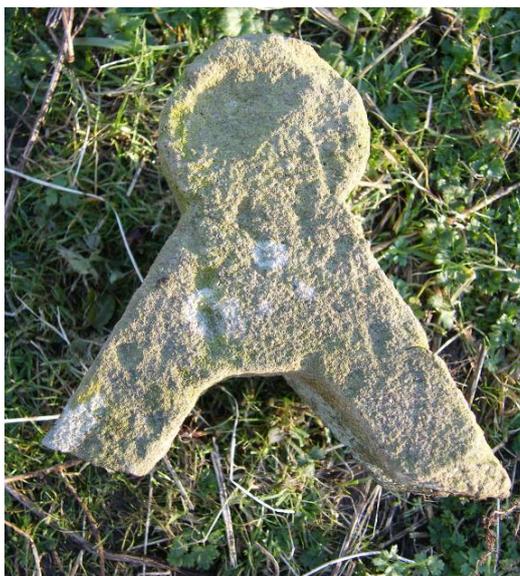
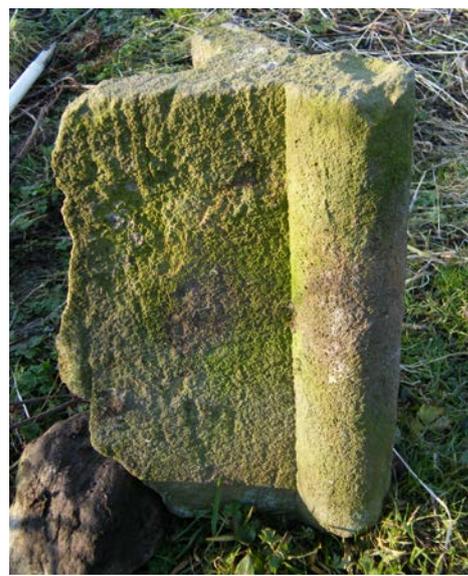
Plate 4.13 Medieval ridge-stone reused as a field wall coping

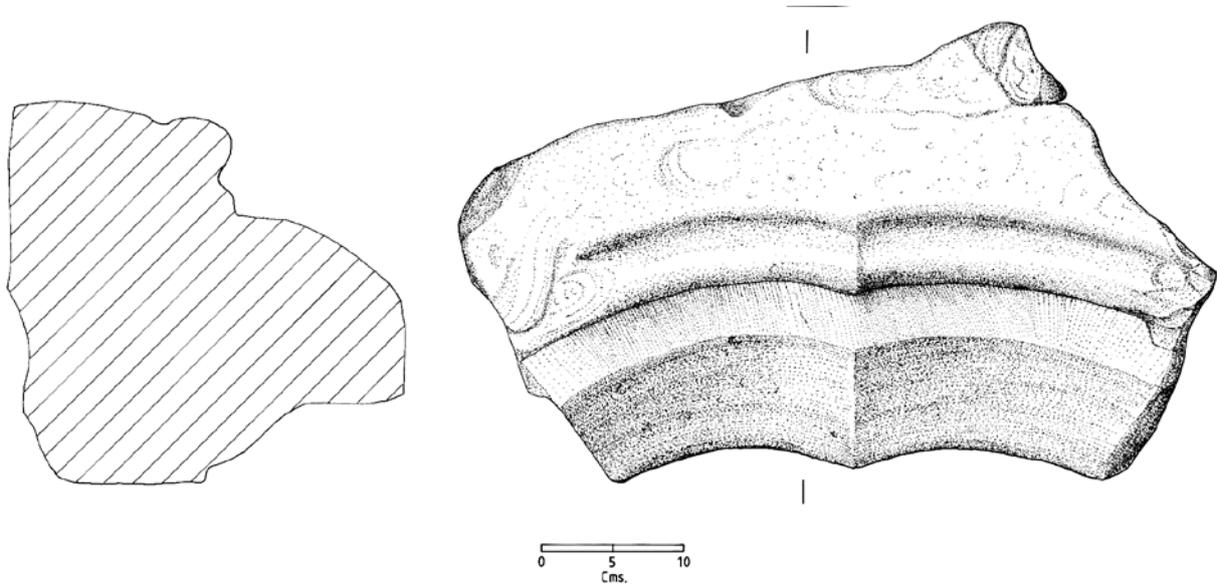
Figure 4.11 WS.01 (drawn by John Davies, AIG)

A number of loose carved stones of early character were identified about the site or recovered from excavation. Of these the most significant is a moulded fragment of grit-stone found within the interior of the chapel ruin towards its east end, *WS.01* - *figure 4.11, plate 4.14*. This stone preserves moulded detail of 13th century character, its cusped profile suggesting it had formed part of the arched head of a wall recess – perhaps a *piscina* or *sedilia* within the chapel interior (thus presumably within its south wall towards the east end).

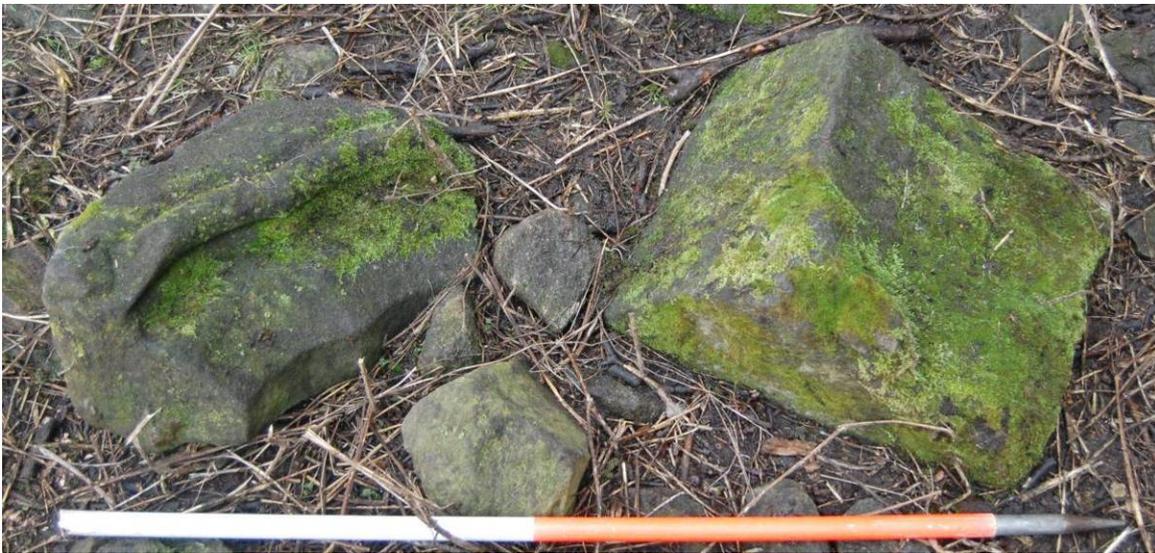
Plate 4.14 WS.01 and WS.02 as found

Two stones, *WS.02* (*plate 4.14, figure 4.12*) and *WS.03* (*figure 4.13*), were of similar detail, being sharply-splayed jamb stones evidently from narrow arrow-slit-like apertures. These stones were both of the same grit-stone generally employed for dressing within the two 13th century phases of construction at the site. Stone *WS.03* was recovered from excavation below the east end of the early range – it may have formed a feature of the gable wall. In the 1890s Greenwell and Knowles recorded two openings of this type within the still-extant south wall of the early range, see *figure 2.7* above.

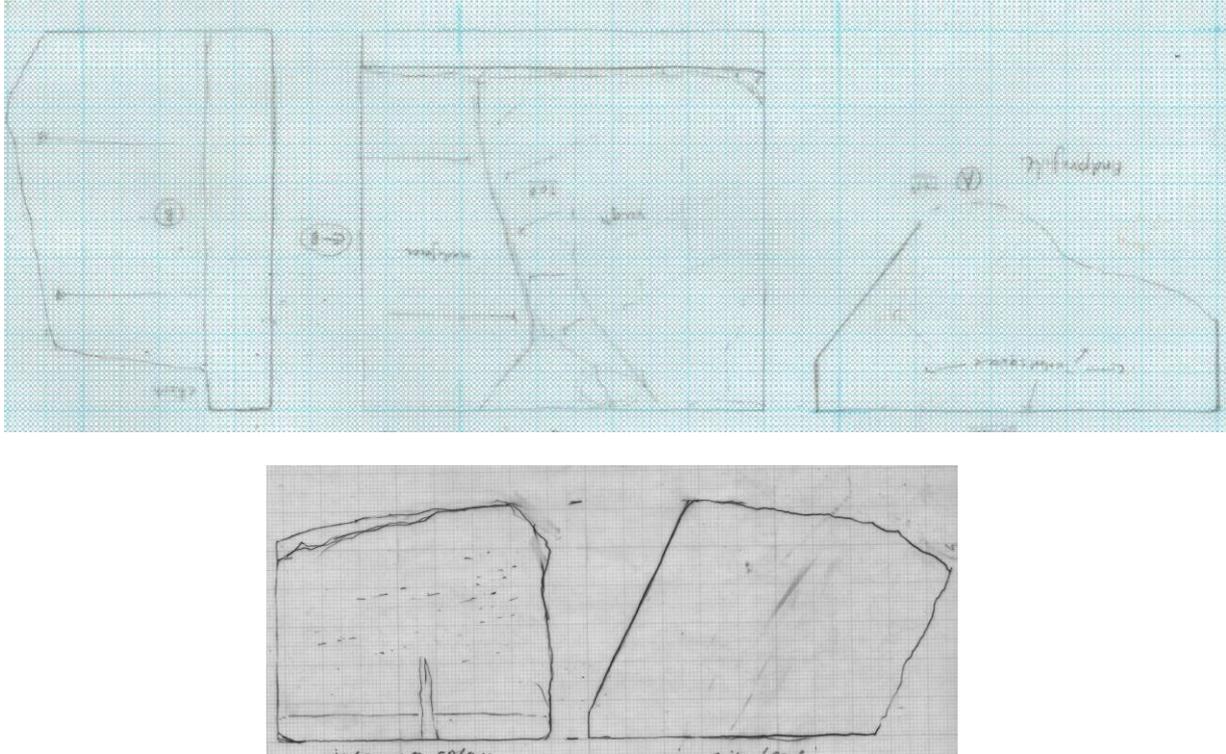
Figures 4.12 – 4.13 Field drawing showing arrow-slit jamb-stones : above, WS.02, from the interior of the east end of the chapel and, below, WS.03, from within Trench 6 below the east end of the early range (both shown at 1:10)
