Muggleswick Grange

Priory Farm, Muggleswick, Co. Durham

Historic building survey and community archaeology projects
(October 2009 - September 2011)

Data Structure Report (March 2011)

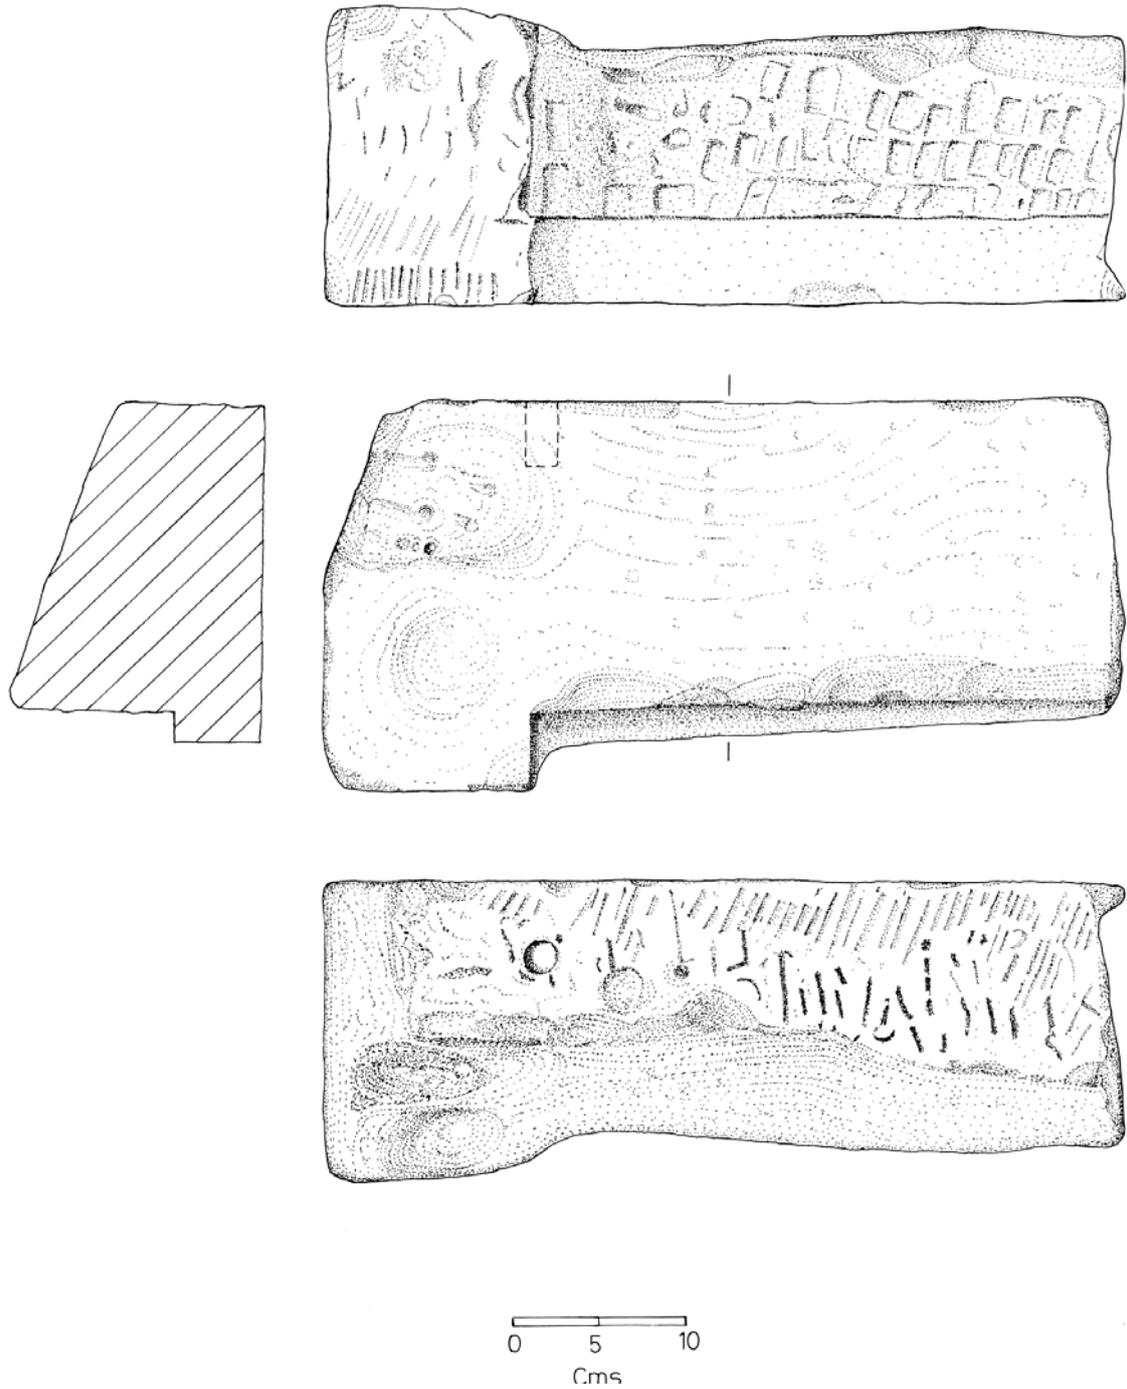
Figure 4.15 WS05 Architectural detail of loose stones from vicinity of Grange (drawn by John Davies, AIG)

Two further stones, WS.04 and WS.05, evidently derive from the site, however their exact find-spots are not known. WS.04 seems to have formed part of a fireplace over-mantel, its moulded detailing suggesting a seventeenth century date, Figure 4.14. WS.05 may be of this or somewhat later date, apparently part of a window sill stone, Figure 4.15.

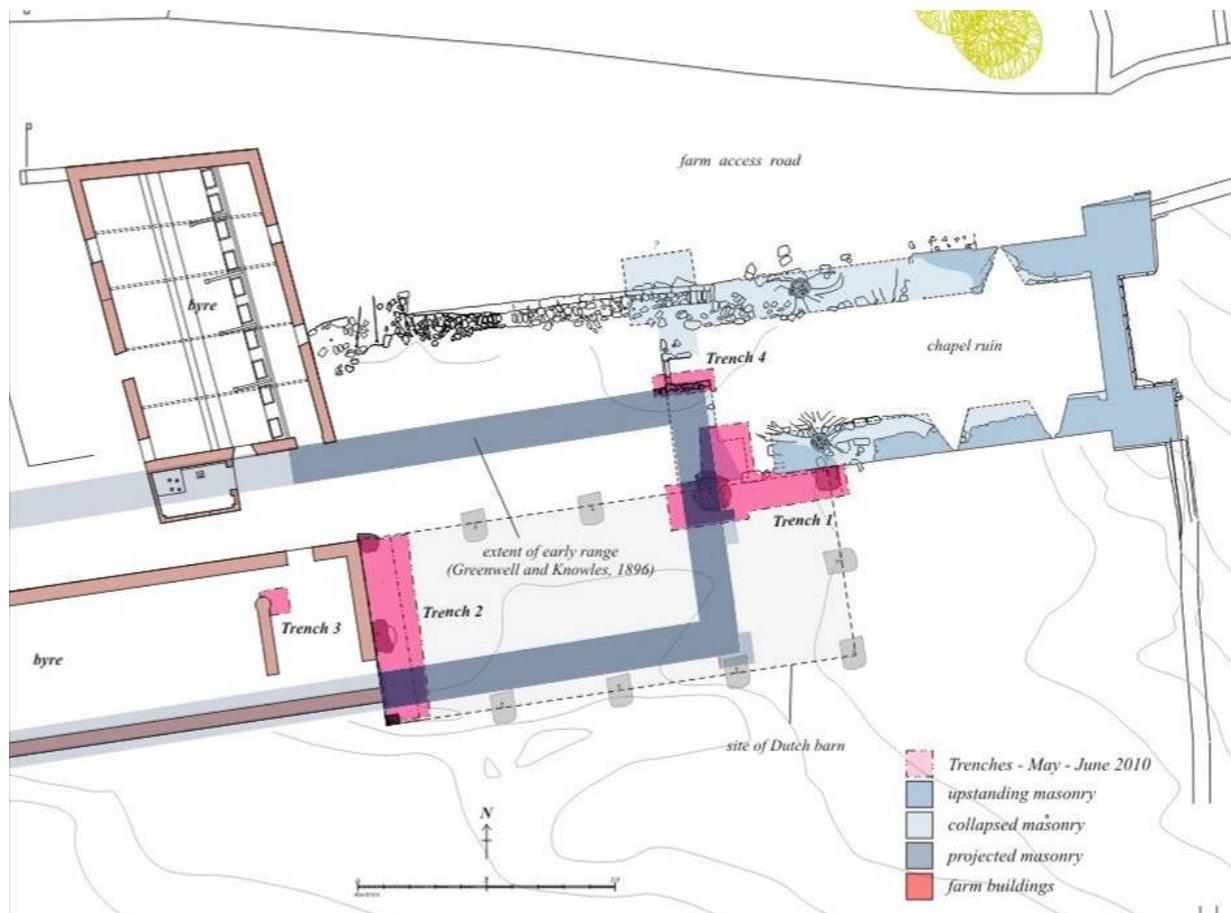
Figure 5.1 Trench locations (May 2010)

In summary four evaluation trenches were excavated (*figure 5.1*) whose archaeological purpose was to address specific questions about the nature of the medieval site – the extent of the chapel ruin (Trenches 1 and 4) and evidence for the eastern parts of the adjacent range as recorded in 1896 by Greenwell and Knowles (Trenches 1, 2 and 3). Trenches 1 and 2 were also sited to expose a number of the concrete footings for the piers of the demolished Dutch barn to determine whether all of these could be extracted without disturbing surrounding archaeology.

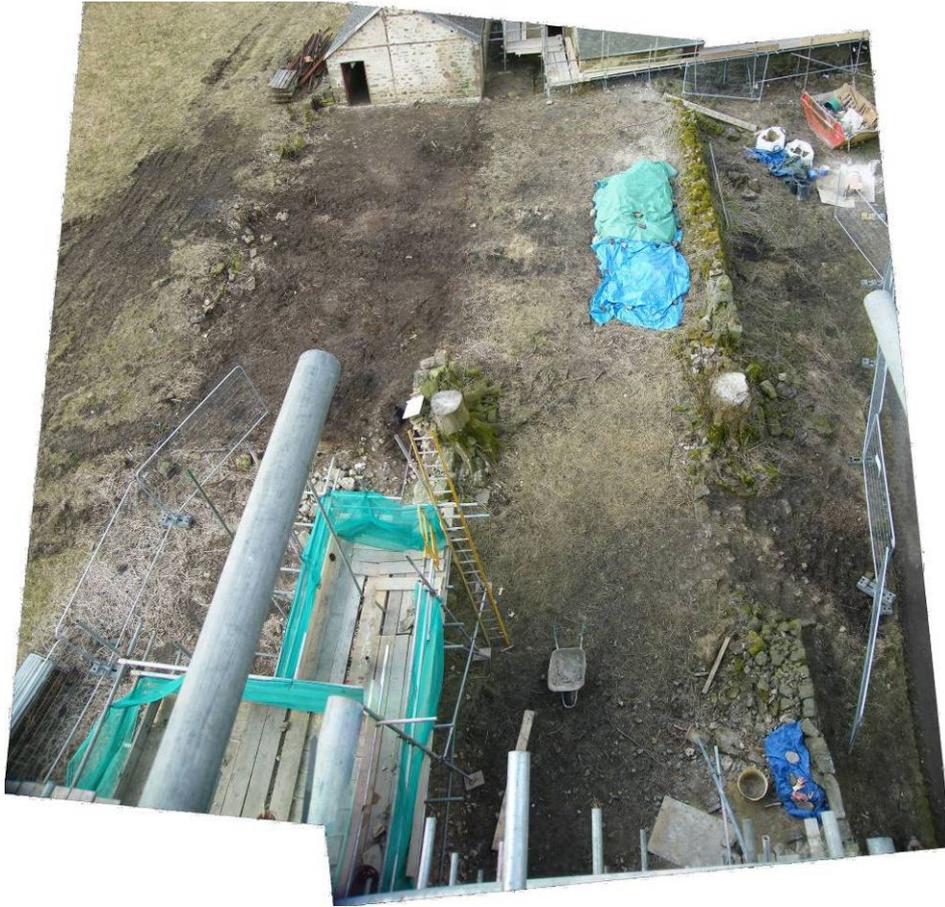
Plate 5.1 Pre-excavation composite photograph, looking west from scaffolded gable following removal of the Dutch barn.

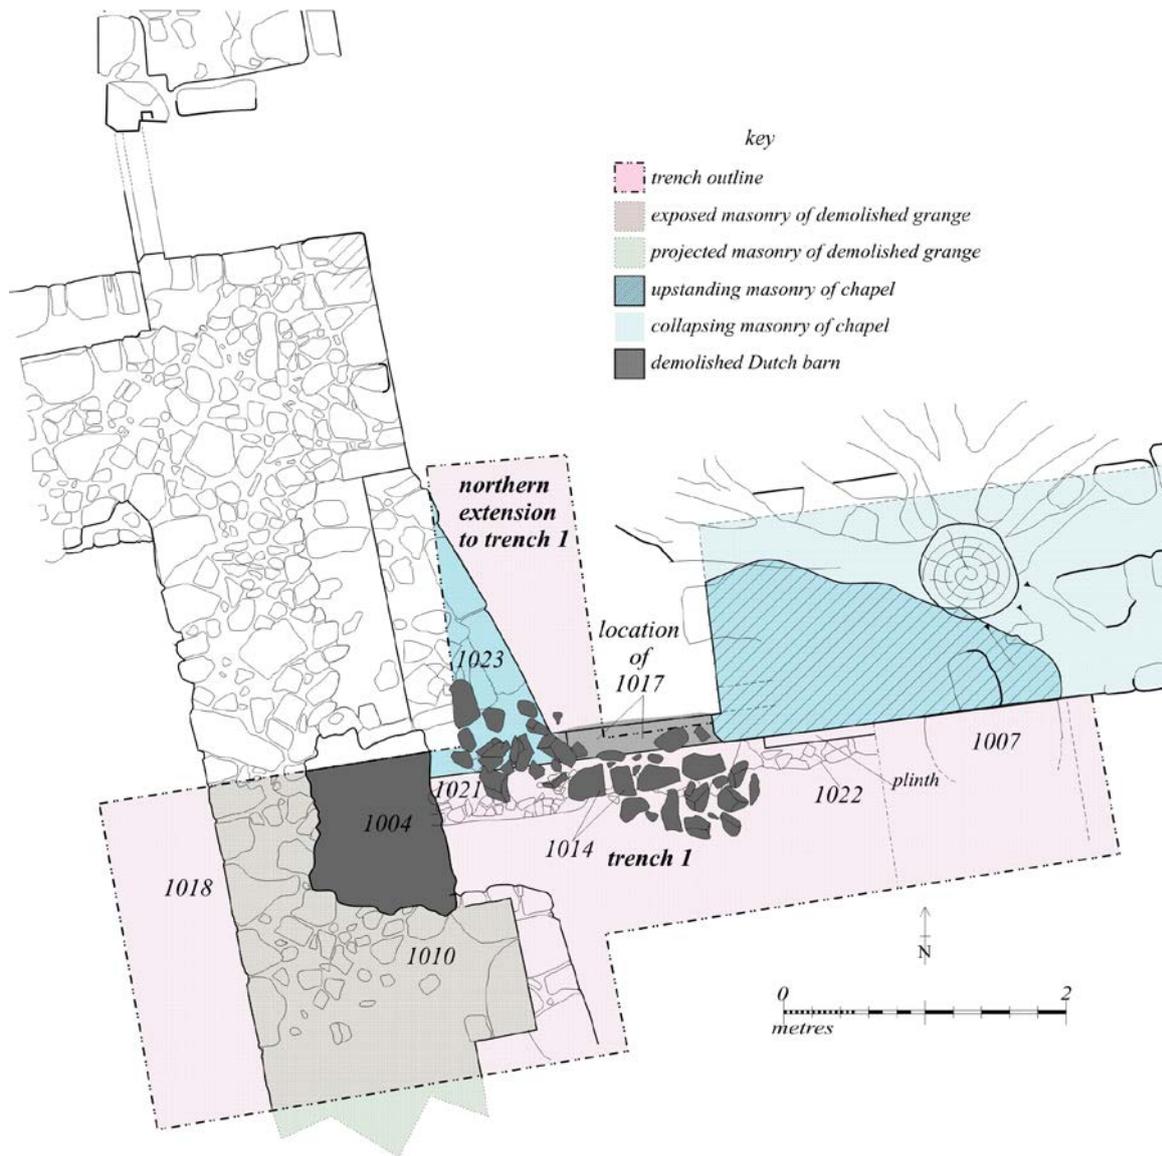
Figure 5.2 Mid-excavation plan of Trench 1; note existence of 1014 and 1017 and compare to post-excavation plan, figure 6.4

Upon removal of 0.05m – 0.1m of overburden across the trench area, a build-up of manure within the barn interior, 1001, the two concrete foundations for the piers of the Dutch barn were fully revealed. Underlying 1001 in most other areas was a substantial layer of compacted rubble within a matrix of crushed mortar, overall of a yellow-cream hue; this deposit formed the base for the Dutch barn, 1002. The western pier base, 1004, was found to have been cut into an area of *in situ* mortar-bonded masonry of apparent early date, 1010. This had been graded almost level with the barn floor surface, only 0.05m or so of the 1002 deposit requiring to be trowelled off. The top of the concrete was reduced to the top of 1010 with a pneumatic breaker as a test as to whether these foundations could be removed easily without disturbing the surrounding archaeology, plate 5.2. The concrete proved to be very difficult to extract and to continue down with the breaker was judged likely to be extremely destructive to the surrounding masonry and so was not pursued further.

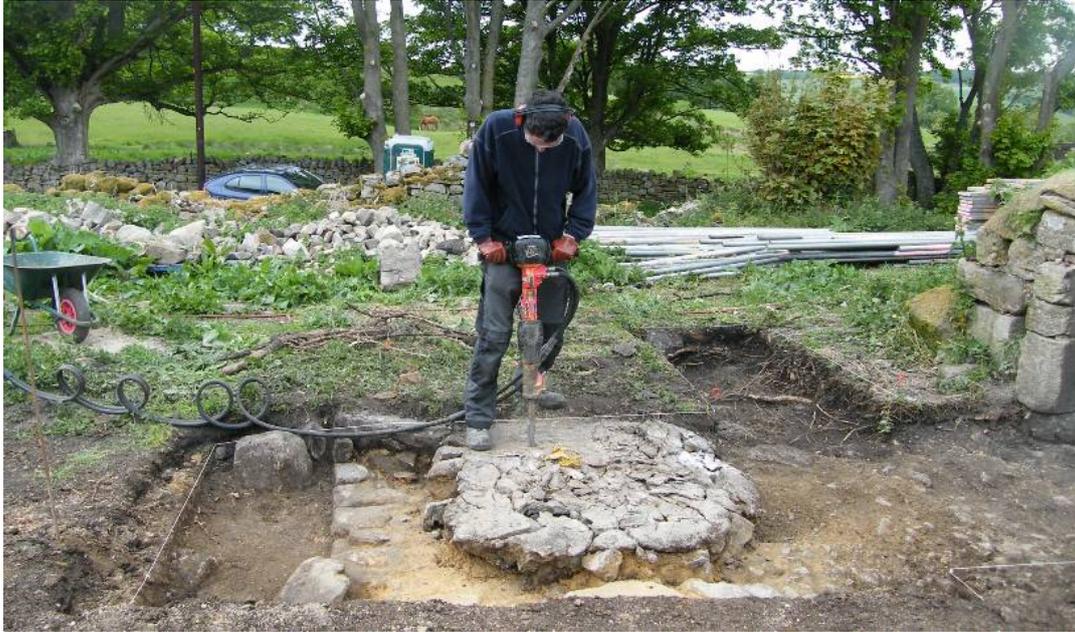
Plate 5.2 breaking the concrete pier base 1004, looking north

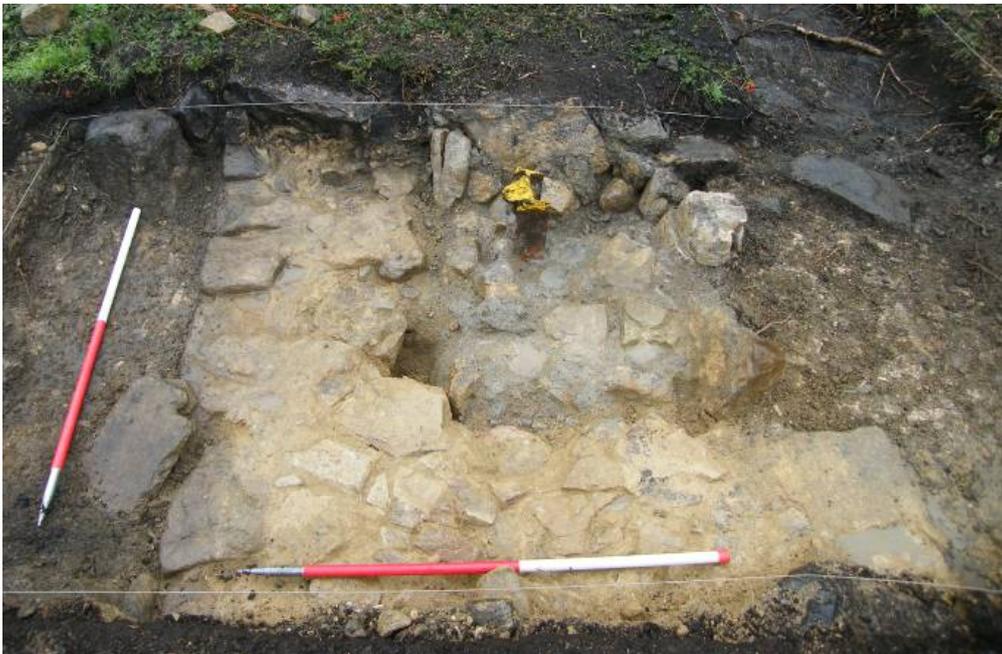
Plate 5.3 The early wall footing as revealed with the modern concrete stanchion 1004 shown cutting through the N-S aligned wall 1010

As noted above removal of some 0.10m or less of the compacted 1002 flooring deposit in the western part of the trench revealed the mortar-bonded rubble masonry footing of a major north/south aligned wall – evidently the eastern gable of a major range of early date, the structure identified by Greenwell and Knowles in the 1890s, 1010. The eastern side of this wall footing had been impacted by the cutting of the large pit within which the concrete and rubble stone setting of an iron barn pier had been poured, *plate 5.3*. Trench 1 extended a little to the west of the footing thereby permitting a sondage to be made into the deposits within the structure.

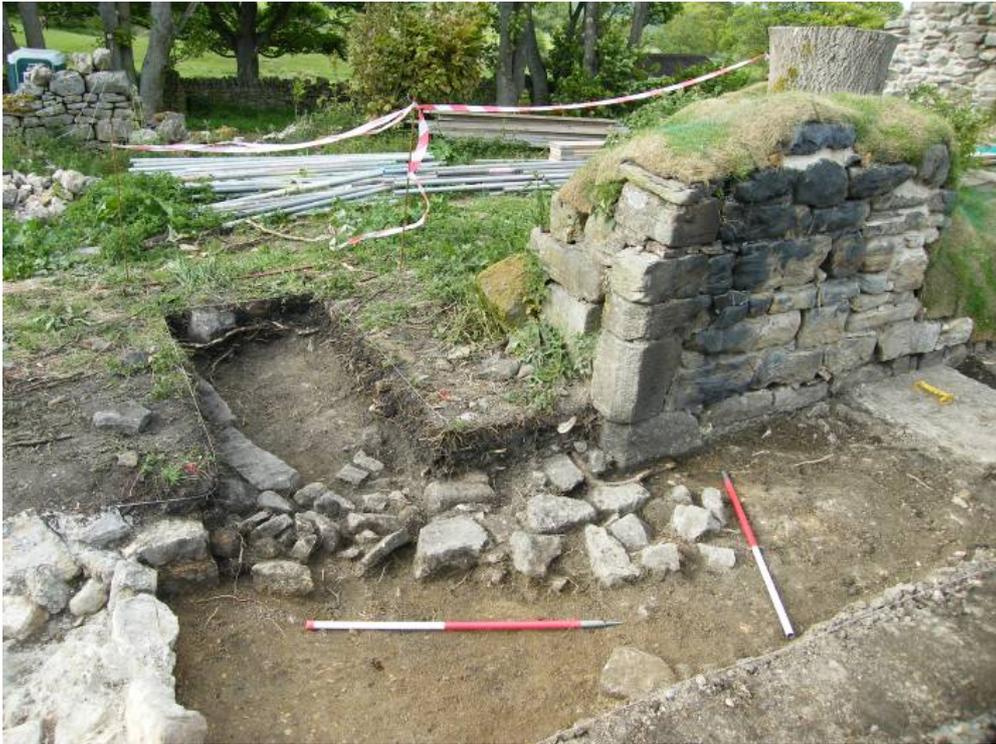
Plate 5.4 1014 rubble as exposed, with upper surface of 1015 beneath, looking NNE

In the remainder of trench 1, to the east (exterior side) of the 1010 walling, the barn flooring deposit 1002 (including 1003, 1005, 1006, 1008) continued down for a depth of 0.30m. 1003, 1005, 1006 and 1008 were small lenses/deposits deposited as part of the general build-up of 1002. These comparatively recent (early 20th century) deposits were found to directly overlie a concentration of rubble stone in the immediate vicinity of the former entrance, this apparent demolition debris, 1014, *plate 5.4*.

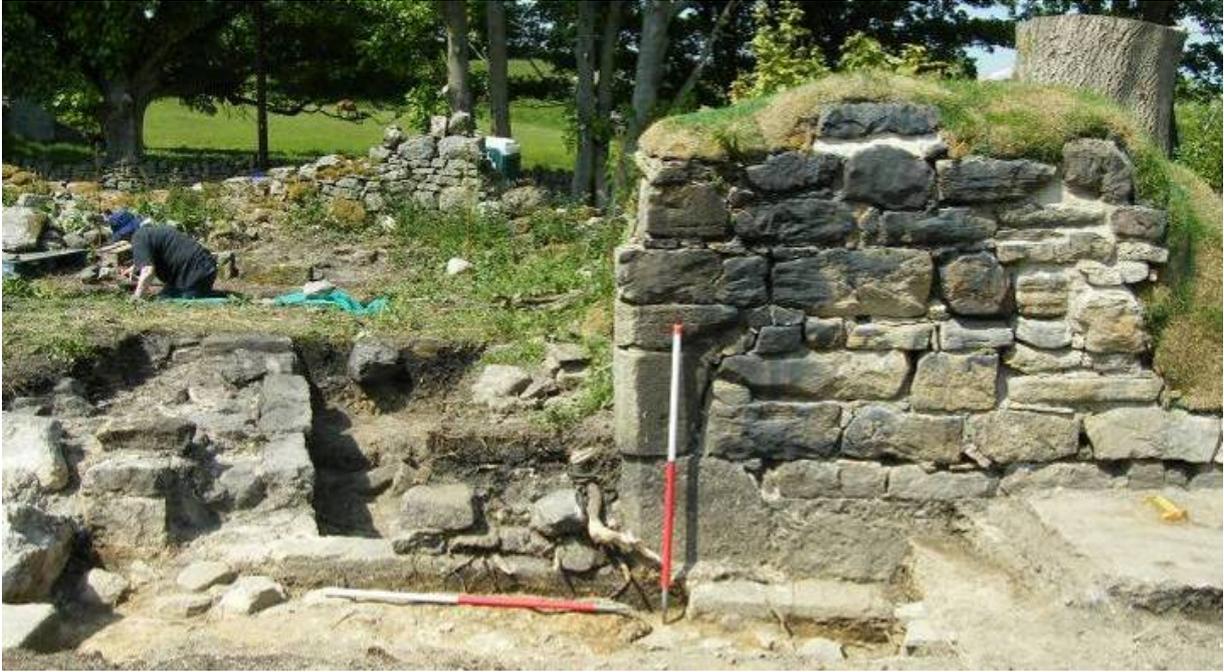
Plate 5.5 Trench 1 at limit of excavation showing the entrance as revealed and the adjacent wall foot plinth course on its east side; looking north. Note the remains of 1017 within the roots on the threshold stone.

Within the entrance itself a line of large coarse angular stones with smaller packing stones in between was exposed that extended across the entrance, placed directly atop its threshold, recorded as 1017. It was unclear whether 1017 had been bonded or of dry-stone construction. Although evidence of lime mortar was discernable on the stones, it was felt this was probably residual and that the stones were likely re-used from elsewhere. This feature was interpreted as a secondary blocking of the chapel entrance; the 1014 rubble had also likely formed part of this blocking material, subsequently collapsed following the build-up of 1015.

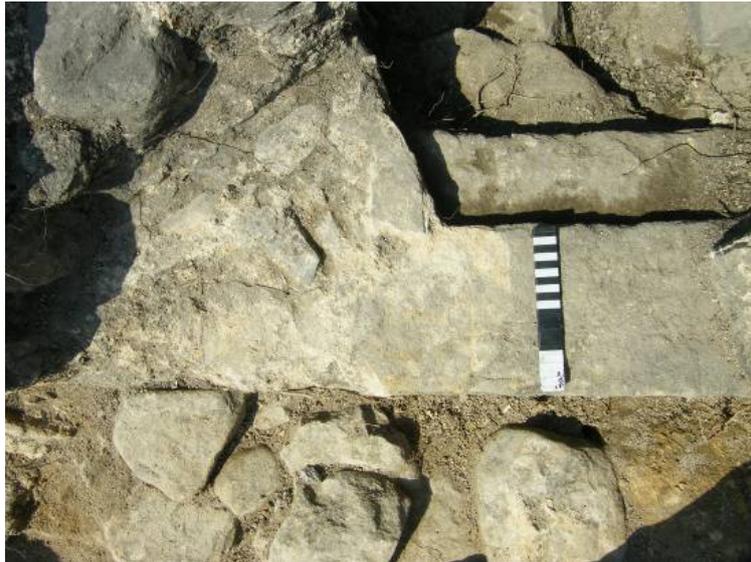
Plate 5.6 entrance threshold with NNW to top showing silhouette of missing jamb

Excavation of this area revealed the surviving entrance threshold stone and the western internal splay of the entrance; while the dressings of the west jamb had been wholly removed the silhouette of the lower jamb stone was preserved, *plate 5.6*. Within the threshold area the solid masonry bedding below floor level was revealed. The floor surfacing, perhaps of flag-stones, had evidently been comprehensively robbed.

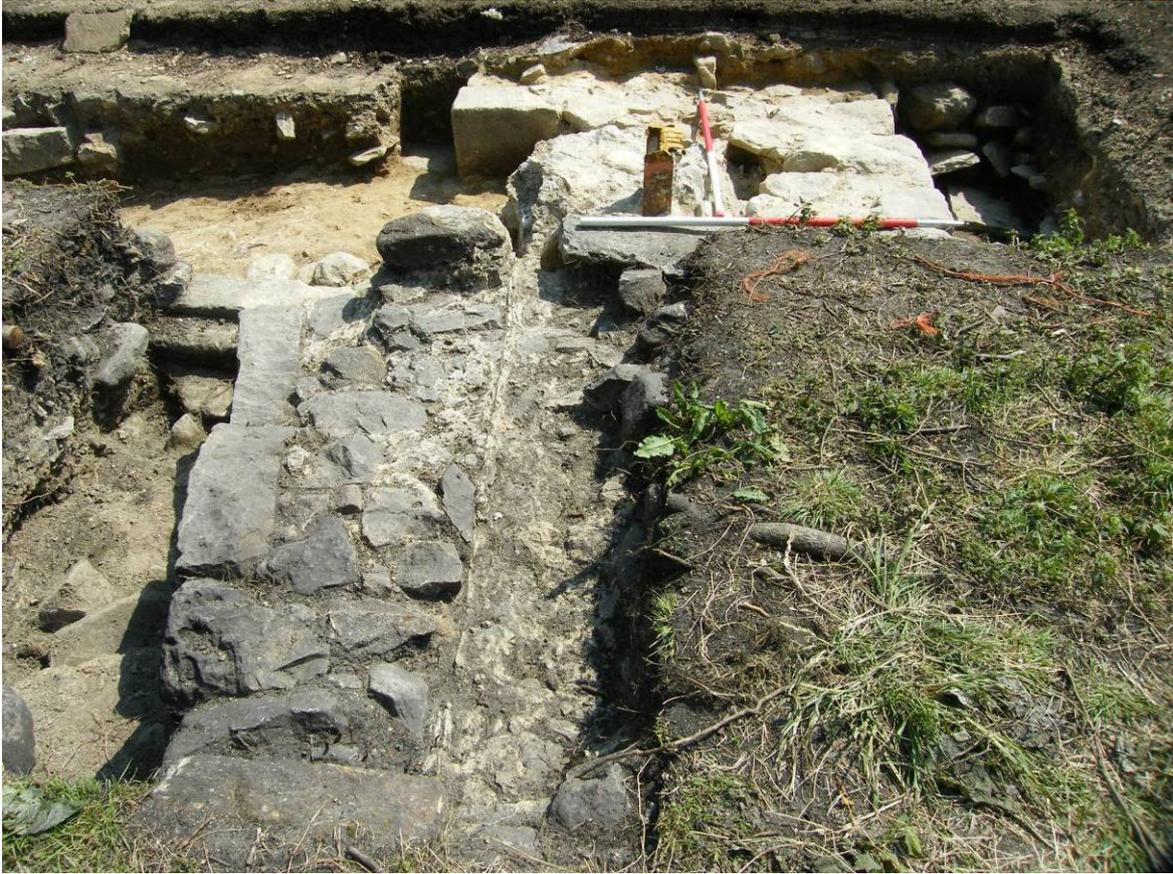
Plate 5.7 General view of the northern extension to Trench 1 showing the junction of the south wall of the chapel 1023 (left) with the east gable wall of the pre-existing building 1010 to the west (poles resting upon this); view looking south

The masonry forming the western jamb of the entrance was found to constitute a narrow strip of bonded rubble construction, *1023*, built up against a section of pre-existing walling, *1010*. *1023* proved to be contemporary with the existing chapel ruin whilst *1010* proved to be the eastern gable wall of the large range shown in plan by Greenwell and Knowles, *plate 5.7*. This junction provided clear evidence that the chapel range was a secondary construction and had been built around the NE angle of the larger range to the west (see *figure 6.4*). At this point, where the secondary masonry *1023* abutted *1010*, the finish of the exterior wall face of the earlier range had been preserved from subsequent weathering. From this it was clear exterior wall face of the large range to the west of the chapel had been brought to a good flush face and then finely plastered over to a smooth finish, *plate 5.8*. Samples were taken.

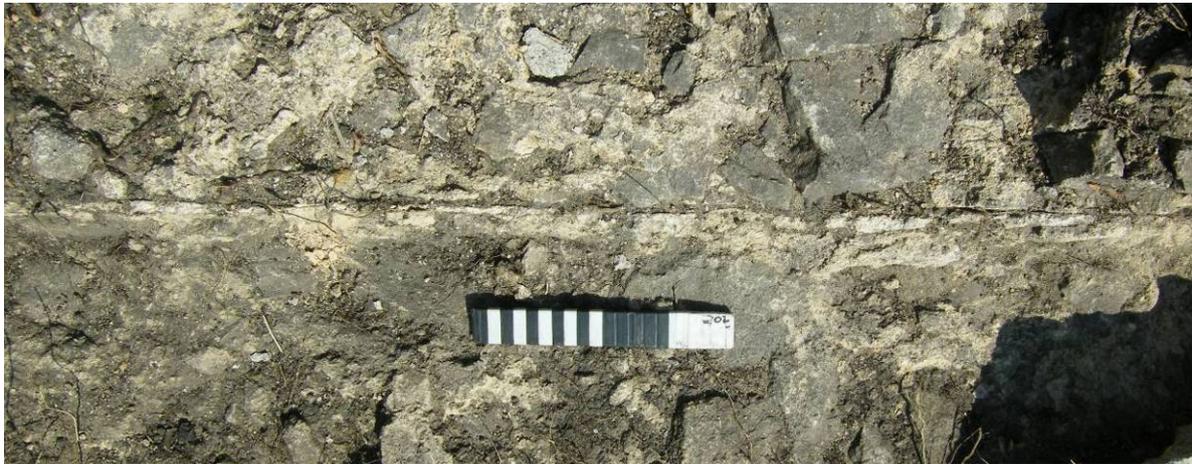
Plate 5.8 Detail of junction of chapel masonry 1023 (top) with that of the earlier gable wall 1010, preserving the original external plastered wall finish of the latter; east at top

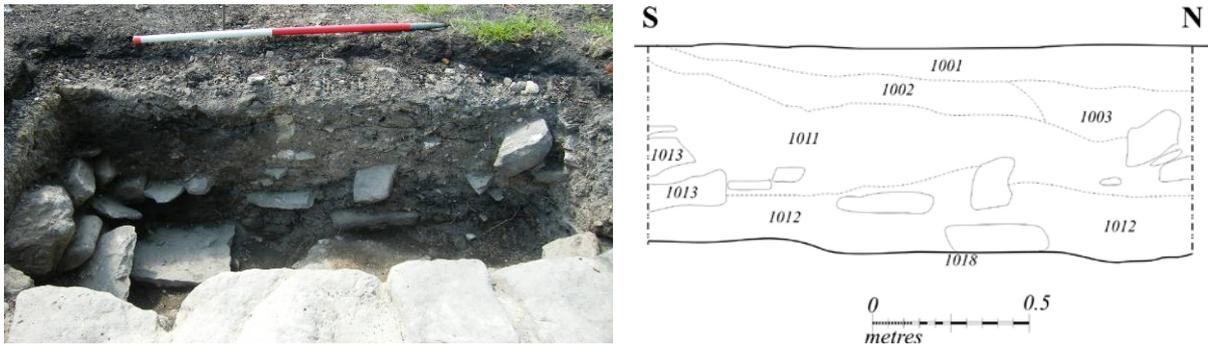
Plate 5.9, Figure 5.3 Deposition at the west end of trench 1, east facing section (interior of the early range)

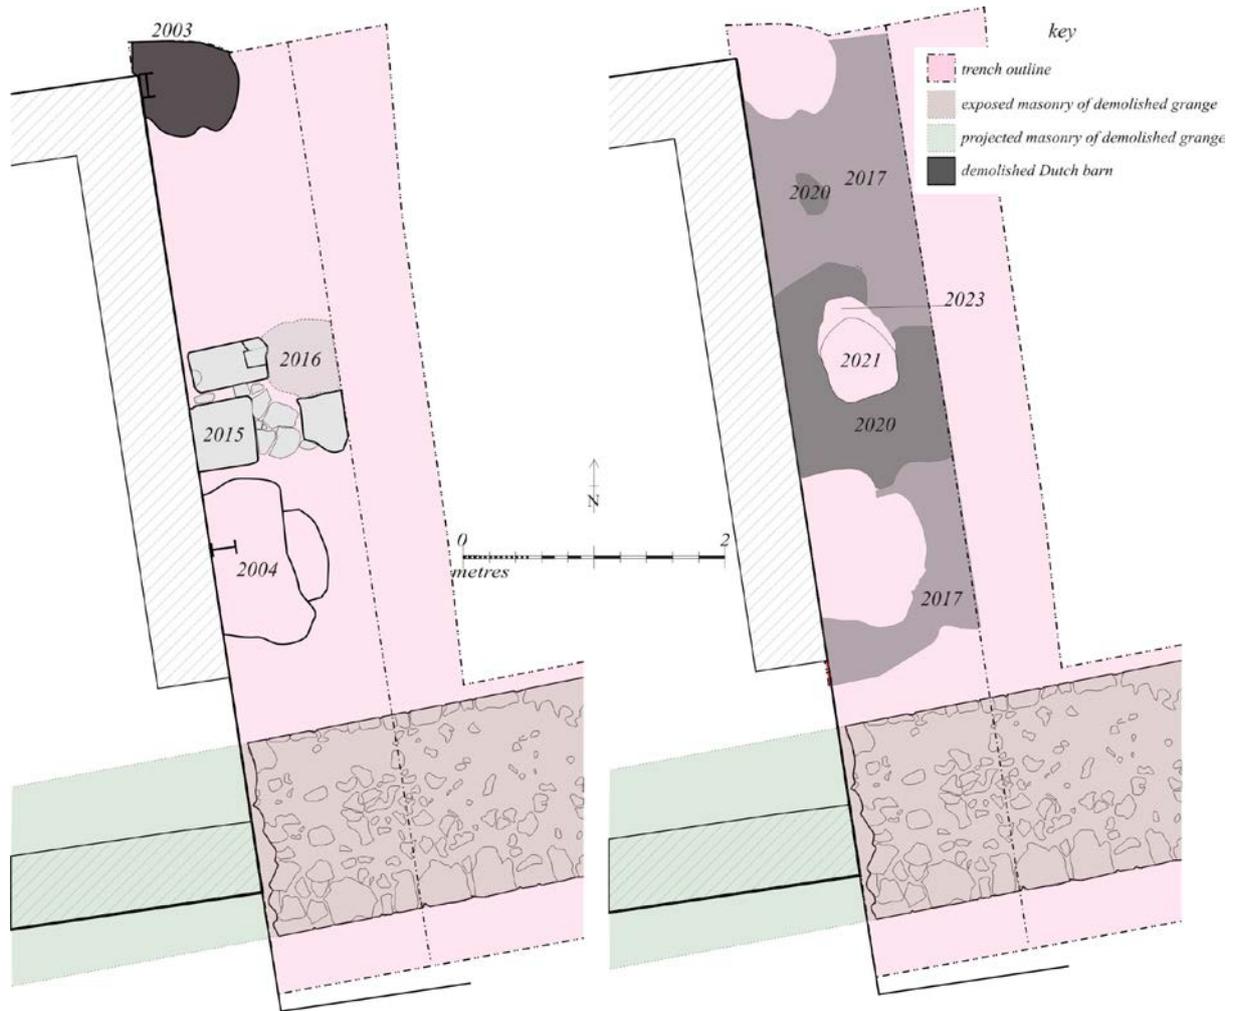
Figure 5.4 (left) Trench 2 showing 2015 and 2016
Figure 5.5 (right) Trench 2 at limit of excavation showing 2017 and 2020

Following removal of accumulated compacted manure 2001 upon the barn floor excavation in Trench 2 rapidly exposed the well preserved footing of the south wall, 2002, this of lime-bonded rubble construction (see *plate 5.11* and *figure 5.4* and 5.5). Its upper surface lay just below the flooring deposits of the overlying Dutch barn. The exterior south face of the walling and its footing were examined by means of a small sondage at the SW corner of the trench. One course of walling remained, 0.20m high, and, after a short off-set of 0.05m, the footing itself was found to continue down a further 0.45m to its base, 2012. This foundation structure had been directly built upon the underlying natural subsoil.

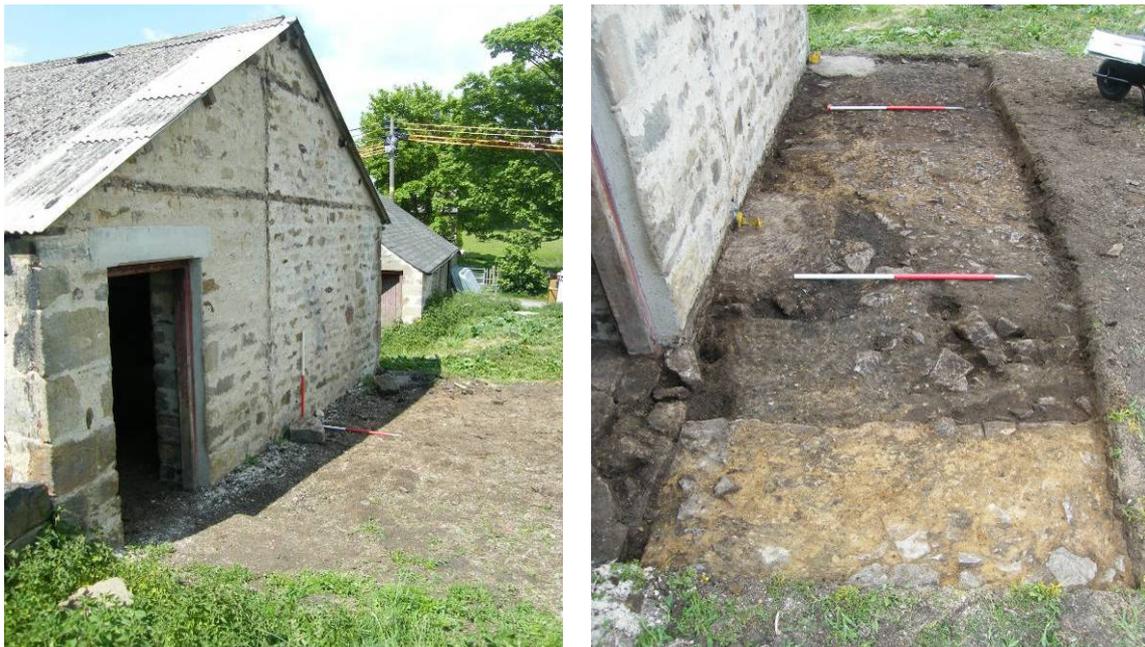
Plate 5.10 Trench 2, before excavation, looking NW

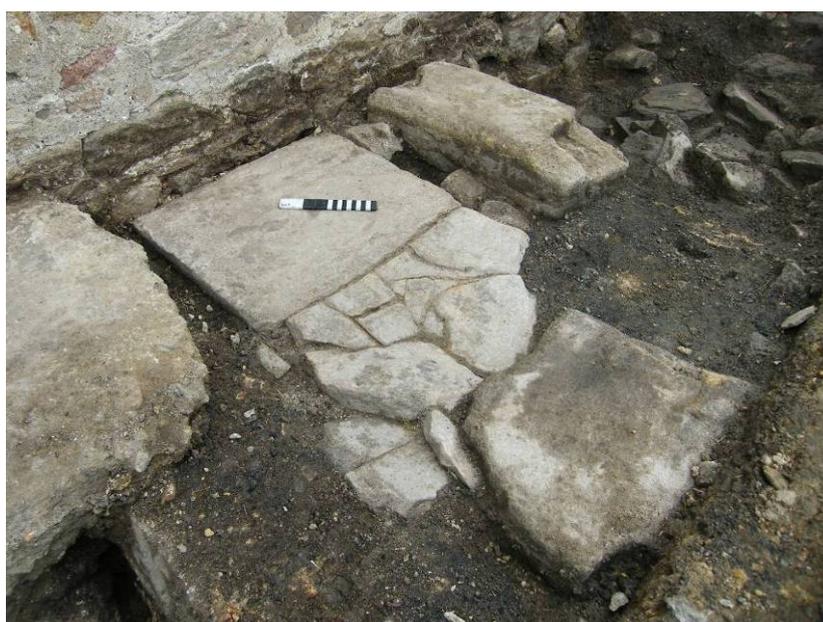
Plate 5.12 Fireplace 2015 with concrete foundation 2004 to the left, looking NW

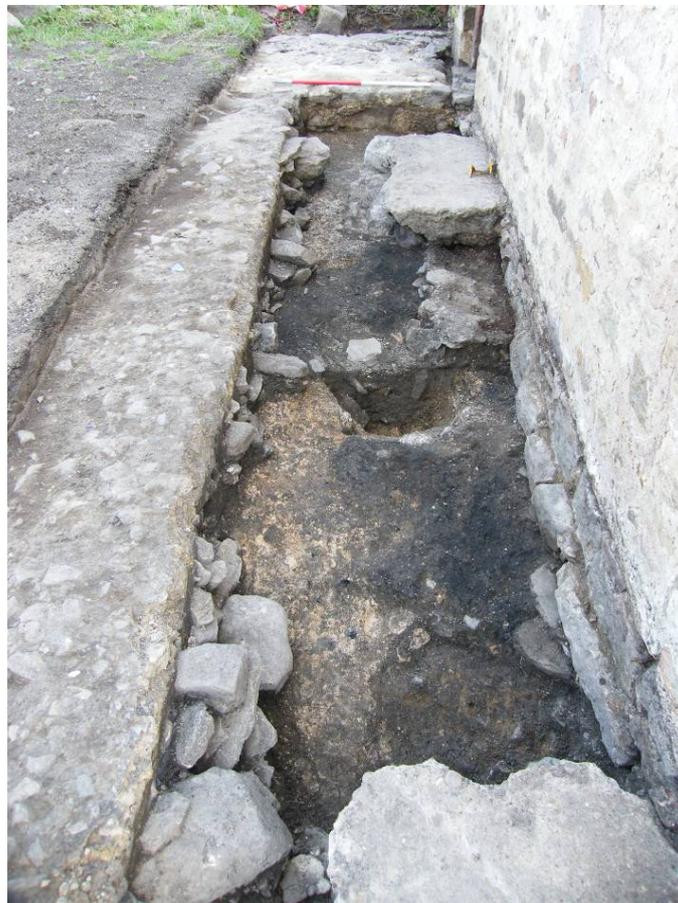
Plate 5.13 Trench 2 at limit of excavation shows mortar 2017 and cinders 2020, with half-sectioned 2021 pit in the mid part of the trench; looking south

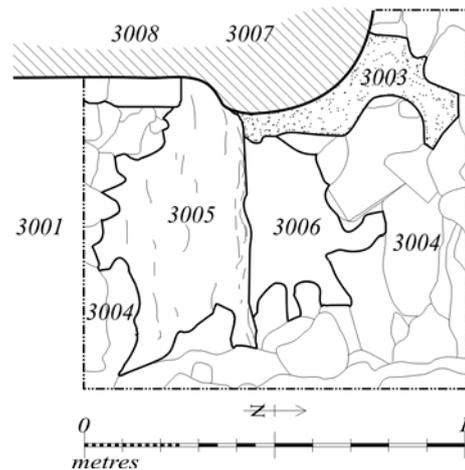
Figure 5.8 Post-excavation plan of Trench 3

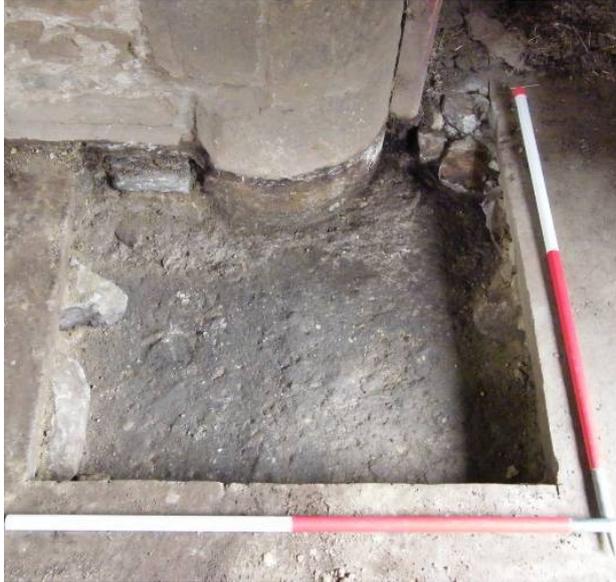
Plates 5.13 Trench 3 looking west with surface 3003 as exposed. Note pillar 3007 at west end of trench

The upper 0.05m consisted of the poured concrete flooring of the byre, 3001; this was cut with a stihl saw and broken up. It overlay a loose rubbly bottoming level for the concrete, 3002 (figure 5.7). Beneath this, at a depth of 0.20m – 0.22m was encountered a level surface of highly compacted soil, perhaps a flooring within a pre-existing structure or a yard surface, 3003. As shown in figure 5.7, this surface formed the base upon which the internal cross wall, 3008, and the pier itself, 3007, were erected. Residues of fallen mortar overlay the 3003 surface close to the base of the cross wall and pier and were evidently associated with the erection of the cross-wall itself (?and, apparently, the re-

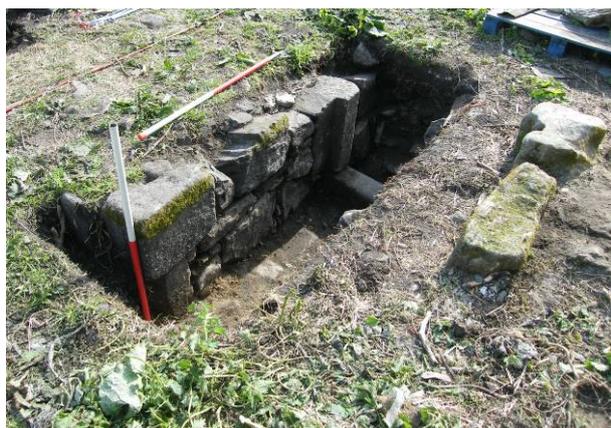
Plate 5.15 (left) General view of Trench 4 showing at limit of excavation looking SW. Note the north jamb of the entrance protruding above ground to the right of the picture

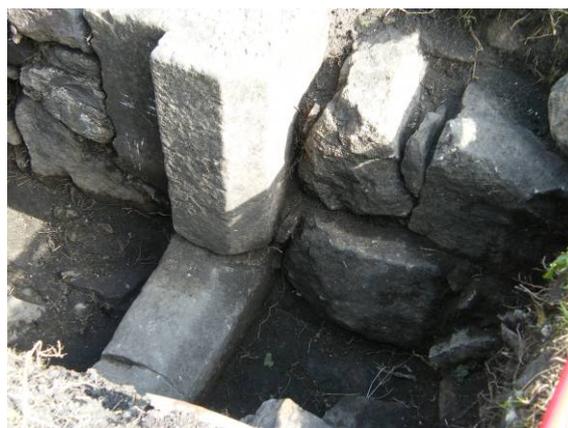
Plate 5.16 (right) Detail of the south jamb and threshold of the entrance as revealed, looking SE

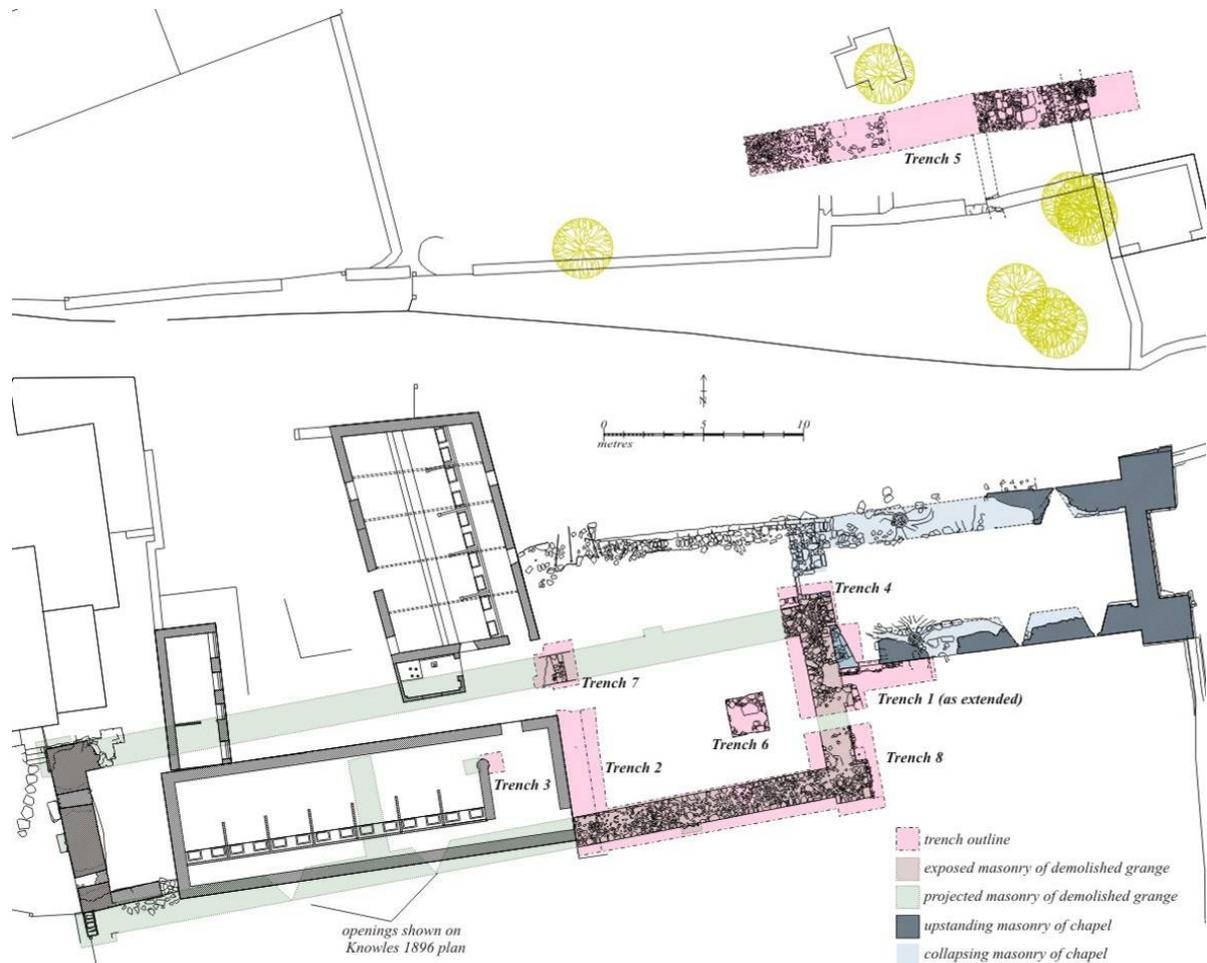
Figure 6.1 Site plan showing the locations of Trenches 1-4 (May-June 2010) and trench locations for the Altogether Archaeology project – Trenches 5-8 (November 2010)

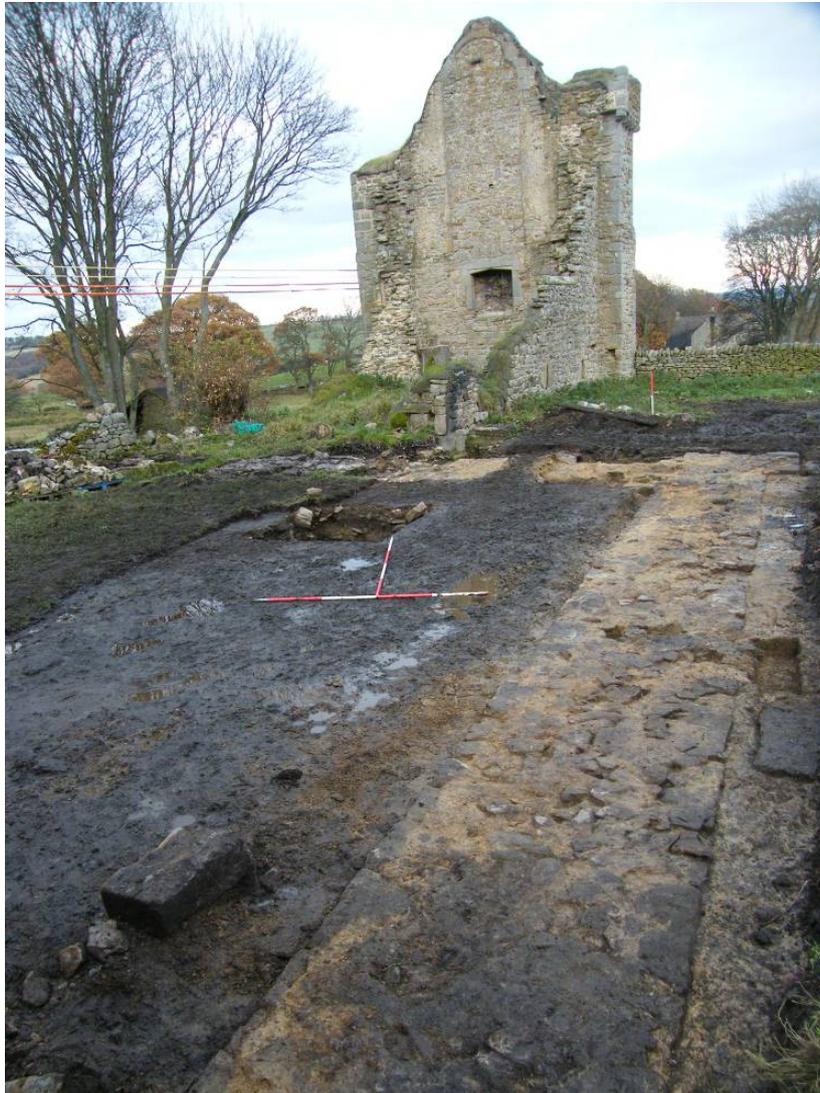
Plate 6.1 General view of the site of the Dutch barn as cleaned to reveal the footings of the south and east walls of the early range; view looking ENE

With the availability of mechanical assistance for the removal of overburden it was decided to clear off the compacted manure that had built up over years within the interior of the Dutch barn. Following the dismantling of the barn structure exposure of the manure to rain meant that the material had begun to liquefy – an impediment to the clean running of the excavation. The barn footprint was therefore cleaned off to the top of the flooring make-up within. The make-up was easily defined; for the most part it was evidently composed of the compacted demolition rubble from the reduction, c.1900, of the remains of the south wall of the early range and a previous agricultural building upon the site. Much as hoped it was revealed that the south wall had simply been cut down to the intended floor level and no further. Thus with minimal trowelling-off in most areas it was possible to fully define the south and east walls of the early structure, *plate 6.1*.

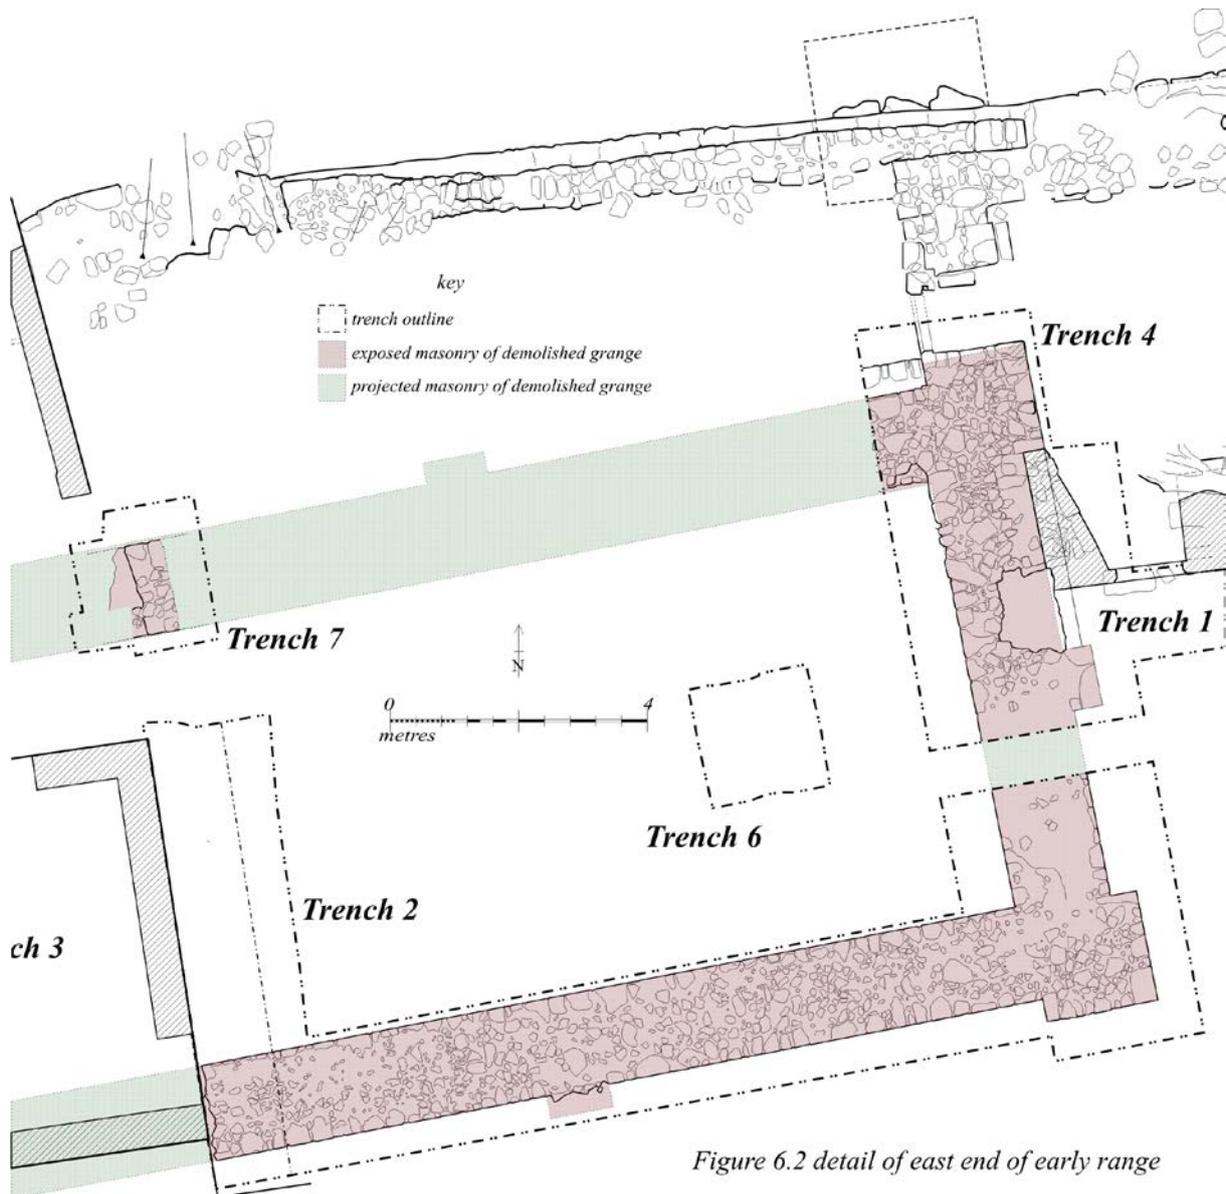
Figure 6.2 detail of east end of early range

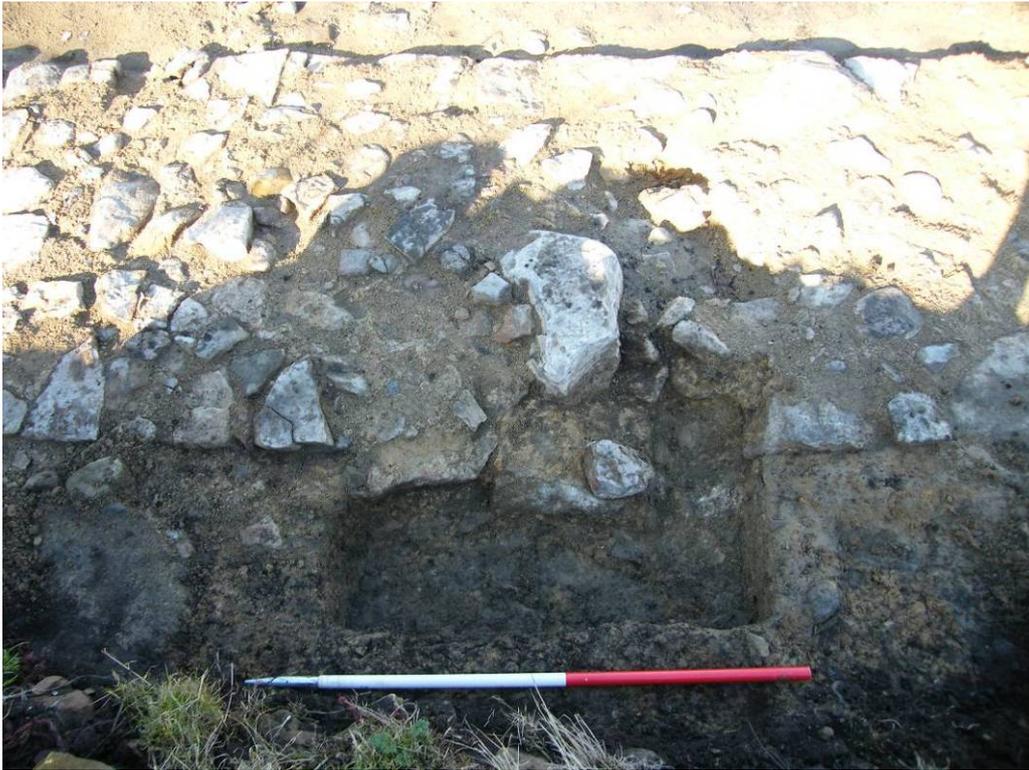
Plate 6.2 evidence for pilaster buttress, south wall of early range (N at top)

The only feature identified along the length of the south wall were the truncated remains of an external pilaster buttress whose dressings were missing but whose extent was defined by a void within surrounding deposits, *plate 6.2*. The feature had measured 0.99m in width and projected 0.41m from the south wall face. Sockets survived for two dressings the eastern of which had been north/south aligned and firmly tied back into the wall core. It was apparent that further masonry existed beneath the level of the lost quoins, evidently a footing.

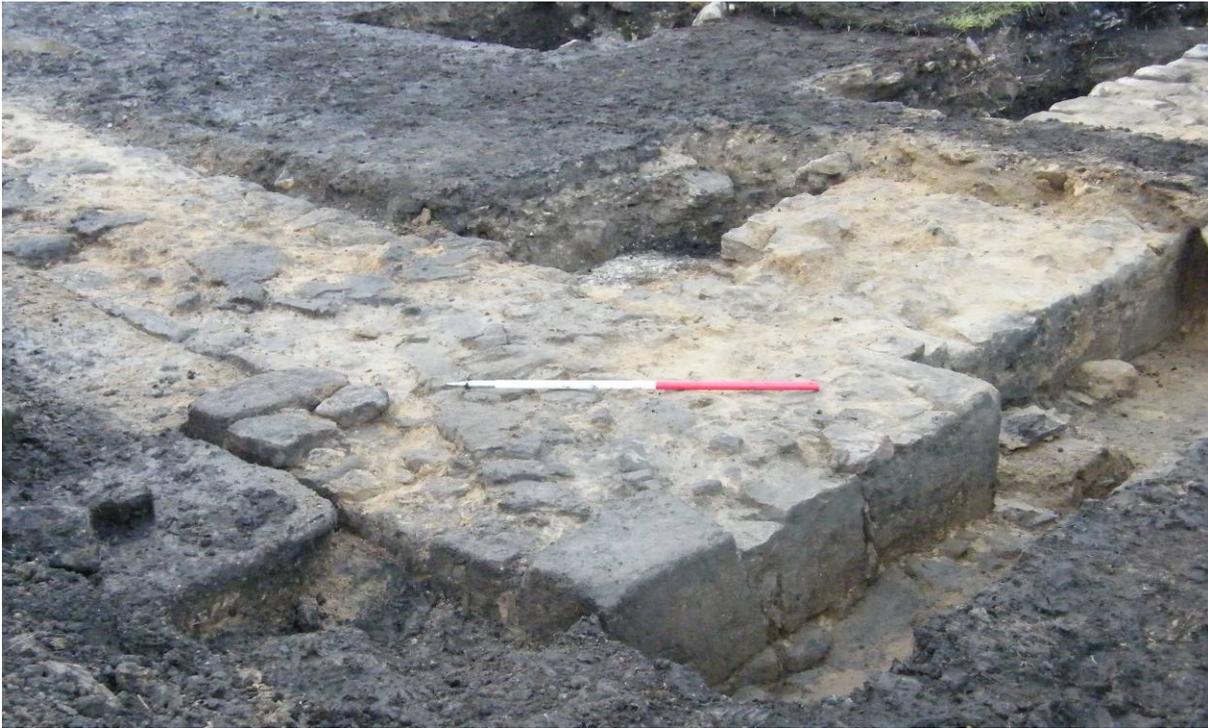
Plate 6.3 Base of clasped buttress at the SE angle of the early range as revealed; looking NW

A substantially built clasped buttress at the SE angle was also found to be well-preserved, defined by dressed grit-stone quoins at the angles that survived for a single course (also see description of trench 8), *plate 6.3*. The returning eastern gable wall was revealed for its entire length – 10.67m from buttress to buttress (individual areas as described in trenches 1, 4 and 8), *plate 6.4*. It measured 1.43m in thickness and was of identical constructional character to the south wall. Overall the width of the range had been 9.77m – 9.80m, with an internal width of 6.80m. The east wall also featured a centrally positioned pilaster buttress, this revealed within trench 1 and its southwards extension, *plate 6.5*. Also defined by grit-stone quoins surviving for a single course, the buttress base measured 0.95m in width and projected 0.39m. The quoins displayed well defined diagonal tooling, applied with a broad-headed chisel.
