Muggleswick Grange

Priory Farm, Muggleswick, Co. Durham

Historic building survey and community archaeology projects
(October 2009 - September 2011)

Data Structure Report (March 2011)

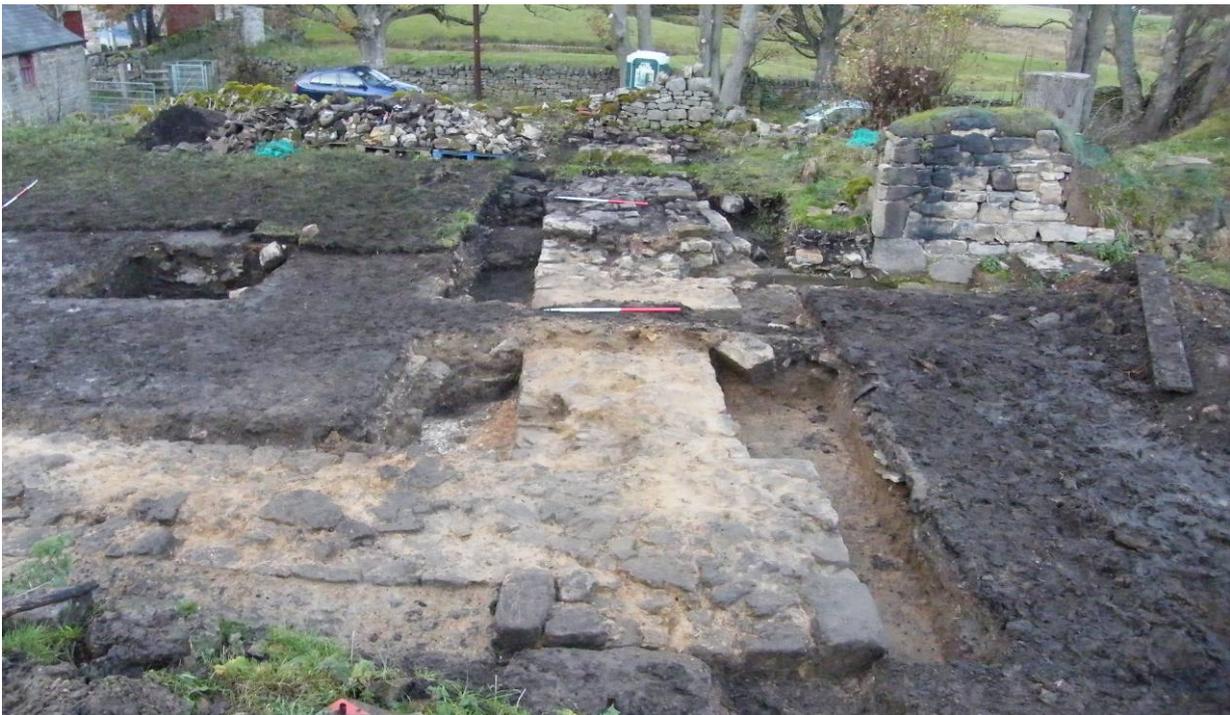
Plate 6.4 East gable wall of the early range as revealed; looking north

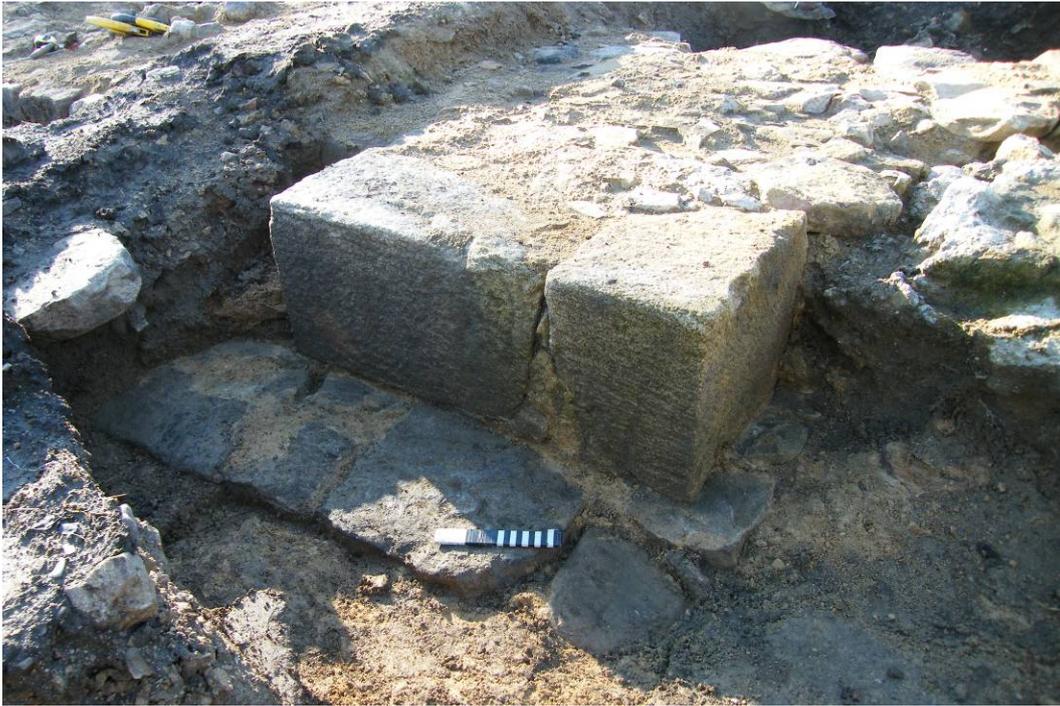
Plate 6.5 Base of pilaster buttress at the centre of the east gable wall of the early range; looking SW

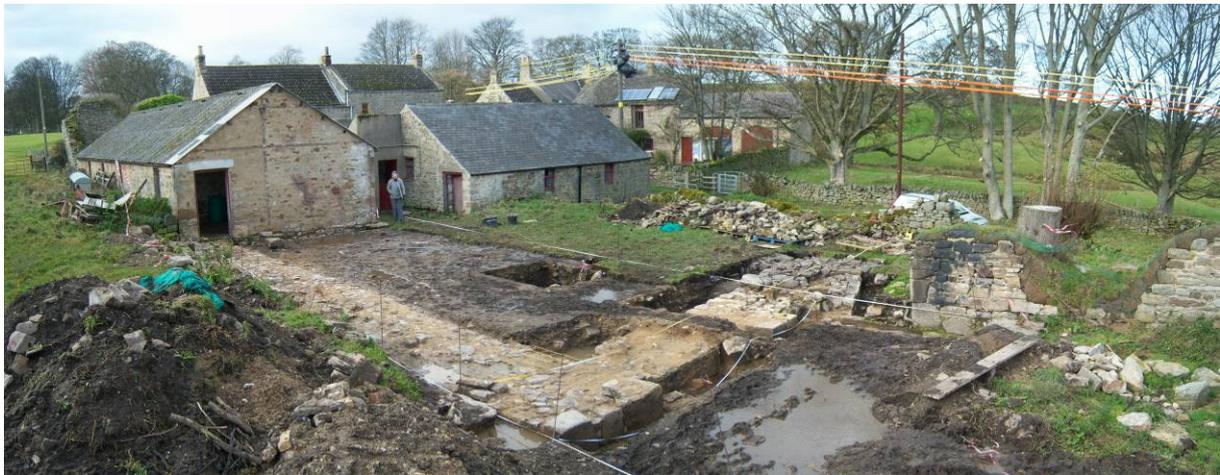
Plate 6.6 General view of the excavation area looking NW

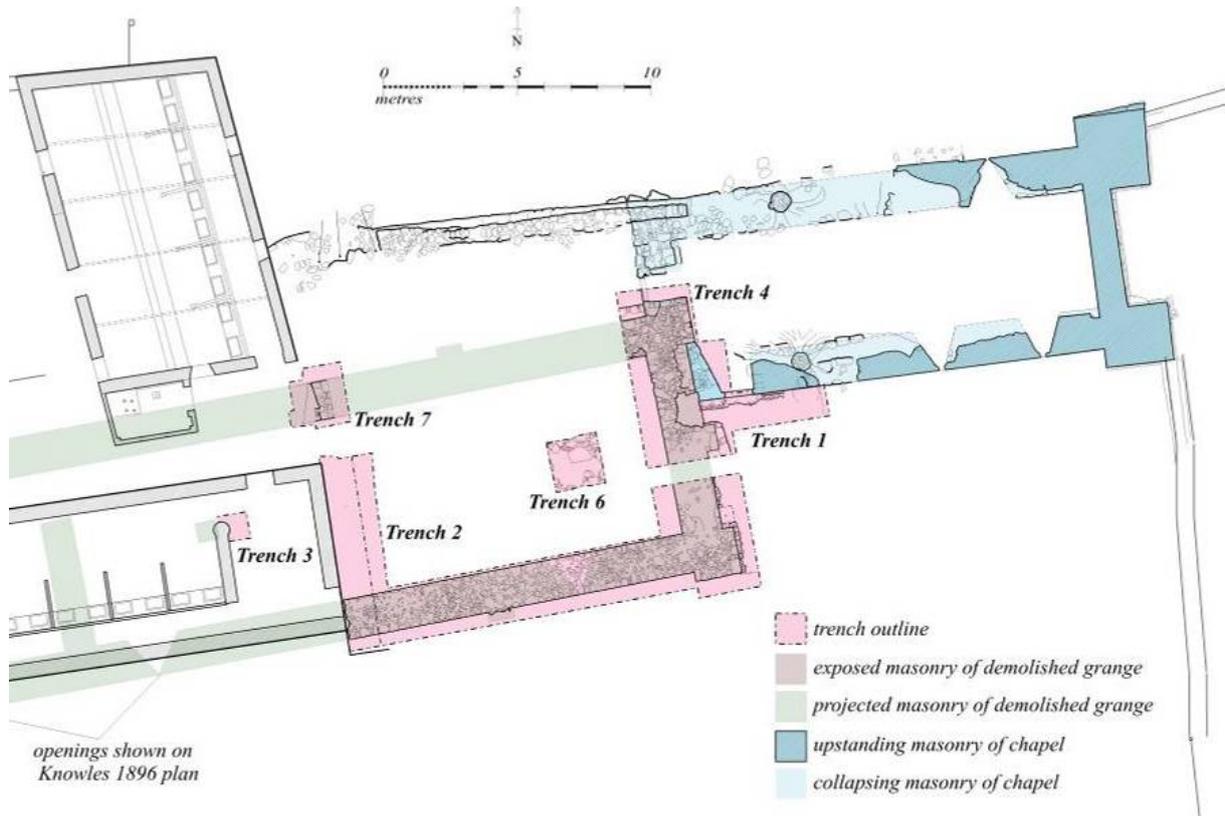
Figure 6.3 Trench locations in the area of the Dutch barn following excavation, showing extent of early footings revealed with a projected floor plan (from Knowles, 1896) of the early grange building

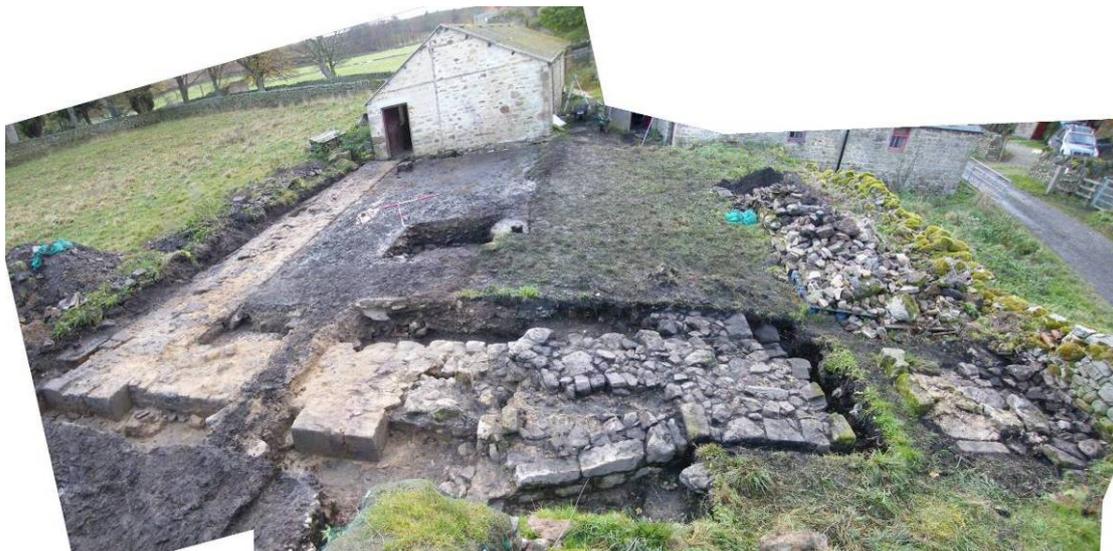
Plate 6.6 Composite panoramic view showing the western parts of Trench 1 as extended; looking west

The western end of Trench 1 was extended northwards in order to fully expose the masonry of the east wall of the early range in that area – thereby connecting through to Trench 4. This was simply achieved by trowelling off a shallow humic topsoil build-up directly that directly overlay the masonry.

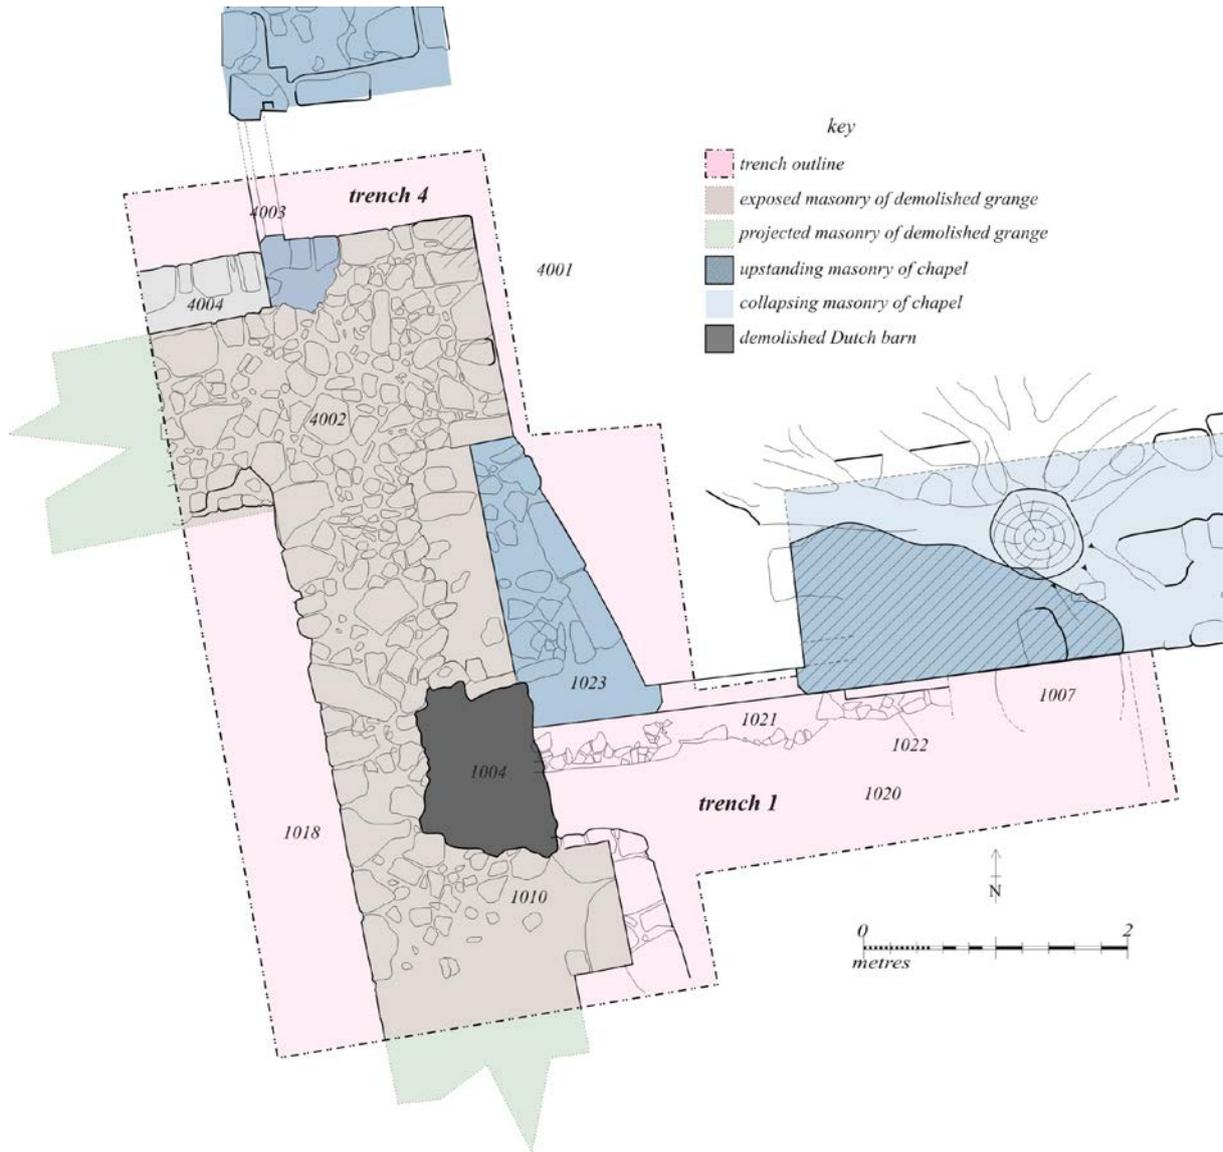
Figure 6.4 Post-excavation plan of Trench 1 and 4 with the extension connecting the two

Figure 5.2 Mid-excavation plan of Trench 1; note existence of 1014 and 1017 and compare to post-excavation plan, figure 6.4

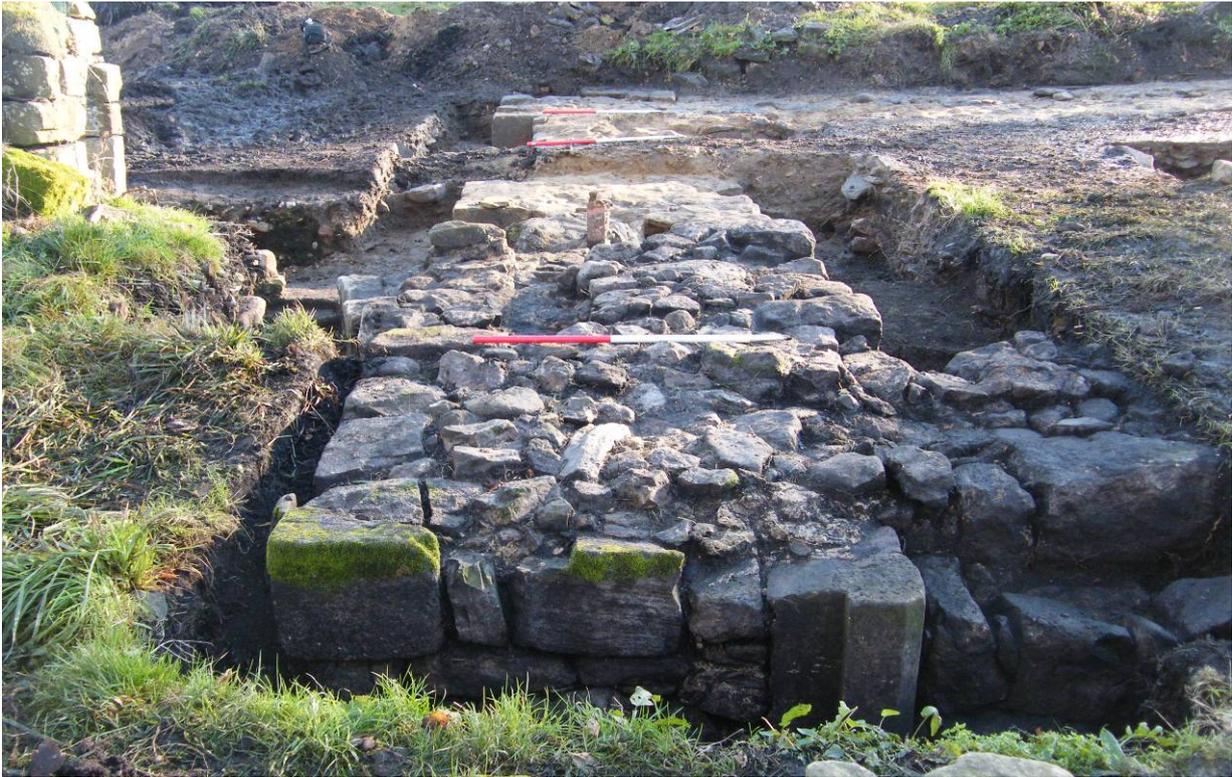
Plate 6.9 Trenches 4 and 1 joined up exposing the whole east gable of the early range

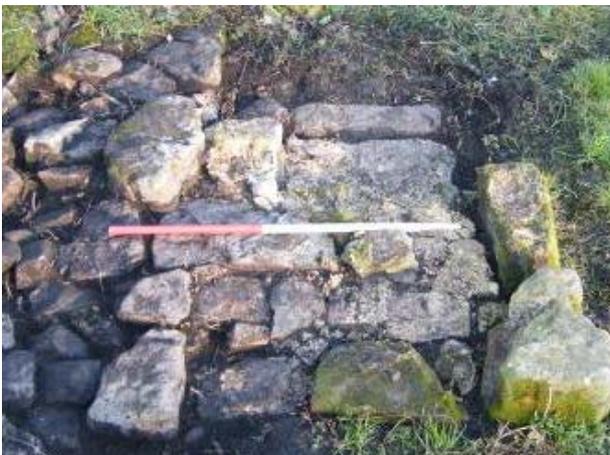
Plate 6.10 Masonry uncovered on the north side of the chapel entrance revealed in Trench 4, looking east

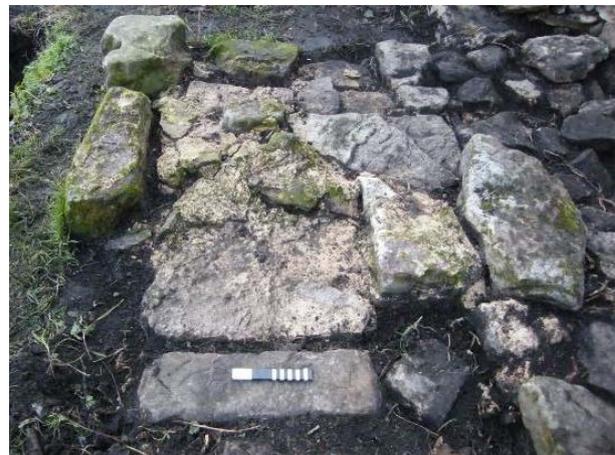
Plate 6.11 Masonry uncovered north of doorway in Trench 4 looking west. Note apparent mural recess – its sill stone beneath the scale

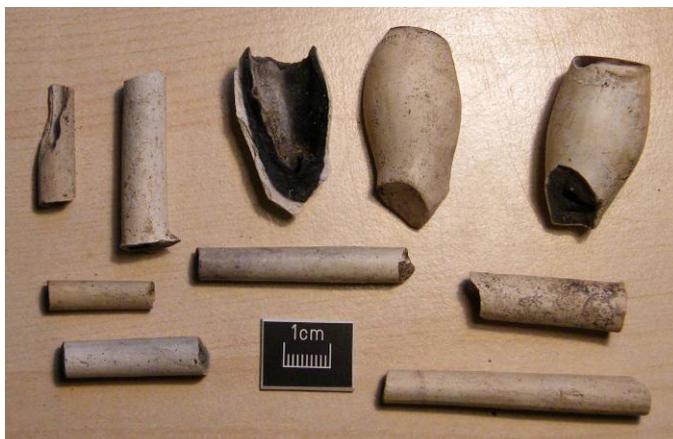
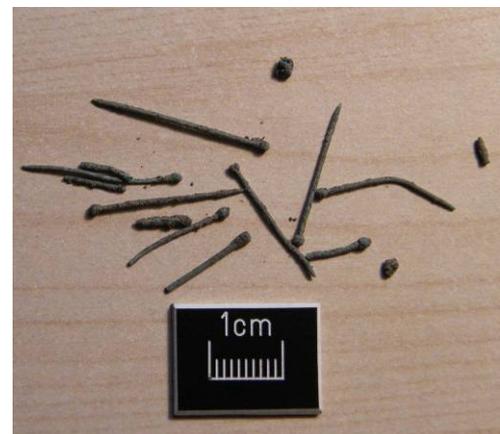
Plates 6.12 – 6.13 Pipe bowls, stems and pins from 6003

Beneath 6002 was encountered a rubbly deposit with a dark soil rich matrix some 0.20m – 0.30m in thickness, 6003; this contained many charcoal inclusions. Recovered from this deposit were an assortment of early tobacco pipe fragments, including bowls, *plate 6.12*, and a number of small copper alloy pins, *plate 6.13*; ceramic finds included green-glazed grey-wares and trail-decorated lead-glazed red-wares. The finds assemblage suggested a 17th century dating.

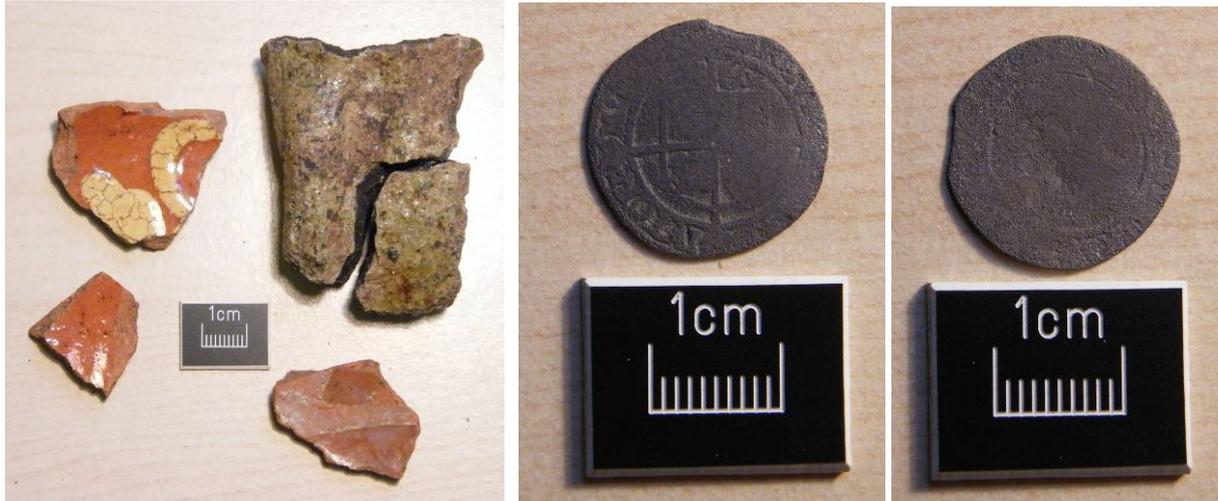
Plates 6.14 – 6.15 Pottery from 6003, and worn coin of Elizabeth I recovered from 6004 (SF0146)

Partly underlying the 6003 to the east was 6004; this was a 0.20m deep deposit of rubble stone and broken stone roofing tiles mixed through with crushed lime mortar and humic soils. Notable finds from this level, in addition to much animal bone, were a highly worn silver coin of Elizabeth I, dated 1576, *plate 6.15*, and part of the base of a free-blown wine glass.

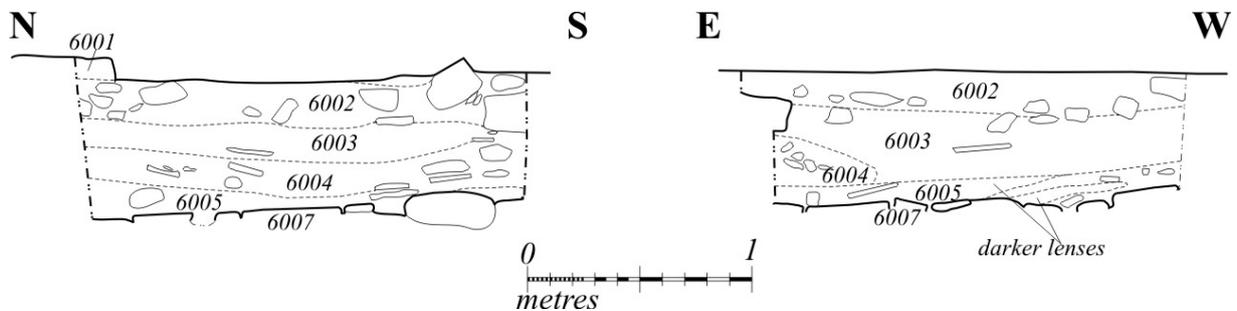
Figure 6.5 West and north facing sections of trench 6

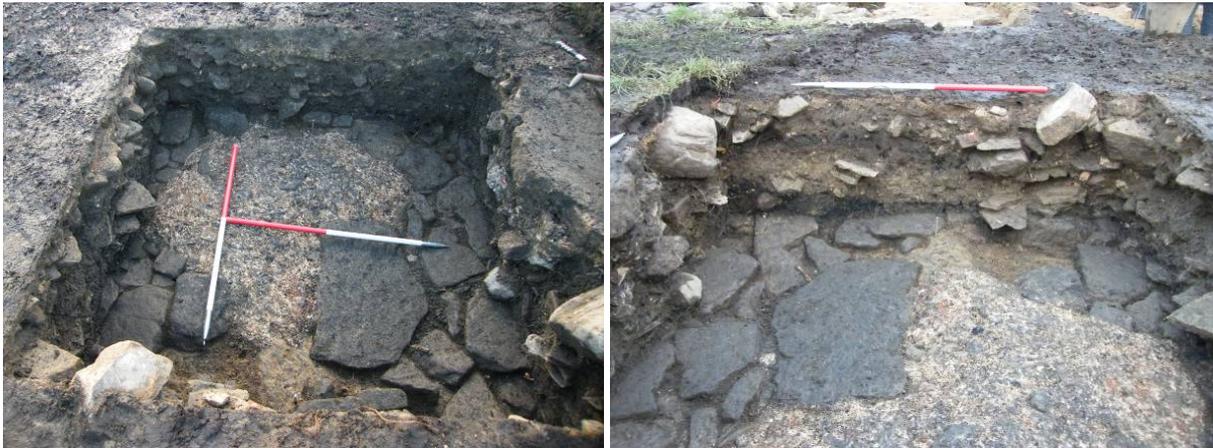
Plates 6.16 and 6.17 Trench 6 showing mortar 6006, east and west facing sections

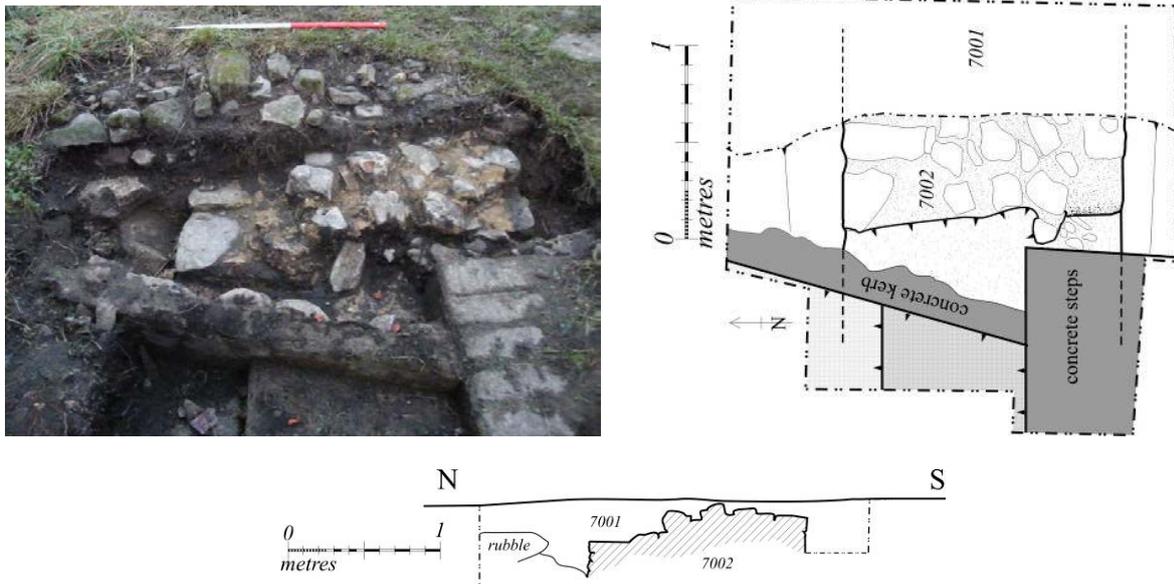
Plate 6.18 and Figures 6.7-6.8 Masonry 7002 exposed at limit of excavation, east section and plan of trench 7

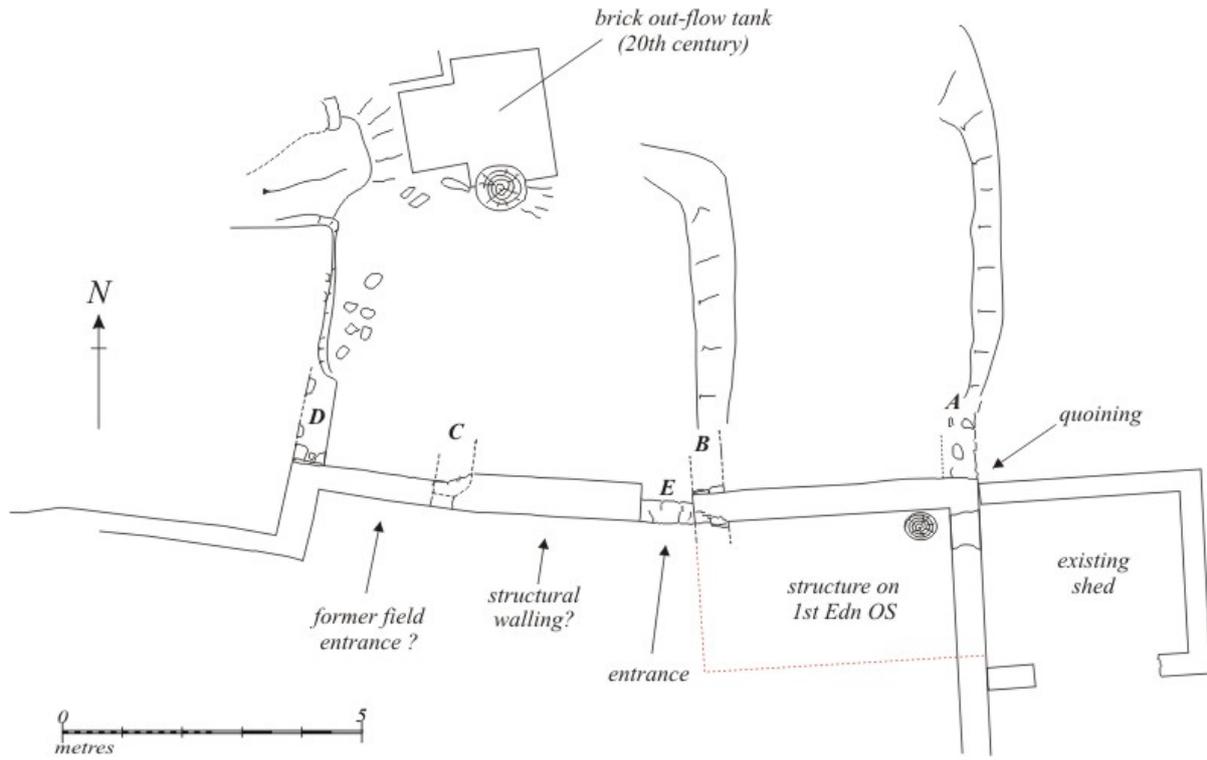
Figure 6.9 plan of the field wall bounding the north side of the farm access road

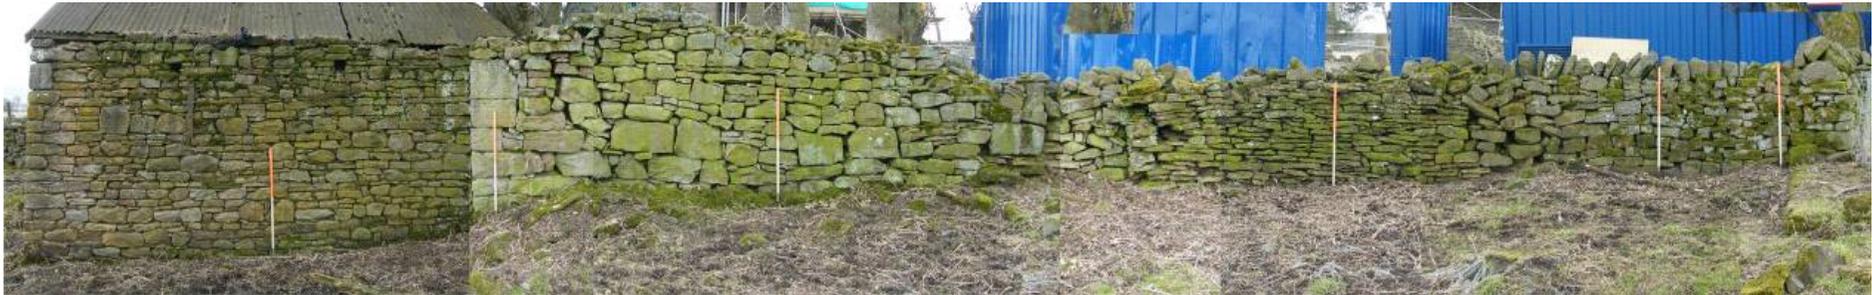
Plate 6.19 Composite view of boundary wall, north side, showing differing construction

Trench 5, 2 x 20m, ran parallel to the field boundary bounding the field to the north of the farm access road. Prior to opening the trench the boundary wall in this area was individually surveyed. It contains a number of different builds and relict features, clearly parts of pre-existing structures present on the site, figure 6.9, plate 6.19. Four individual footing alignments were noted running perpendicularly through or northwards from this section of wall, figure 6.9, (A)-(D). The 1st Edition OS demonstrates the former existence of an agricultural building on the eastern part of this wall on its south side, figure 6.10. The eastern parts of the field wall correspond to this structure and, indeed, the lower quoining of its NE and NW angles can still be made out. The quoining to the NE includes grit-stone blocks that seem likely to be reused from medieval structures at the site. A wall alignment extends northwards from beneath the quoining at (A); that this precisely lines through to the east end wall of the chapel suggests the wall footing may well relate to the medieval complex. This footing, which is about 0.90m – 1.0m in width, corresponds to a slight level change in the field beyond.

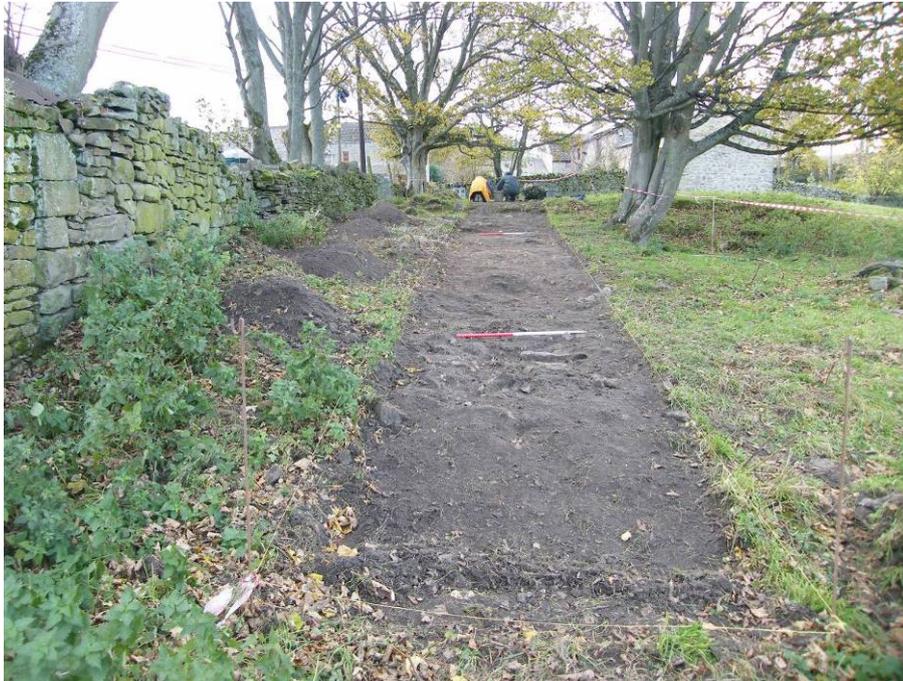
Plate 6.20 Trench 5 - initial topsoil strip, looking west

Trench 5 was positioned to examine these various northwards-running wall alignments, and the eastern side of the platform in general. Topsoil was removed along the length of the trench (*plate 6.20*) and a number of structural features immediately revealed. Within the limited resources of the Altogether Archaeology project it was not possible to complete the excavation of Trench 5. Excavation work was thus restricted to better defining structural remains within two areas, at the western and centre-eastern parts of the trench. Further work in Trench 5 was undertaken in September 2011; it is hoped that the completion and final recording of the trench will be undertaken at a future stage.

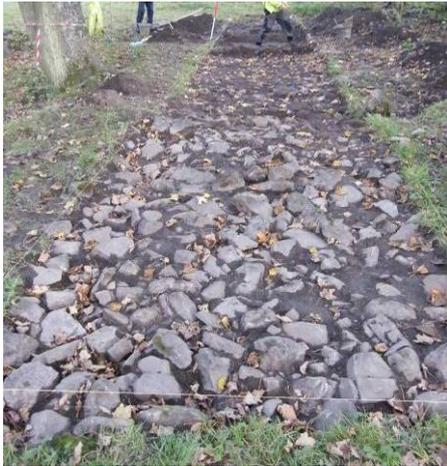
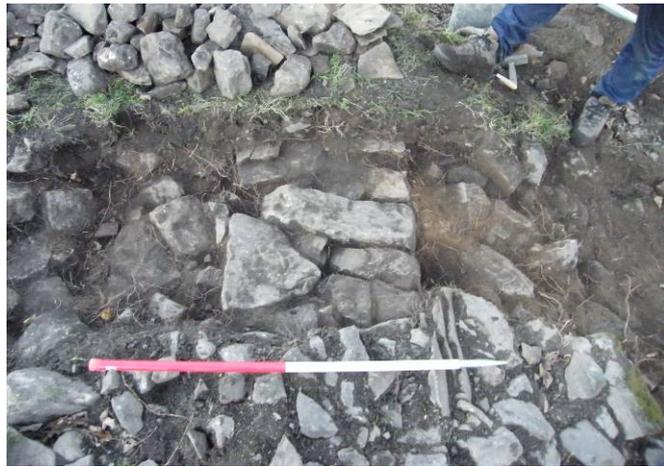
Plate 6.21 Western end of trench 5 – remains of cobbled surface as revealed, looking east;
Plate 6.22 sondage along north section with wall footing, looking north

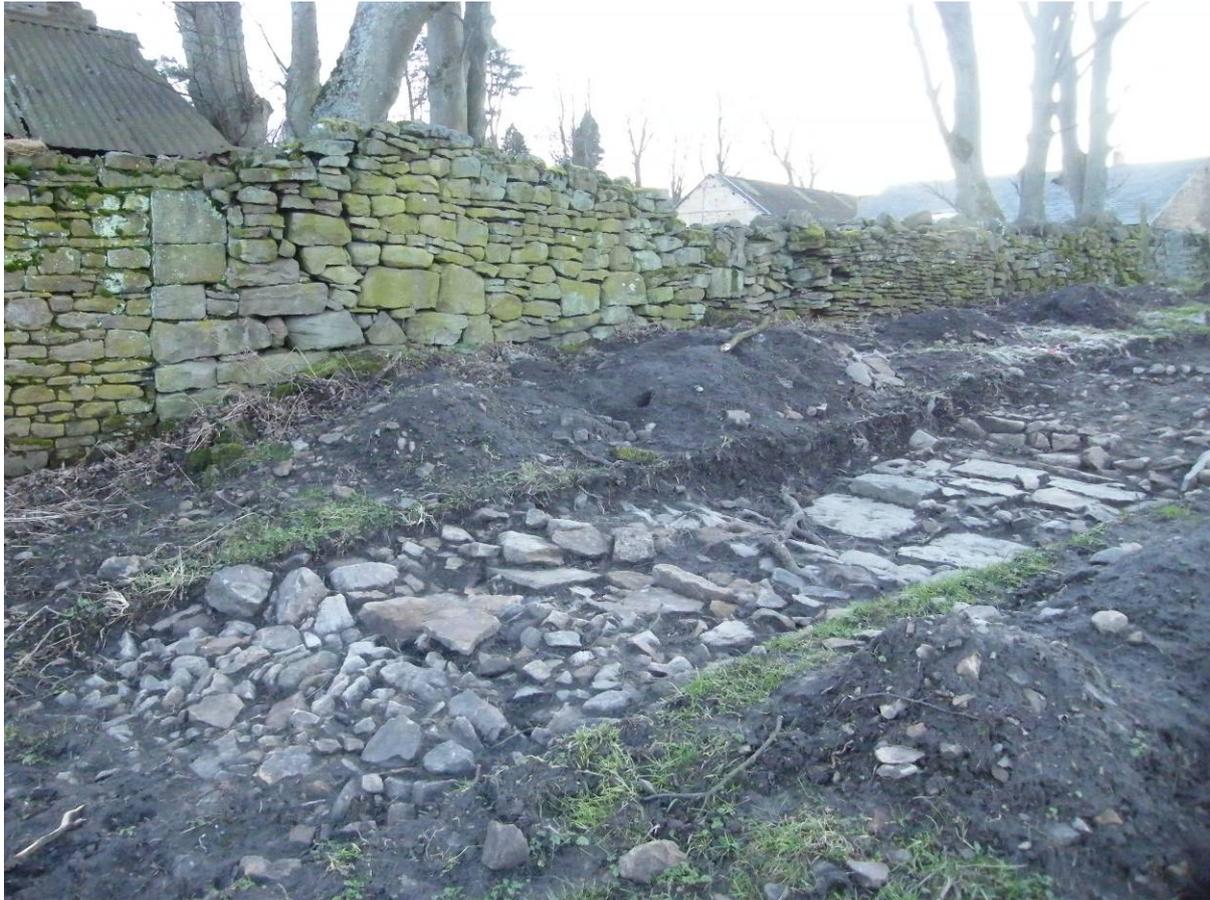
Plate 6.23 general view of the centre-eastern part of Trench 5 showing structural remains in relation to the field wall – note quoining to left which overlies wall alignment (A); looking SW

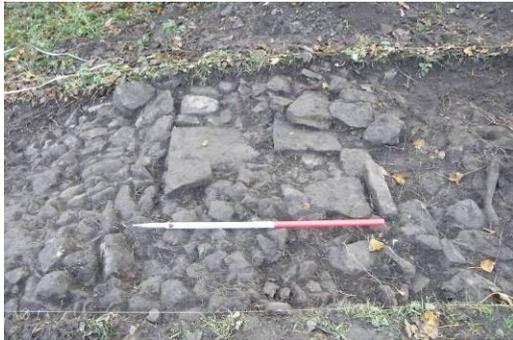
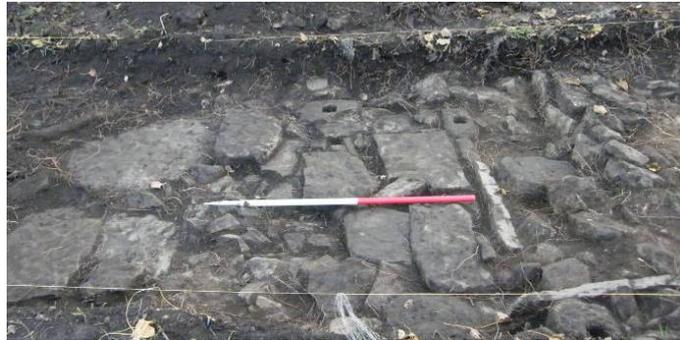
*Plate 6.24 (left) Eastern end of trench shows wall line first exposed
Plate 6.25 (right) Eastern end of trench shows cobble floor; note the various socket holes*

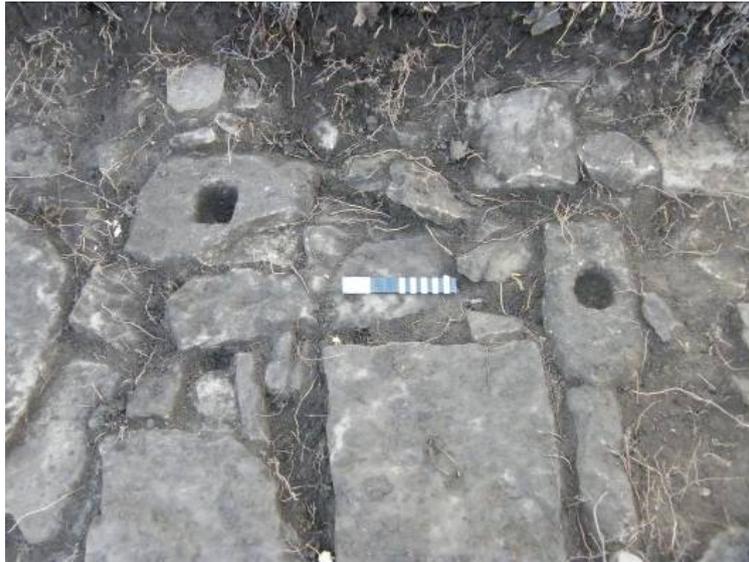
Plate 6.26 Detail of cut sockets in floor

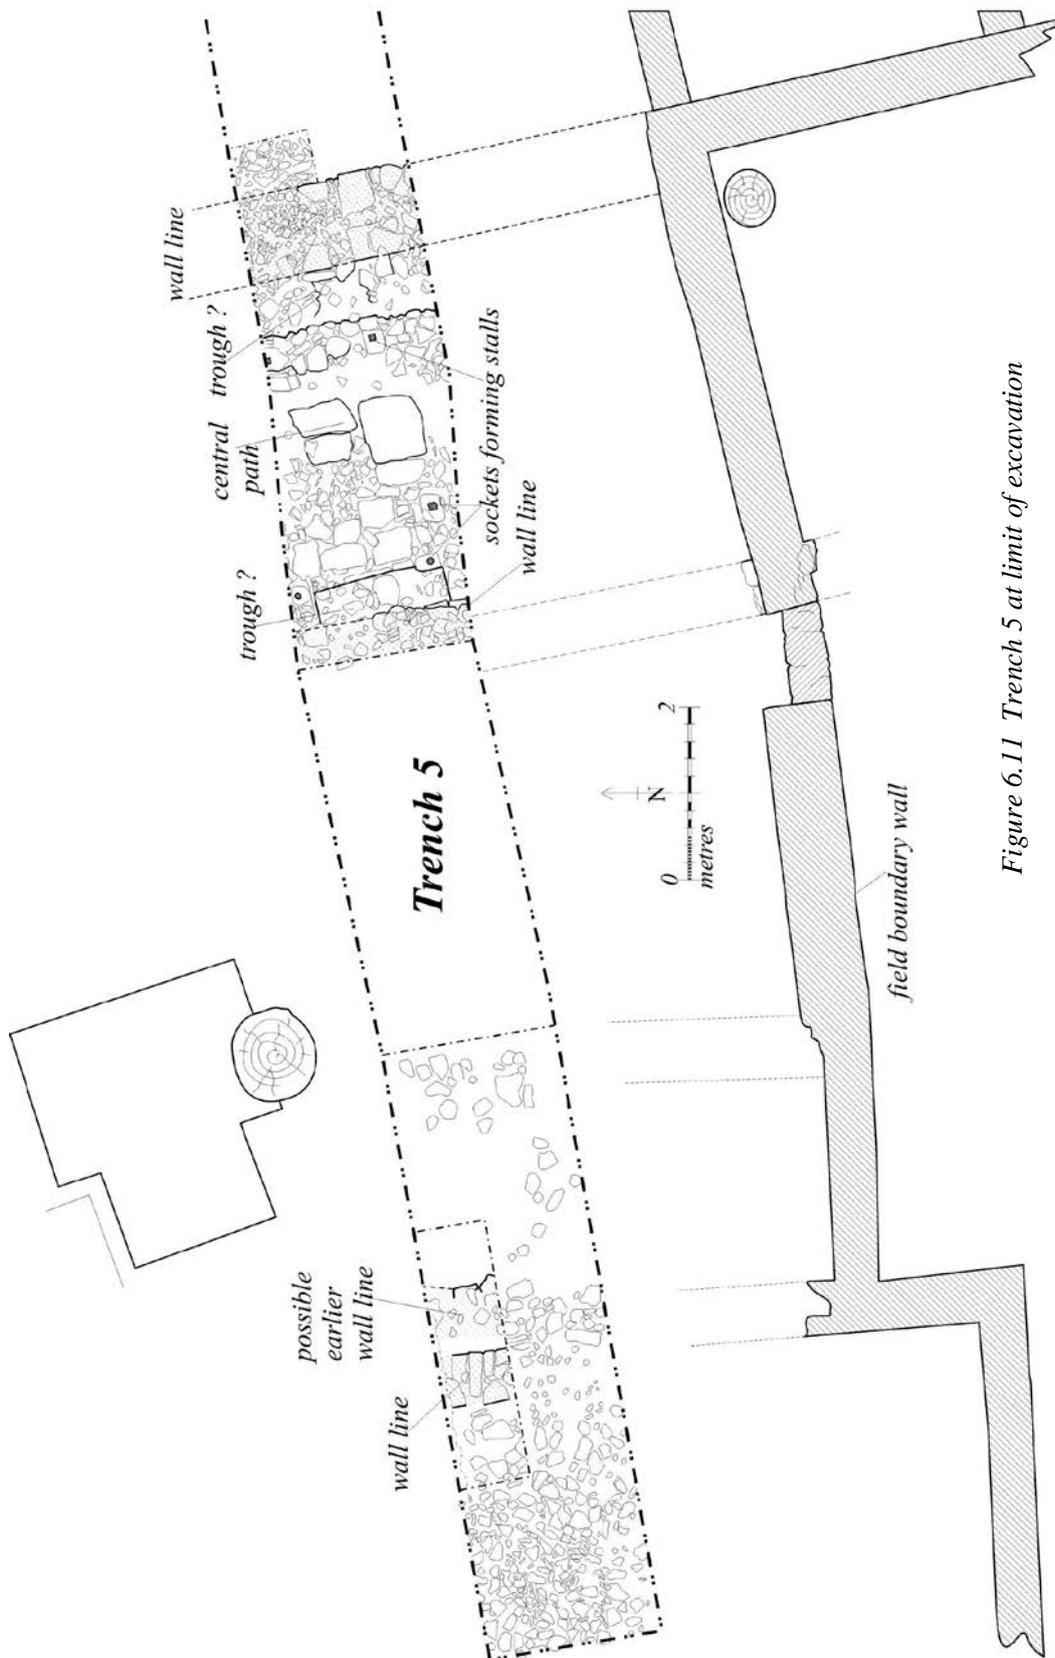
Figure 6.11 Trench 5 at limit of excavation

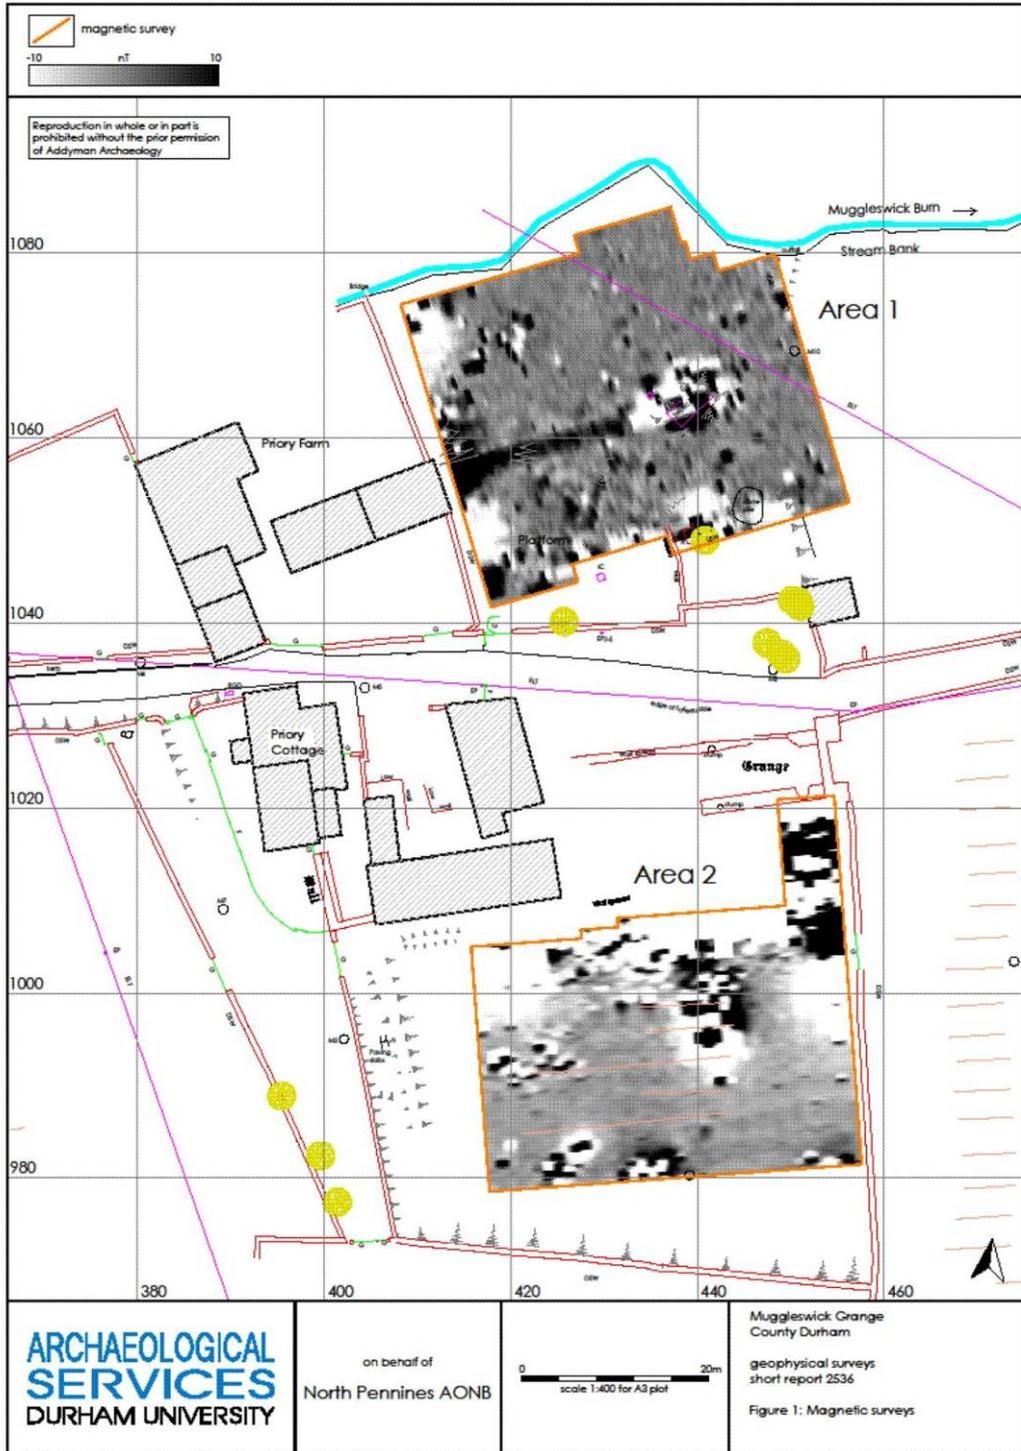
Figure 6.12 Geophysical survey, November 2010

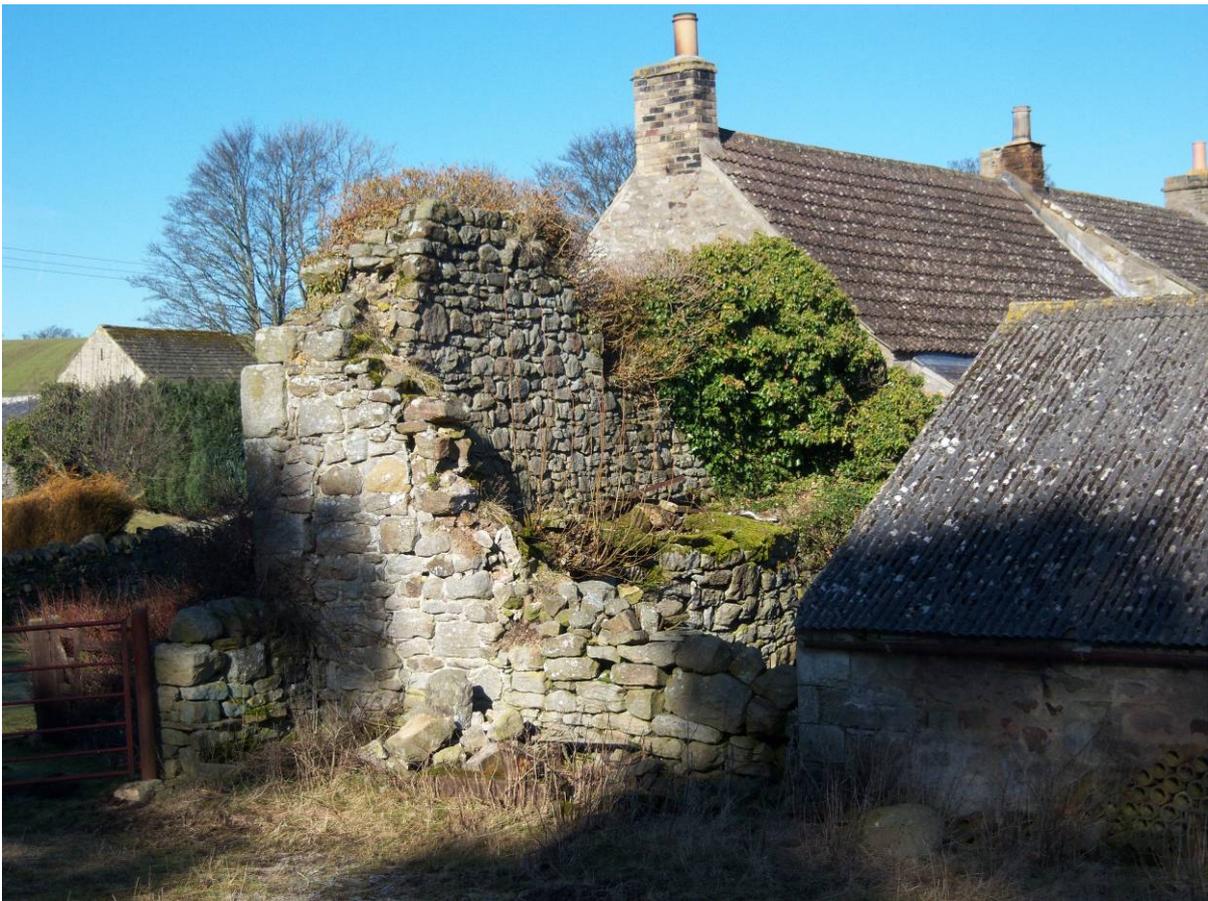
Plate 6.27 General view of the western gable wall of the early range from the SE

A substantial remnant of the west gable of the wall of the early range survives upstanding as an ivy-covered ruin lying immediately to the west of the existing byre, located within the garden of the cottage just beyond, *plate 6.27*. One objective of the community archaeology project was to record this structure as a buildings archaeology training exercise. This was undertaken on 21 January 2010, *figure 6.13*. In 1896 Greenwell and Knowles had first suggested this to have formed part of the early range – much more of the structure survived then. It was hoped that this could be confirmed by recording its precise alignment by the identification of diagnostic features of similar character to those revealed to the E on the site of the Dutch barn.

The complexity of the present walling, which incorporates masonry of more than one period, was somewhat masked by the existing cementitious pointing. However it is clear that much of the lower parts of the gable, up to first floor level, and parts of an eastwards return at its north end are of early date. Its recordable features indeed confirmed it to be the west gable wall of the early range as revealed by the excavations further east.

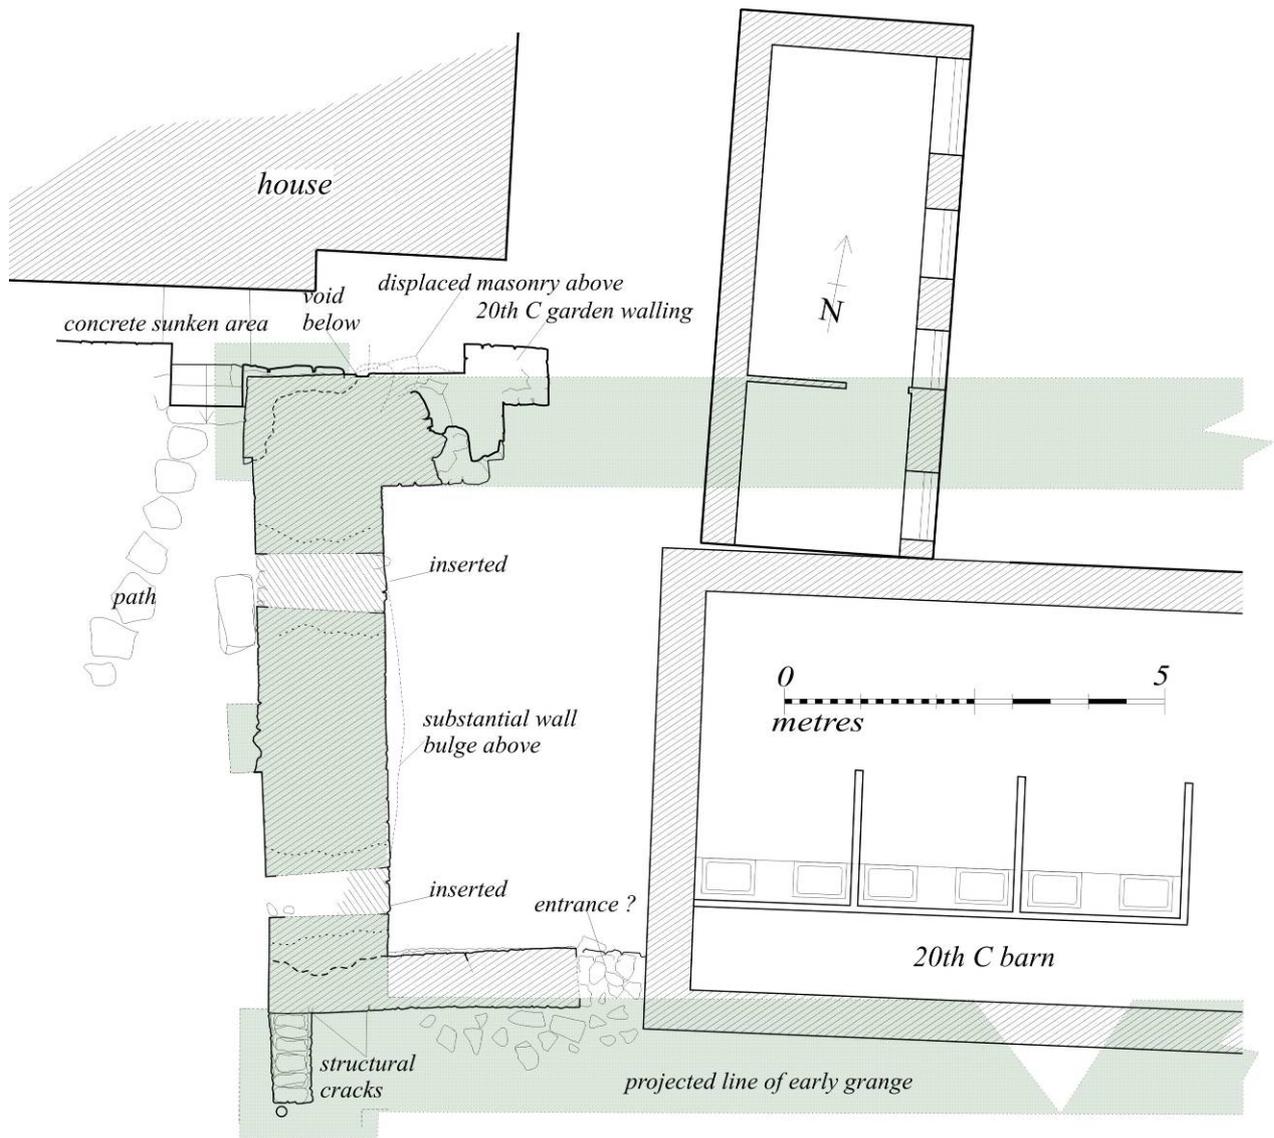
Figure 6.13 Plan of the west gable wall of the early range; pale blue – projected former extent

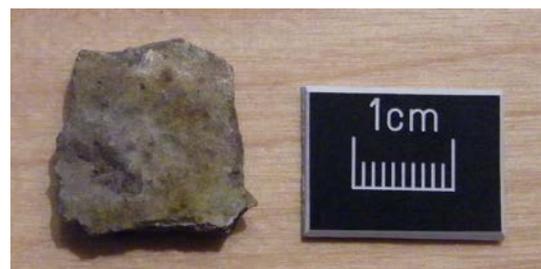
Plate 7.10 SF230 Medieval ceramic

In the end the Sondage was excavated to a depth of 0.50m, revealing a deposit interpreted as a demolition layer and recorded as 5006. This deposit contained a large quantity of rubble and roof tiles in a fragmented state, but also a small fragment of medieval green-glazed ceramic (SF230 – plate 7.10).

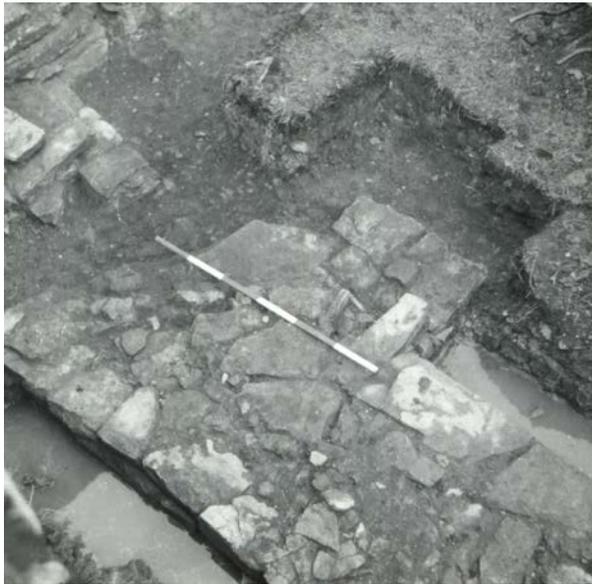
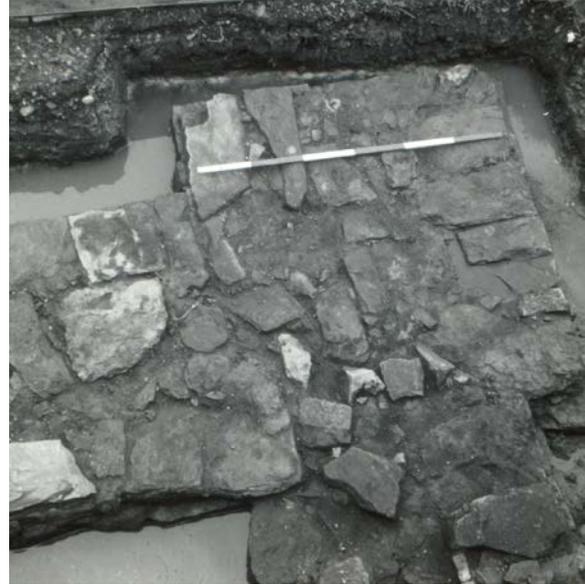
Plates 7.1 and 7.2 Pilaster and clasped angle buttresses as excavated by Leslie Still in c.1960-1 at the grange of Bewley (photographs courtesy Martin Roberts)

These diagnostic details, taken as a whole, permit a far more authoritative comparison to be made with structures of similar form and date elsewhere in the region. Martin Roberts and Peter Ryder have suggested a number of parallels for these architectural details, particularly the presence of clasped buttresses which, though an archaic feature with roots in the Norman period, were still employed in the region well in to the 13th century – as seems to be the case with Muggleswick and the comparable sites of Bewley (one of the most important sites of the Prior of Durham, said to have been built between 1258-73), *plates 7.1 – 7.2* and *figure 7.1*, and the inner camera added at Beaurepaire at about the same time c1260-70,²⁸ and other sites such as Bellister Castle (*figure 7.1*), near Haltwhistle, Tynedale.²⁹ The earlier structure at Bewley in particular, with its clasped and pilaster buttresses, is a close parallel to those of the early range at Muggleswick.
