Muggleswick Grange

Priory Farm, Muggleswick, Co. Durham

Historic building survey and community archaeology projects
(October 2009 - September 2011)

Data Structure Report (March 2011)

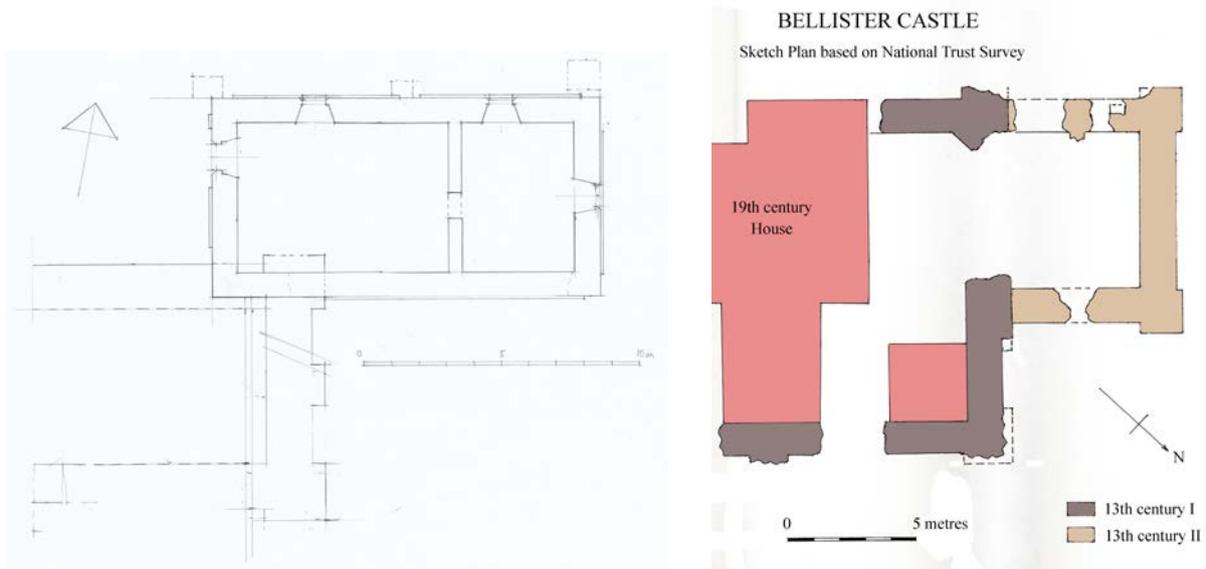
Figure 7.1 Comparative plans of 13th century buildings at Bewley Grange and Bellister Castle (c/o Martin Roberts and Peter Ryder)
