ALTOGETHER ARCHAEOLOGY  
MODULE 9-D REPORT

**NENTHEAD LEAD MINES,  
NENTHEAD, CUMBRIA**

NENTHEAD LEAD MINES, NENTHEAD, CUMBRIA  
COMMUNITY ARCHAEOLOGY PROJECT

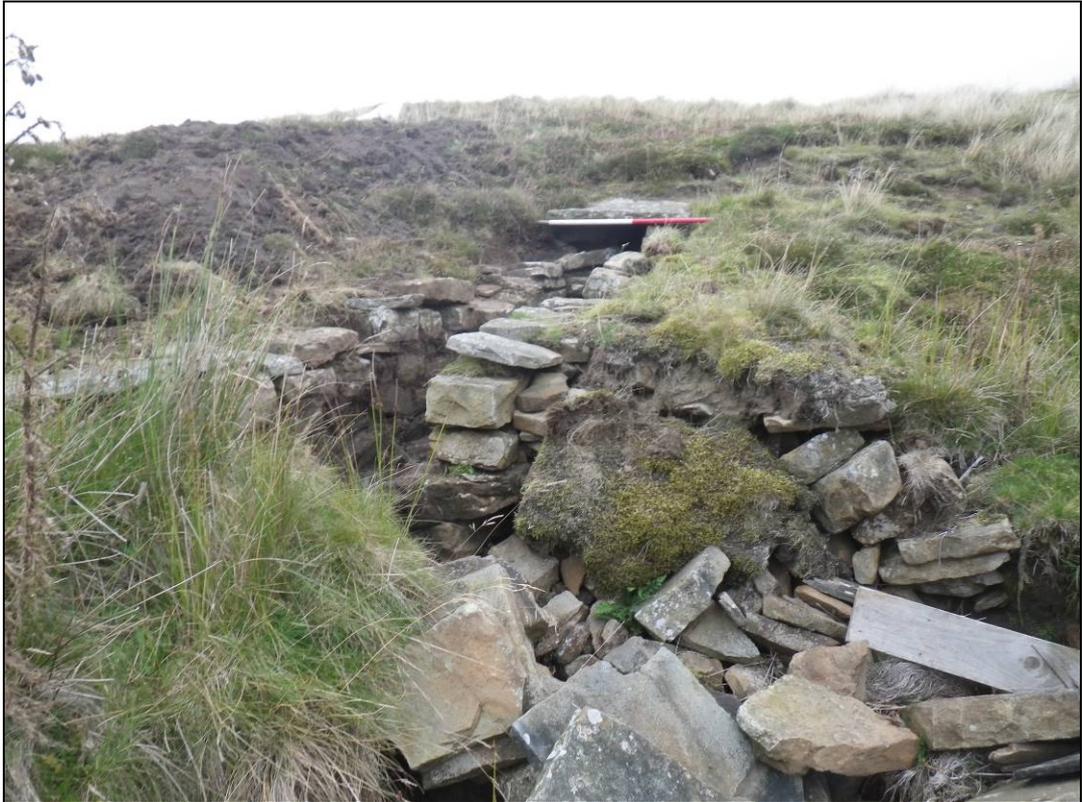
*Plate 9: Exit of culvert (2440).*

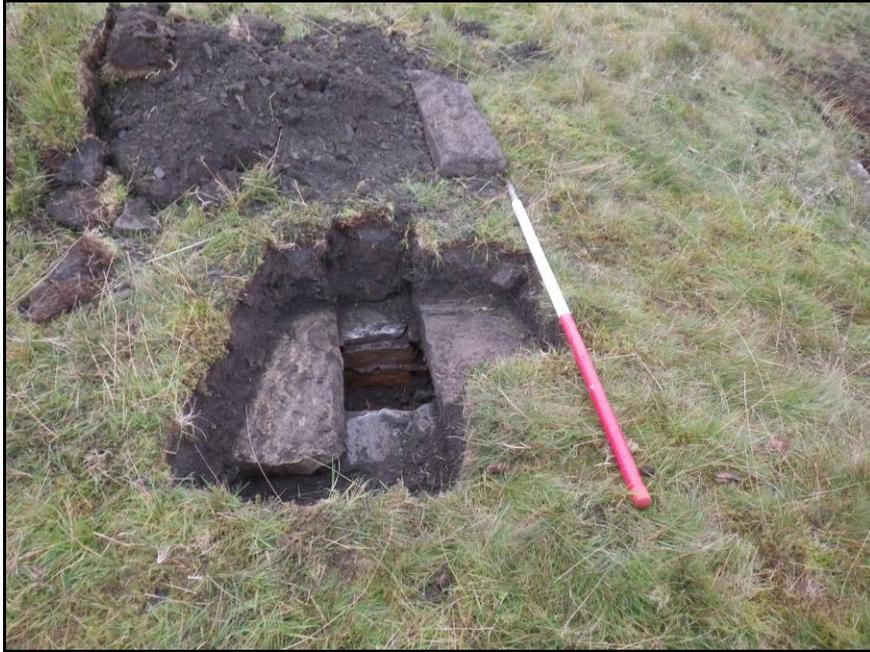
- 10.48 Trench 4, Plate 16, was located at NY 78742 43496 to investigate the flow of leat (**2615**) coming out of Firestone Level. The trench measured 0.40m by 0.60m and the location of this Trench is shown on Figure 5.

*Plate 16: Trench 4 showing leat (2615) facing southeast.*

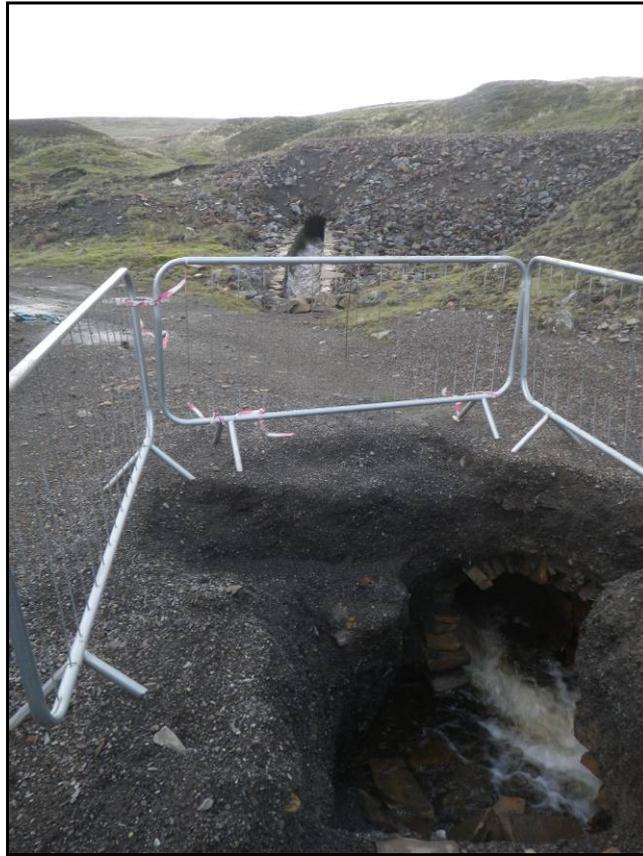
- 10.55 Culvert (2462, Plate 18) is located to the west of Handsome Mea adjacent to the modern track way, where it joins the trackside leat (2460). Trench 6 was excavated to investigate a collapse in the culvert, which was forcing water to flow northwest, creating a void in the overlying deposits. The location of culvert (2462) is shown on Figure 4.

- 10.56 Trench 6 was excavated down to the top of the culvert arch, to investigate the collapse. Water has been flowing through the culvert to an area where the plank lining stops. This was causing the water to pool and gradually washing away the surrounding gravel creating a large void. The pooling water has subsequently washed away the side wall, causing the arch to collapse and block the culvert.

- 10.57 During the excavation, safety concerns over the size of the void made the trench unworkable. A JCB, with a toothless ditching bucket, was used to make the trench safe by machining the gravel above the void, and battering the sides. The trench was then fenced off and no further work was undertaken.

*Plate 18: Culvert (2462) facing northeast.*

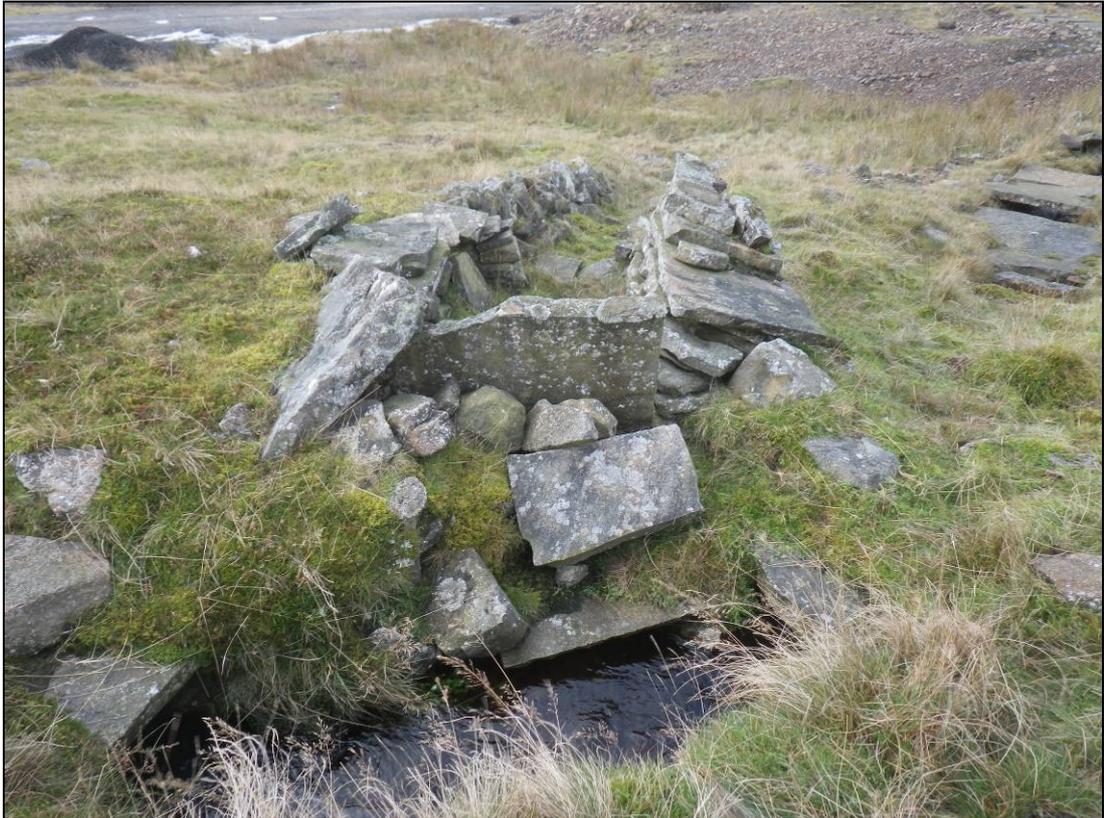
*Plate 20: Overflow (2617) with the continuation of leat (0010) to the right of the image.*

- 10.63 Overflow (2617, Plate 20) is located at the junction between leats (0010) and (0020) and was in a ruinous state. The structure survived up to four courses high of randomly coursed limestone blocks for approximately 10m after which the structure appears to have been robbed out.
- 10.64 The overflow served to take water out of the southern feeder leat and diverting water away from the reservoir and into the trackside leat.
- 10.65 The connection between overflow (2617) and the trackside leat is now lost. At some stage an attempt had been made to re-establish the water flow out of (2617) in the form of ditch (2618) which looks to have joined to ditch (2616) at the end of the trackside leat (2460). Most of the evidence has now been lost due to the partial construction of a car park at the junction between the two features (*Jackson, pers com*).

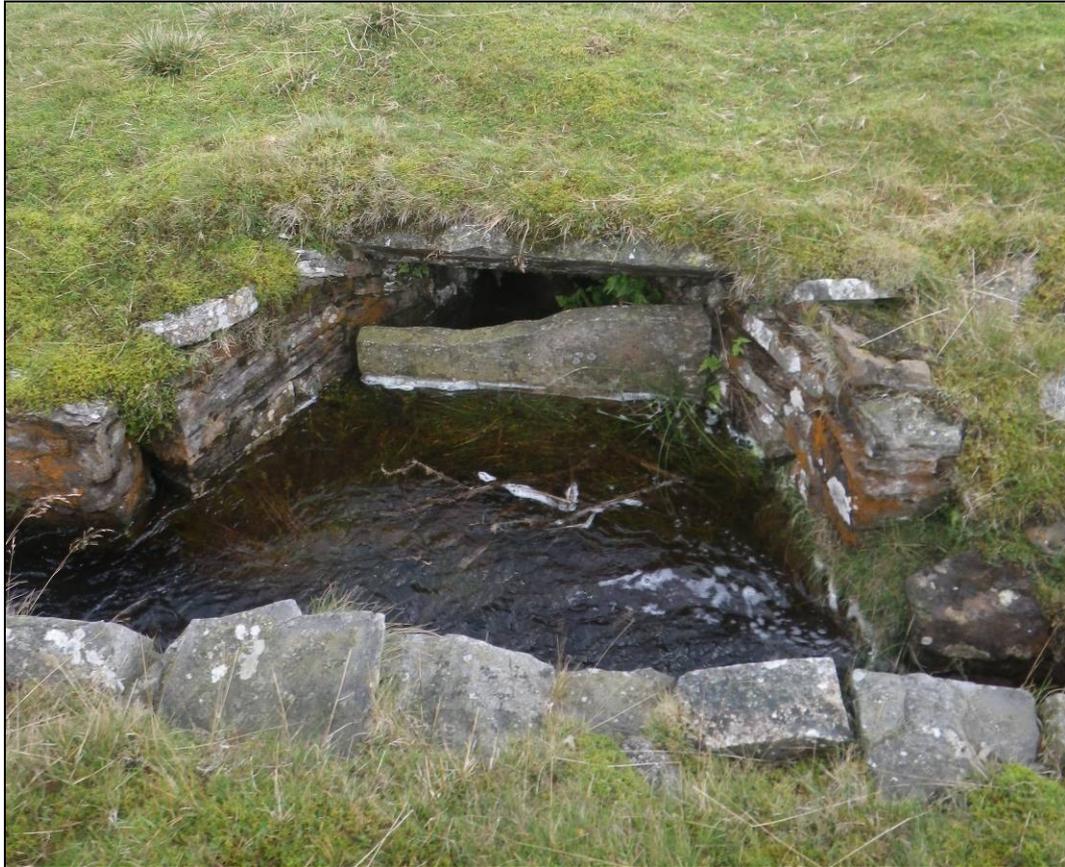
- 10.66 Overflow (2580, Plates 19 and 21) is located immediately to the south of Handsome Mea and diverts water from the southern feeder leat into the trackside leat (2460). This feature is of very similar construction to overflow (0032) and serves the exact same purpose. Under closer examination it seems overflow (2580) has been inserted into the side of leat (0010) (Plate 19), supporting the fact that overflow (2580) is a later replacement of overflow (2617).

*Plate 21: Overflow (2580).*

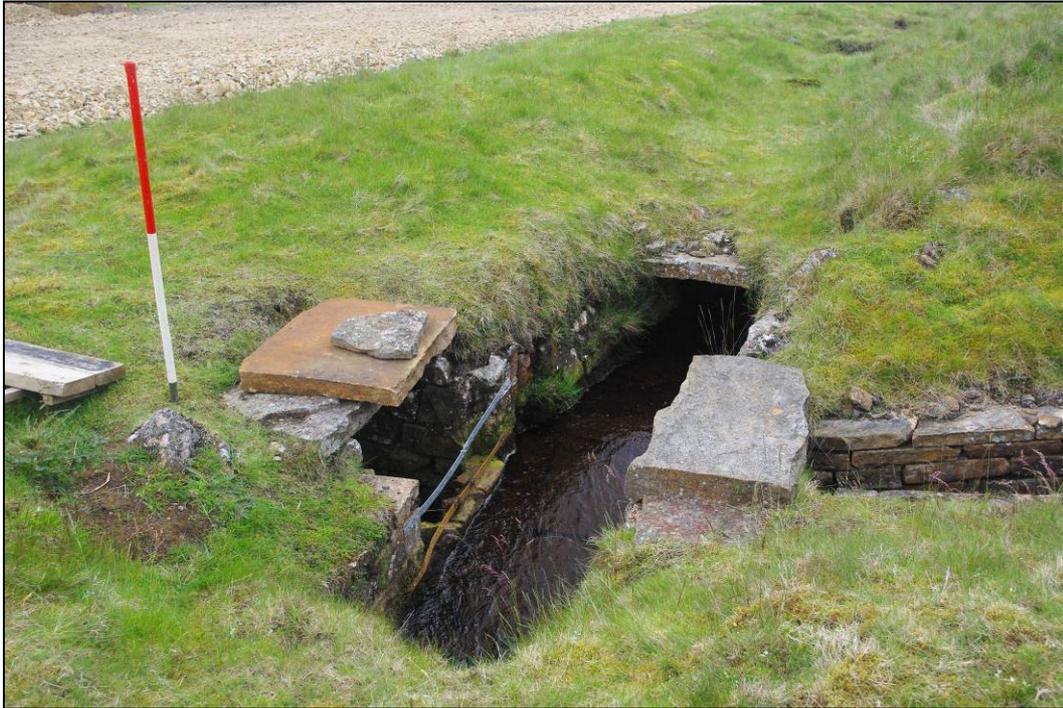
- 10.67 Overflow (0017, Plate 22) is located adjacent to the track way to the north west of the Compressor House at NY 78852 42810 and served to divert water into Old Carr's Burn from leat (0010) probably during periods of heavy rainfall. The structure consists of six courses of randomly coursed limestone blocks up to 0.40m high with large limestone capstones and a flagged base. The sluice gate at the junction with leat (0010) is mostly rotten and has been recently repaired. A small masonry overflow exists at the base of the overflow and slots can be seen either side, which likely represents the position of the original sluice gate.

*Plate 22: Overflow (0017) facing northwest.*

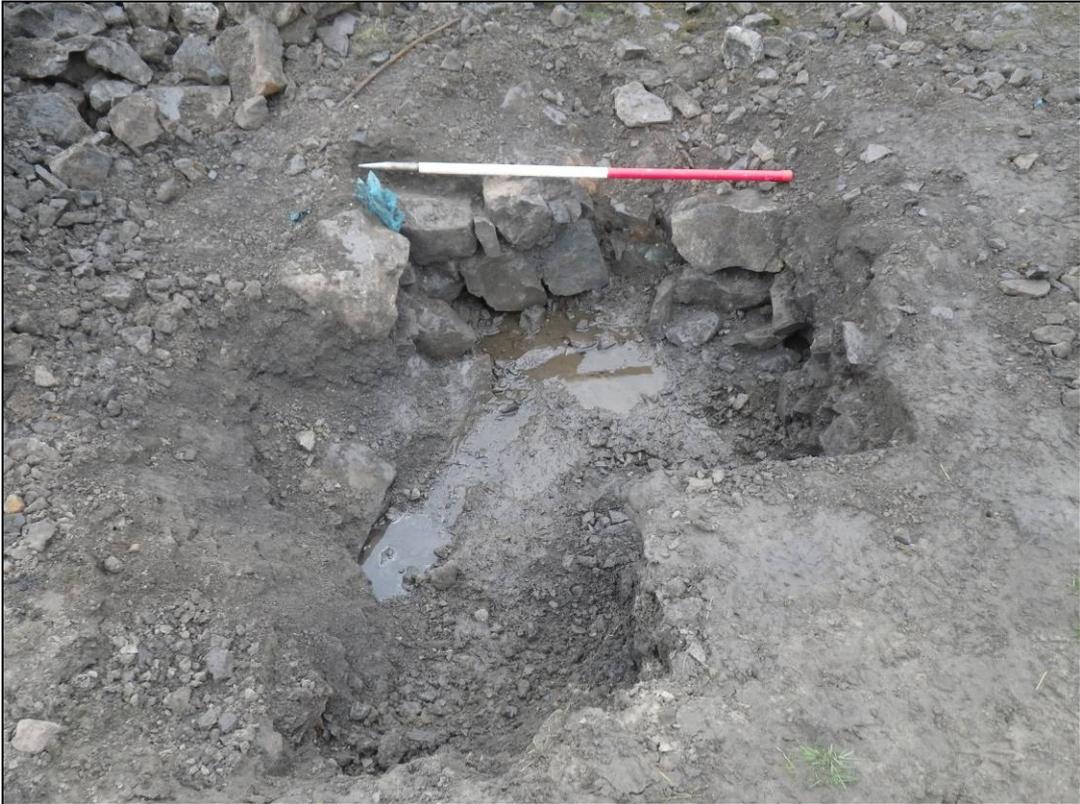
- 10.79 Trench 12, Plate 24, was located directly adjacent to the track way to the west of Trenches 7 to 11 at NY 78756 42996. The trench measured 1.00m by 1.50m and 0.30m deep.
- 10.80 This trench was excavated to investigate a boggy area next to the track way, which was suspected as being the cause of flooding coming out of the retaining wall to the southeast of the track way. It was noted that the trench was filled by large angular stones and was acting as a soakaway (Plate 24). This allowed water to drain through the south-western retaining wall for the track way, causing significant damage.
- 10.81 No features of archaeological interest were found in Trench 12 as the area had been disturbed by the partial construction of the car park adjacent to Handsome Mea.

Plate 24: Trench 12 to investigate boggy area of ground.

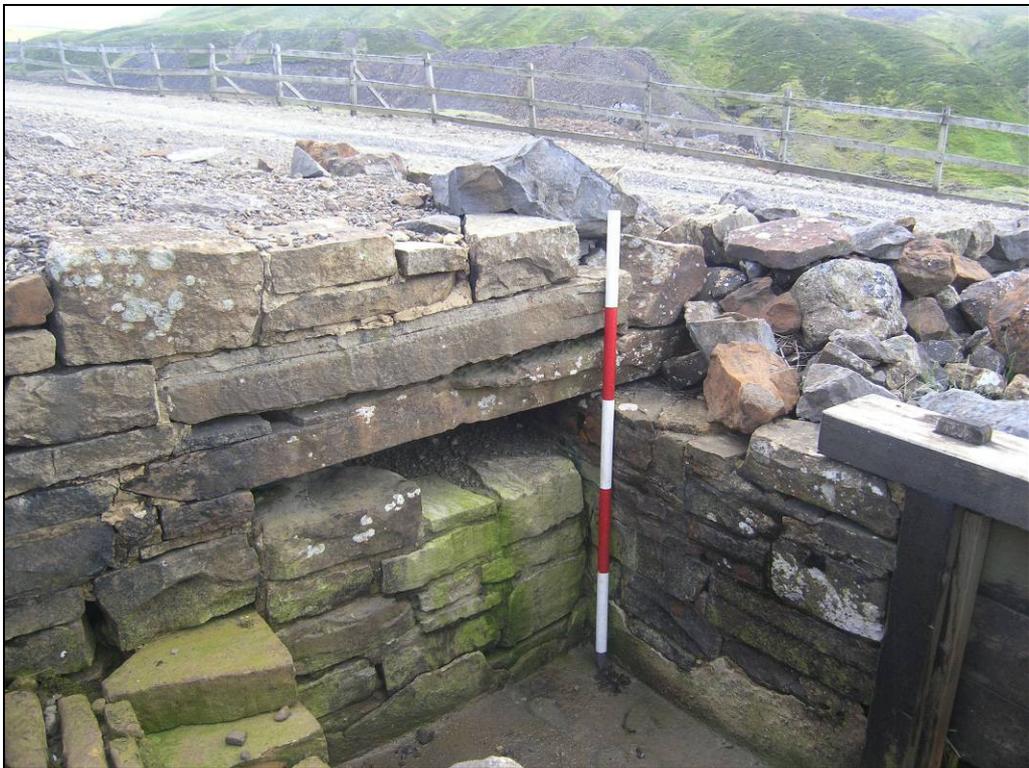
- 10.84 At its north-western end leat (2460) enters sluice (2619, Plate 26) and runs into culvert (2574) which is carried across a modern launder (2573) towards the Stag Condenser wheel pit. The exit of leat (2460) as it enters sluice gate (2619), has been partially blocked off and is currently heavily silted up. It is likely this was meant to act as an overflow to limit the amount of water entering the sluice gate from leat (2460), but has now become too silted up to function correctly. At its south-eastern end leat (2460) turns into a poorly defined earthen ditch (2616) which runs for a short distance before it

*Plate 26: North-western exit of leat (2460) as it enters sluice gate (2619).*

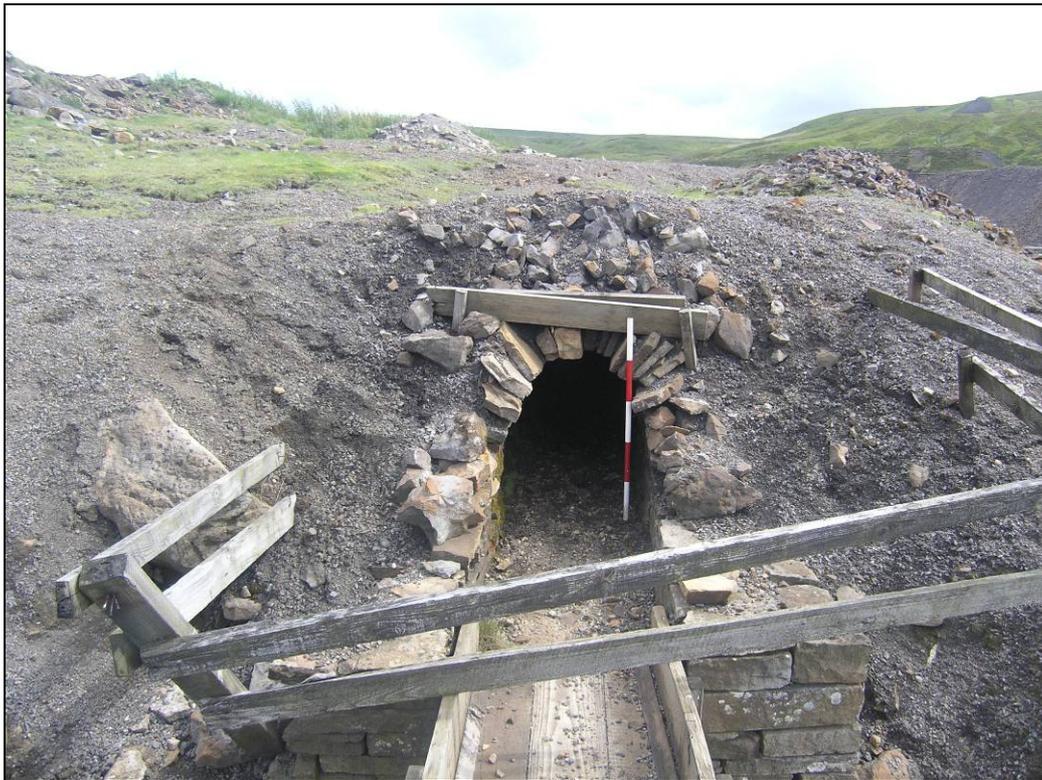
- 10.89 Culvert (2573, Plate 28) starts in the side of sluice gate (2619) and runs to the northwest over a modern launder (2574). It runs underneath spoil heap (2457) and continues beyond the launder as culvert (2575) towards the Stagg Condenser wheel pit. The culvert is made up of two side walls approximately 0.40m high made up of randomly coursed limestone blocks with a vaulted arch spanning both walls made from thin sections of limestone voussoirs. The base of the culvert was partially covered by gravel and fallen debris. The entrance to the culvert, shown in Plate 28, has partially collapsed, but is largely clear of debris.

*Plate 28: Culvert (2573) as it crosses launder (2574) to meet culvert (2575).*

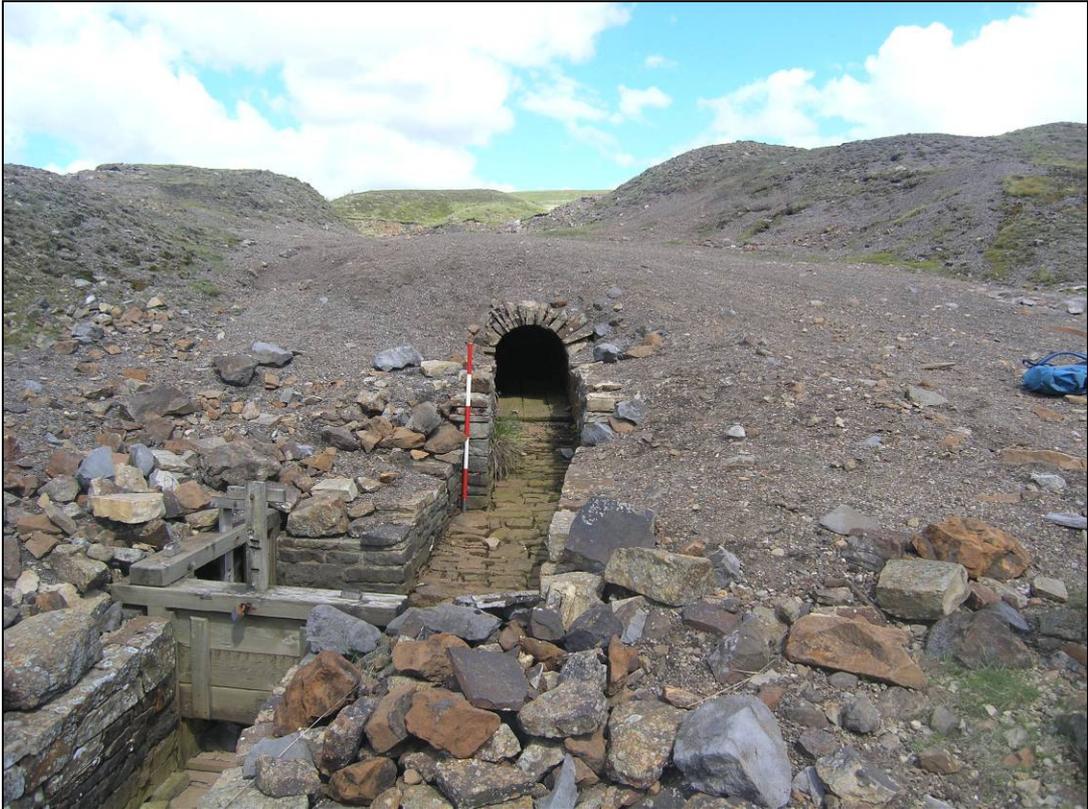
- 10.91 Sluice gate (2619, Plate 29) controlled the flow of water from culvert (2462) and leat (2460) and directed into culvert (2574). This is presumably contemporary with the construction of the Stagg Wheel Pit. The current sluice gates are modern timber replacements and are currently set up to divert

Plate 29: Sluice gate (2619) and culvert (2462) facing north-east.

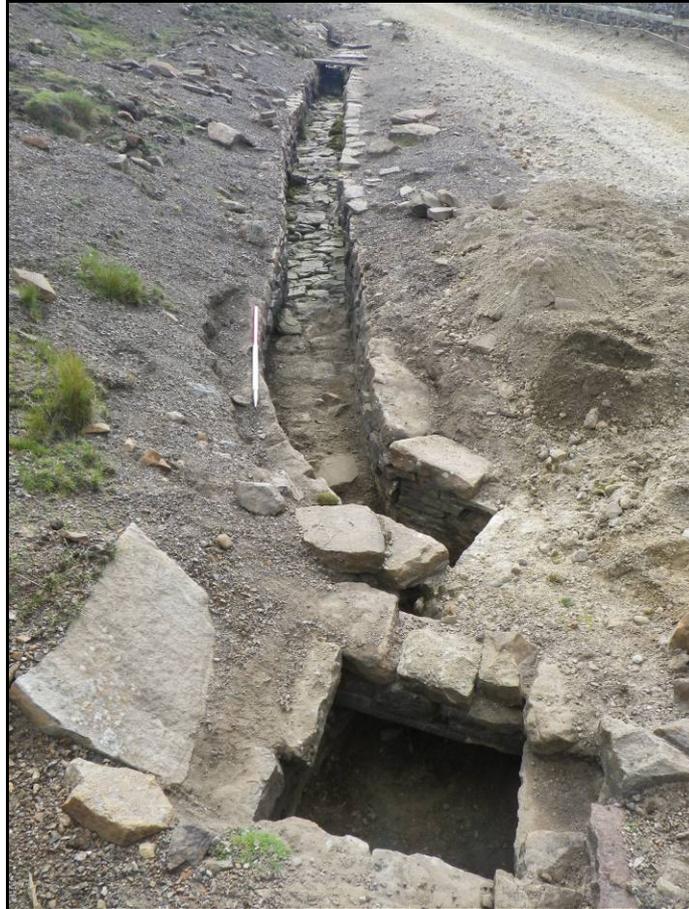
10.100 Trench 13 was located between the junctions of leats (2460) and (2620) at NY 78581 43176, Plate 34. It was investigated to examine the junction of these two leats and to clear a series of blockages causing water to pool at this point. The trench measured 9.00m by 0.75m and 0.55m deep and the location of this feature is shown in Figure 8.

*Plate 34: Trench 13 showing leats (2460) and (2620), facing southeast.*

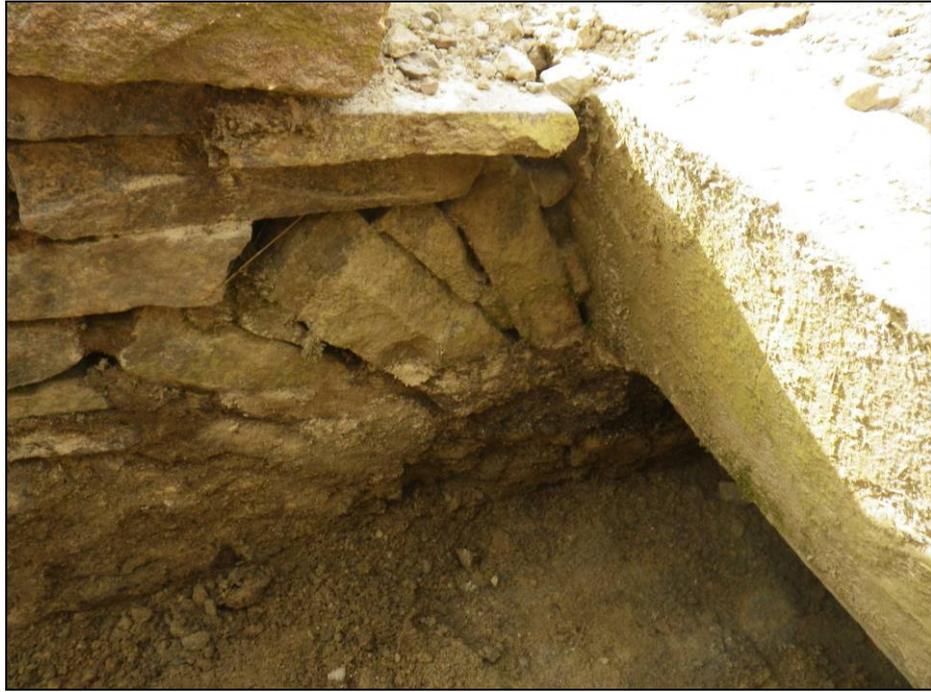
- 10.101 The trench was excavated to the top of the cobbled surface of leat (2460) and as far as practicably possible around the junction between (2460) and (2620). Due to the width of the leat it was not possible to clear the entire blockage. It was noted that leat (2620) is significantly blocked towards the southwest. A square inspection hatch was visible between the junctions of the two leats. The capstone for the inspection hatch had been removed and was allowing debris to fall into the leat. This stone was replaced to stop further material falling in.
- 10.102 Sections of arching within the leat were also investigated. It was not possible to fully excavate around each section of arching due to the width of the leat. It is assumed that the sections of arching represent the line of numerous leats which have been blocked up (Plate 35).

*Plate 35: Trench 13, facing south showing section of blocked arching.*

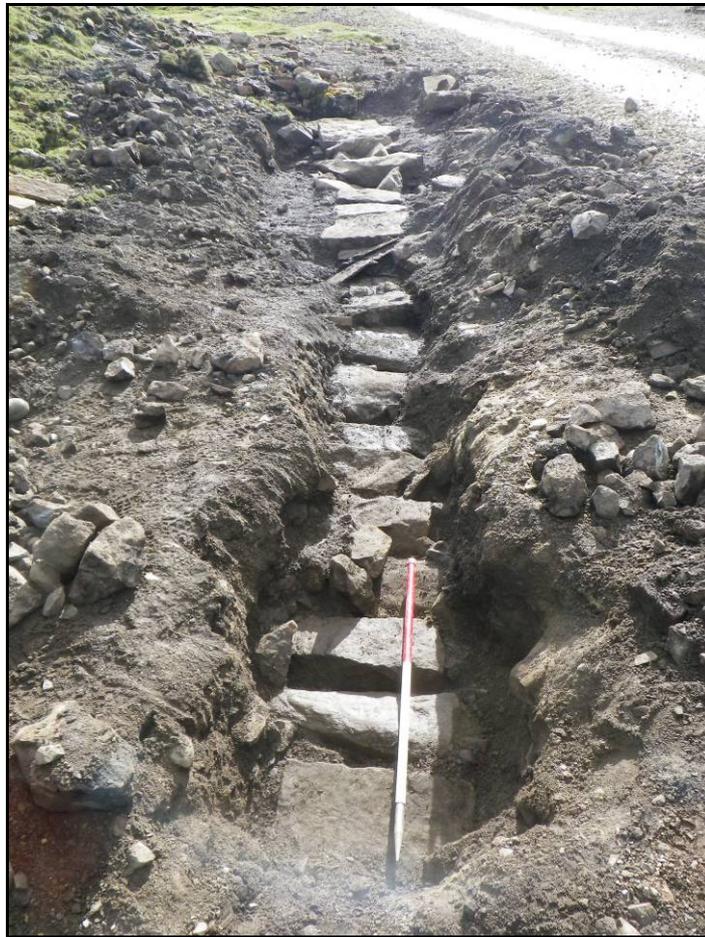
- 10.106 Trench 14 was dug across a section of leat (2460, Plate 37) at NY 78114 43125 to investigate a number of blockages. The trench measured 9.00m by 0.75m by 0.30m deep; the location of this feature is shown in Figure 8.

*Plate 37: Trench 14 showing leat (2460) facing southeast.*

- 10.107 The trench revealed a large section of *in situ* stone capping. A number of capping stones had cracked and fallen into the leat causing a blockage. This is possibly a result of quarry traffic, but is uncertain.
- 10.108 Sections of wooden planking can be seen directly underneath the stone capping that are not part of the wooden launder. These are thought to have been put in place in an attempt to stop water leaking into Smallcleugh level (*Jackson, pers com*).

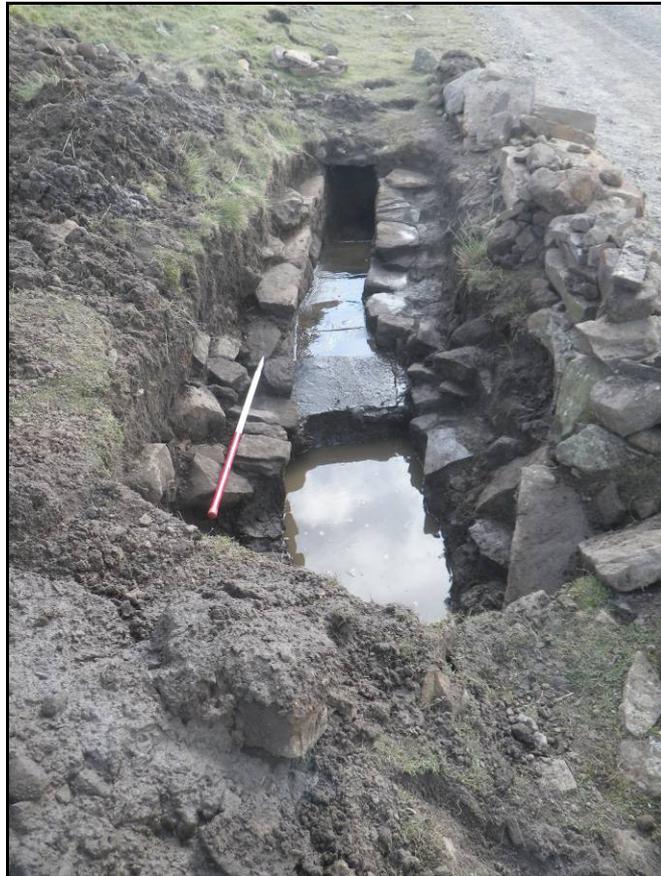
10.110 Trench 15 was excavated across a section of collapsed track side leat (**2460**, Plate 38). It was placed in this location to examine the cause of a significant blockage, and also to examine the structure of the leat. The trench measured 3.00m by 0.55m and 0.40m deep.

10.111 At the north-western end of the trench a modern pipe trench cuts the line of the leat at a right angle. The north-eastern wall, taken out by the pipe trench, has been partially rebuilt (this can be seen at the half metre mark on the ranging pole in Plate 38). However, the stone base was not re-established and was causing water to pool and wash out both sides of the leat. If left unattended this will cause the walls to collapse and block the leat further.

*Plate 38: Trench 15 showing leat (2460), facing southeast.*

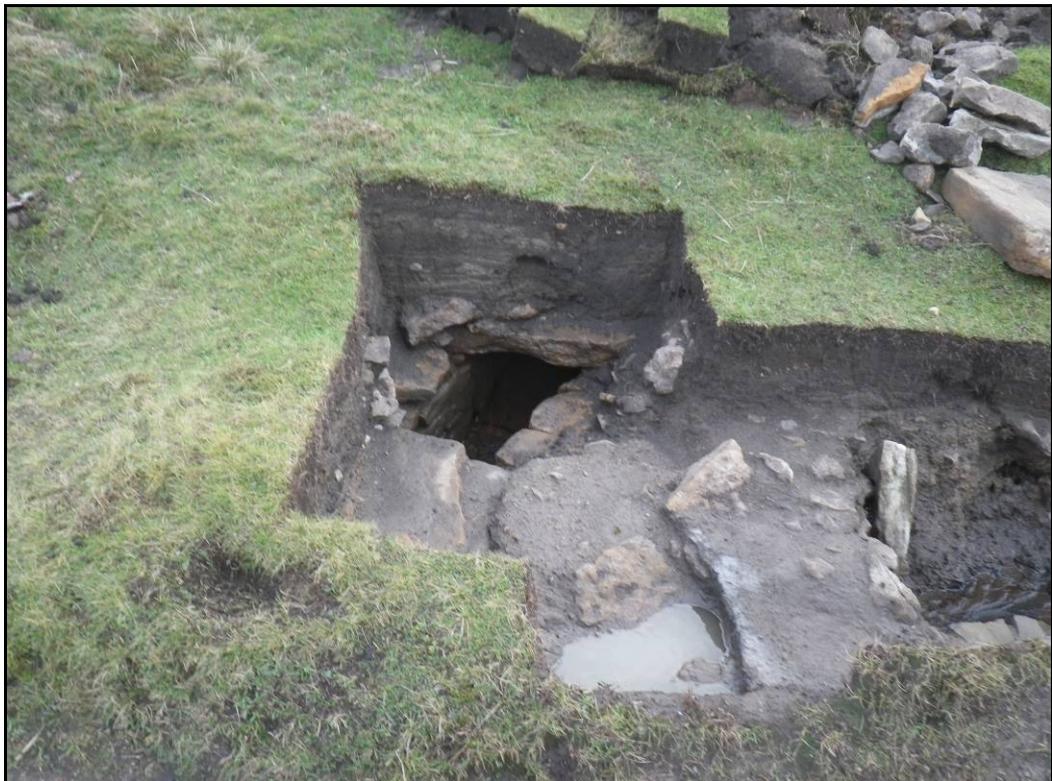
- 10.114 Trench 17 was located directly to the south of Handsome Mea and was placed to look at the junction between culvert (2580) feeding leat (2460) from Handsome Mea and the junction between (2460) where it turns into ditch (2616) and runs along the side of the track way.

*Plate 39: Trench 17 showing junction between culvert (2580) and leat (2460)*

- 10.115 Trench 17 was initially placed to investigate a boggy area of long grass where the line of leat (2460) was thought to have been. The trench revealed that leat (2460) is no longer a stone lined and capped leat past this point, but becomes a ditch. The trench was then extended to the northwest to find the junction between the ditch and the stone lined leat. No blockages were found down the length of the stone lined leat to the northwest, but a junction with the culvert from Handsome Mea (2580) was observed.

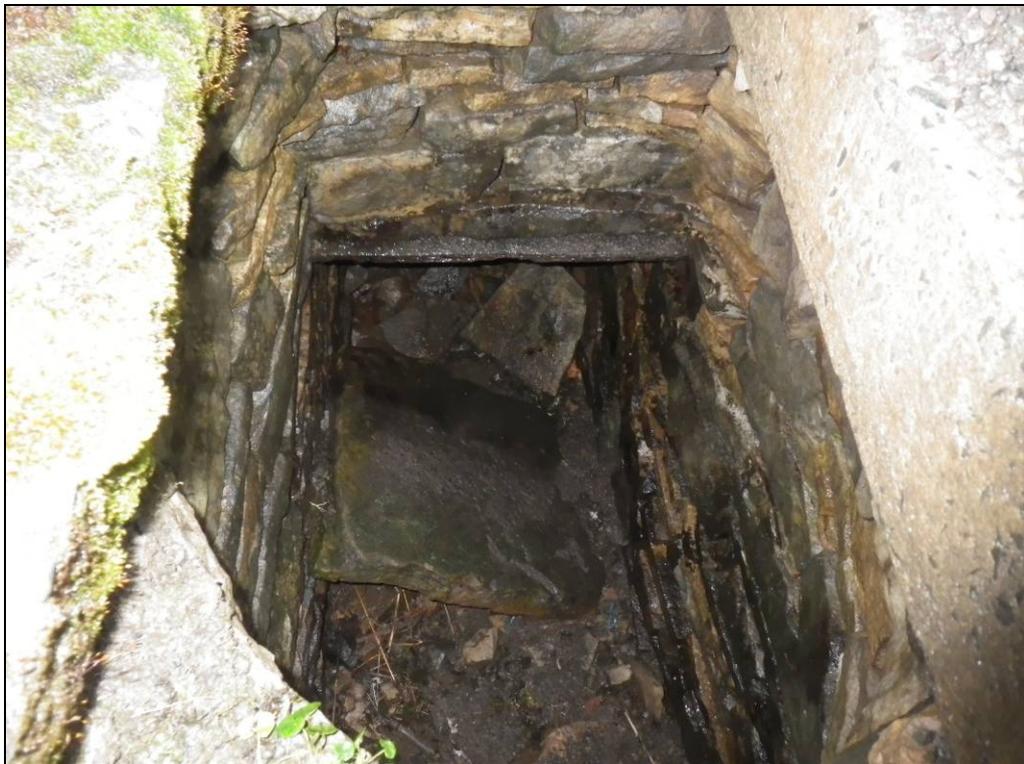
*Plate 40: Looking down into inspection hatch (2445).*

- 11.4 This inspection hatch (2445, Plate 40) is located roughly 60m to the northwest of modern timber launder (2573). Currently the inspection hatch is covered by railway sleepers and has been cordoned off as it has been previously misidentified as a mineshaft due to the circular outer profile. Closer inspection of the hatch was not possible during the survey.

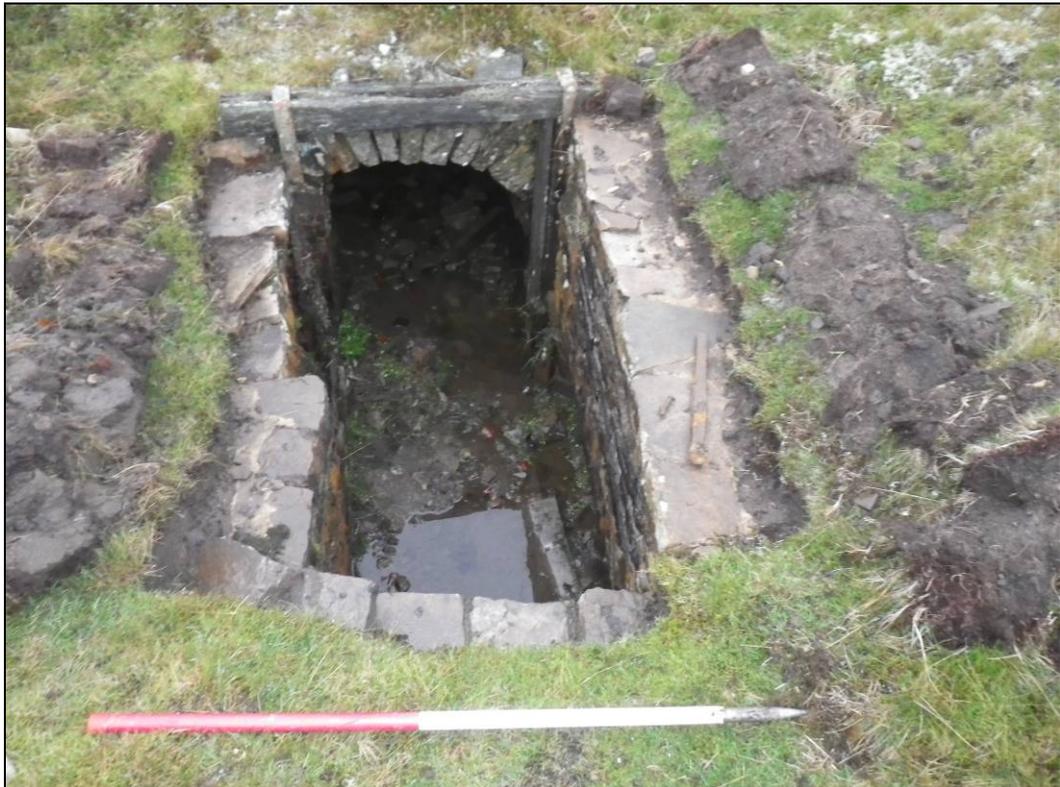
- 11.5 Sluice gate (2628, Plate 41) is located at NY 78538 43365 and is described by the RCHME as 'a timber frame for a sluice gate at the junction of numerous channels with an overflow that leads downhill to the southwest' (RCHME 1993). It is further described as being formed by two grooved posts connected to a horizontal cross timber by iron straps. The frame is 1.2m high and is well preserved (BHWB 1995).
- 11.6 Sluice gate (2628) controls the flow of water through culvert (2575) and diverts it through a modern pipe (2525).

Plate 41: Sluice gate (2628) with pipe (2525) entering the sluice to the left of the image.

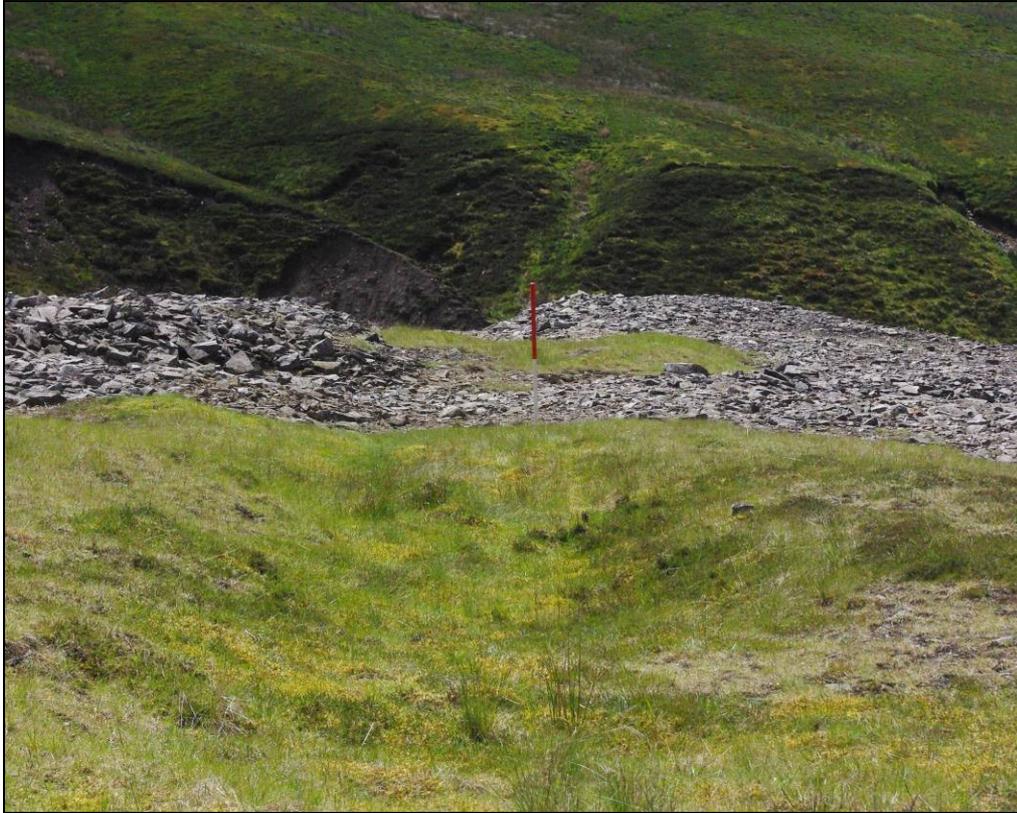
- 11.7 Pipeline (2525, Plates 41 and 42) appears in the side of sluice gate (2628) and runs to the southwest for roughly 90m where the line of it is lost beneath the rubble of the smelt mill flue. The line of pipe

(2525) to the north can be traced as far as Rampgill Burn where it then becomes unclear. It is possible that the pipe originates further to the north around reservoir (0599), used for hushing at Longcleugh, but this is uncertain.

Plate 42: Pipeline (2525) headed down towards the smelt mill area.

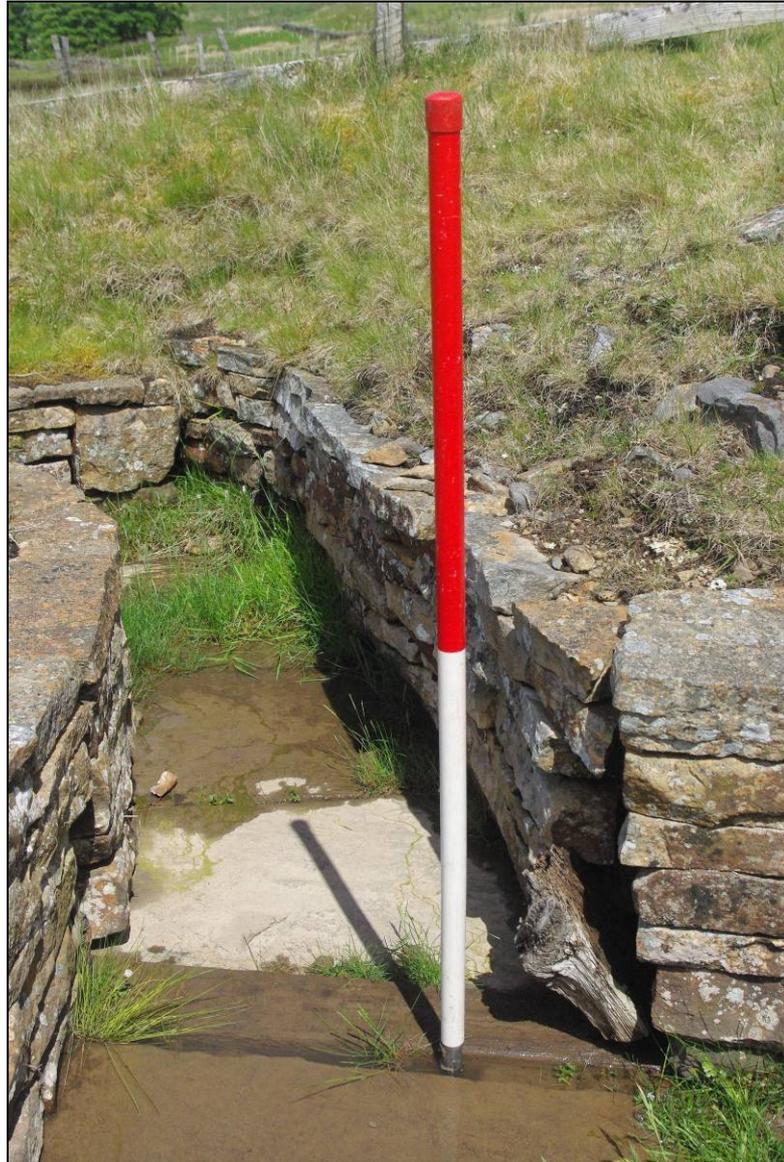
- 11.11 Sluice gate (2628, Plate 44) appears at the junction between leat (2572) and culvert (2575). The sluice gates purpose was to divert water away from the wooden launder, which fed the wheel pit, and take water down leat (2572), bypassing the wheel altogether. Currently the sluice gate only exists as a small channel which would have held the gate in place with the remnants of a wooden post to one side.

*Plate 44: Sluice gate (2629) with the start of leat (2572) at the top of the image.*

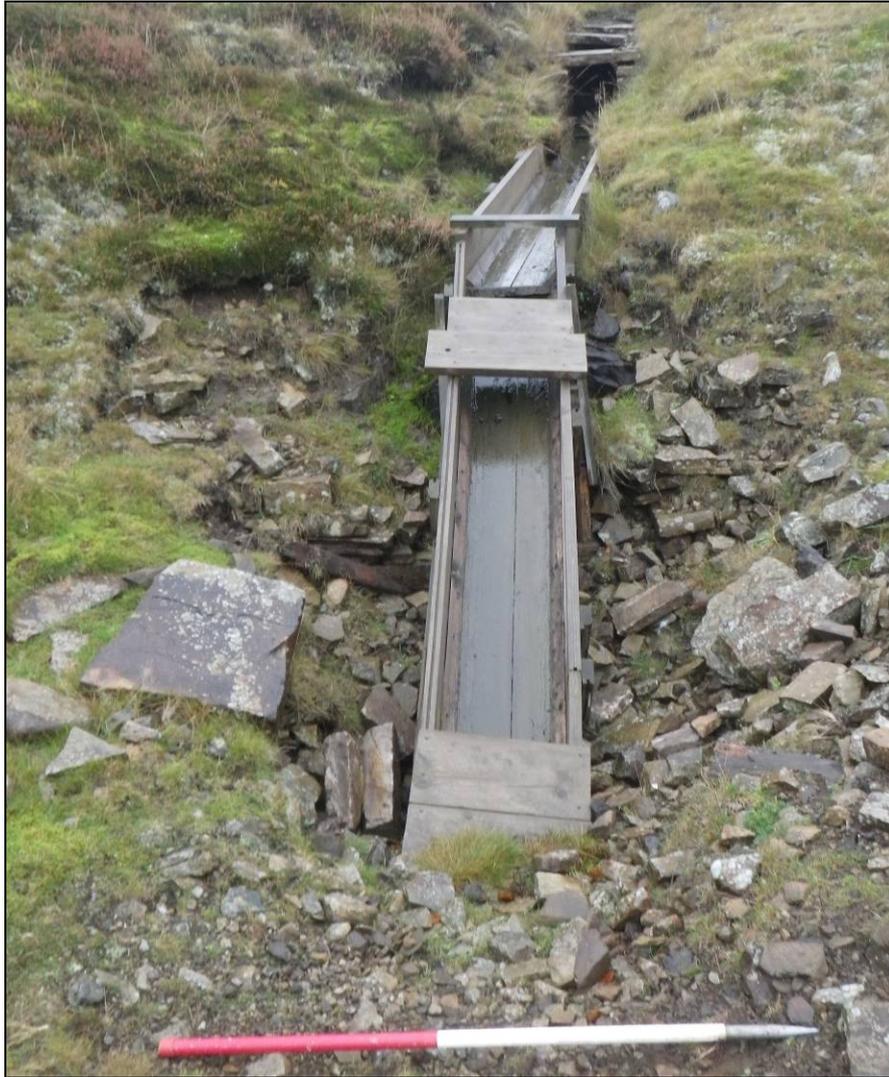
- 11.12 Leat (2572, Plate 45) is located at NY 78468 43369 and is made up of roughly coursed stone with a stone slab base and roof. It heads to the west and down into a timber frame and into wheel pit at its base. The leat enters the wheel pit at the base, meaning that it was likely constructed as an overflow system as it entered the wheel pit too low to power the wheel.

*Plate 45: Exit of leat (2572) into Stagg wheel pit.*

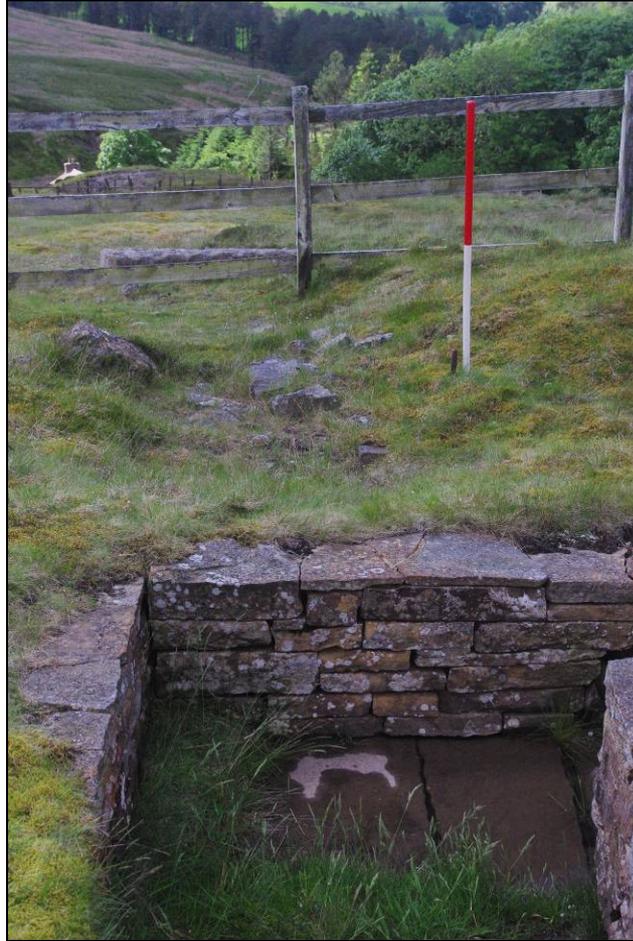
- 11.13 Launder base (2630, Plate 46) is located to the west of sluice gate (2629) and consists of one large stone slab. This would have been used to support a wooden launder carrying water to the west to power the Stagg wheel pit.

Plate 46: Launder base (2630) behind fence with sluice gate (2629) to the right of the image.

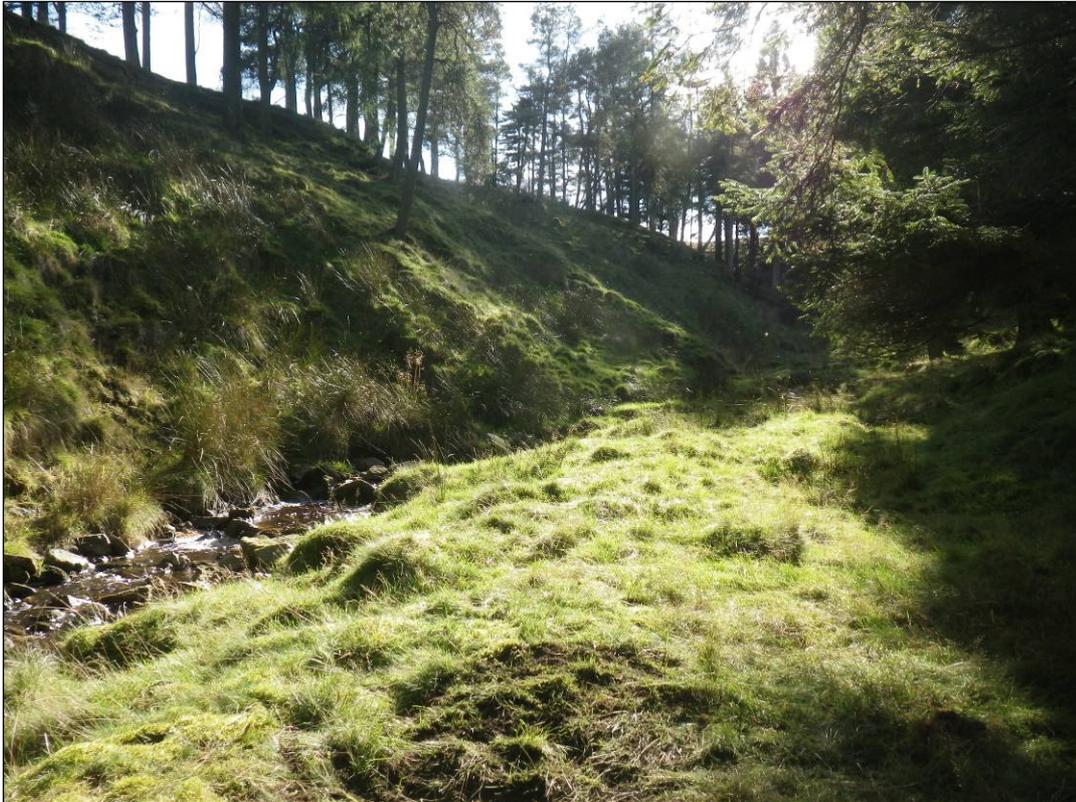
- 12.5 This feature lies outside the boundaries of previous surveys conducted by the LUEAU and RCHME (BHWB 1995). The vicinity of this area is discussed briefly in BHWB however no fragmentary dam or features of a similar nature were identified during the previous survey.
- 12.6 The survey identified a small flat area adjacent to Dowgang Burn likely to house a fragmentary dam. A series of linear mounds were observed at right angles to each other and are thought to represent

walls of a structure (BHWB 1995).

*Plate 48: Remains of fragmentary dam (2625).*

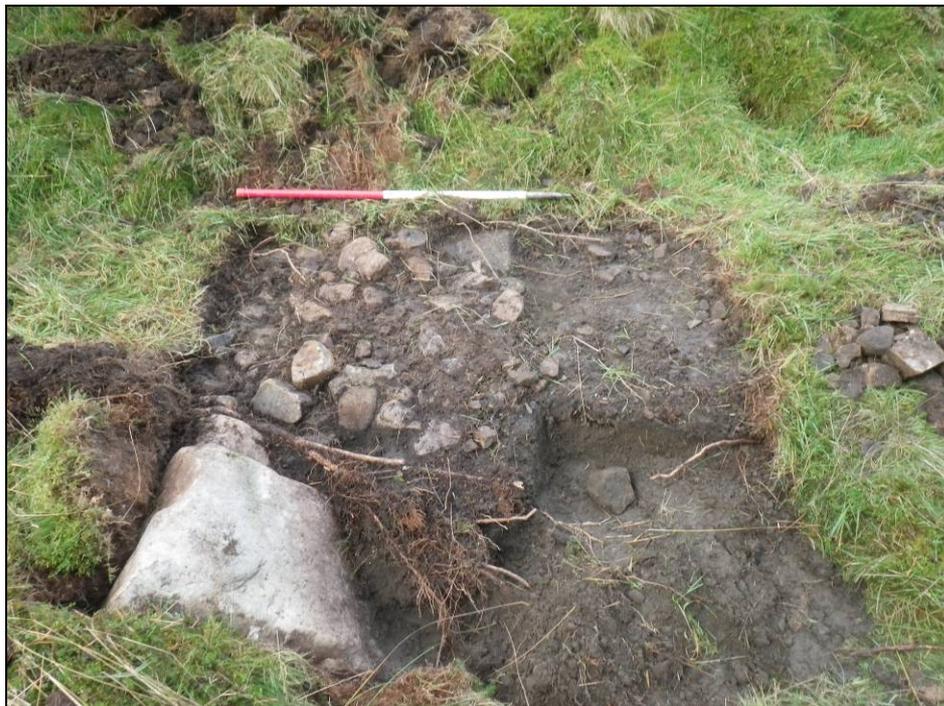
- 12.19 Trench 21, Plate 49, picked up the remains of a possible track way (2631) at a depth of 0.05m. The feature consisted of a flat area of metalled stones running broadly parallel to the existing boundary wall. The full extent of the possible track way was not established during the trenching phase, but it is likely that it does not extend further towards the burn at this location.

*Plate 49: Trench 21 showing part of working surface (2631)*

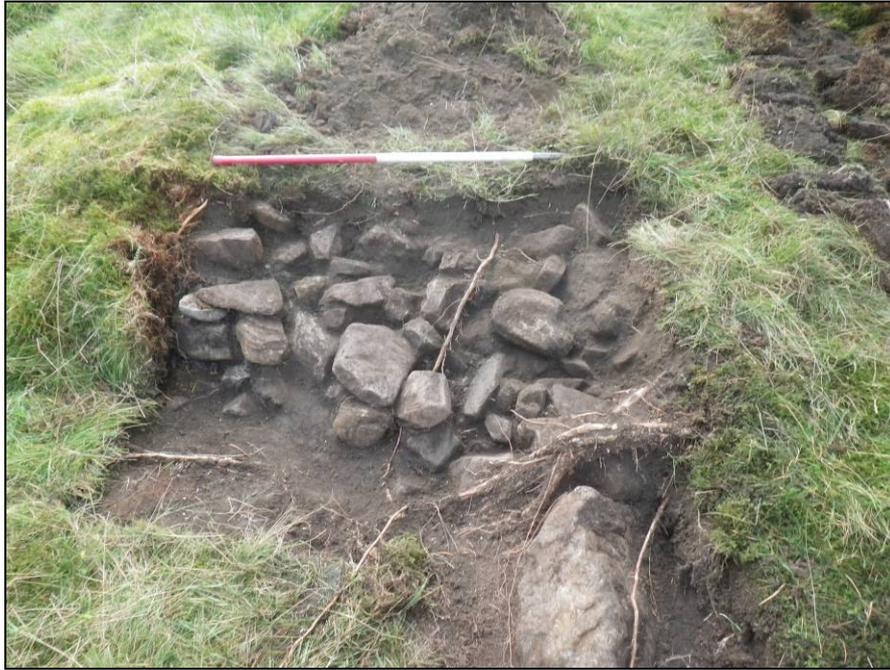
- 12.20 The remaining four trenches were placed on a patch of land adjacent to Dowgang Burn thought to be the location of a fragmentary dam related to the hushing activity in the area. Trenches 22-25 were unable to pick up any trace of a dam within them. The line of a possible wall was picked up in Trenches 22 and 23 however, this is inconclusive.

*Plate 50: Trench 22 showing possible wall facing southwest*

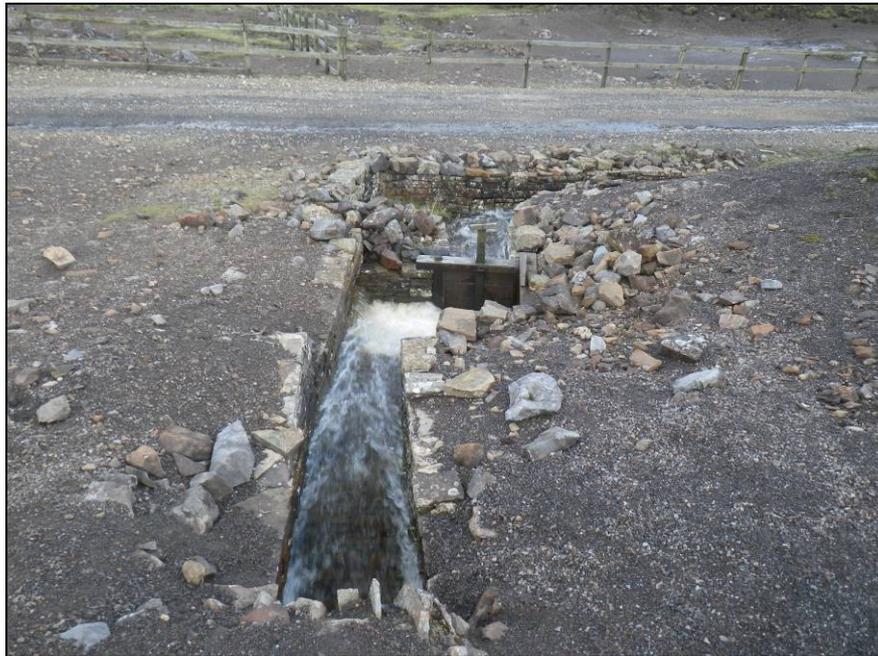
- 14.9 Once water exits culvert (**2462**) it enters into an area of sluice gates. The current set up of these sluice gates (Plates 51 and 52) allows water to travel down culvert (**2462**) where it turns to northwest (Plate 53) and disappears underground and emerges at culvert (**2609**).

*Plate 51: Water flowing from culvert (**2462**) to series of sluice gates and changing course to the northwest.*
