ALTOGETHER ARCHAEOLOGY  
MODULE 9-D REPORT

**NENTHEAD LEAD MINES,  
NENTHEAD, CUMBRIA**

NENTHEAD LEAD MINES, NENTHEAD, CUMBRIA  
COMMUNITY ARCHAEOLOGY PROJECT

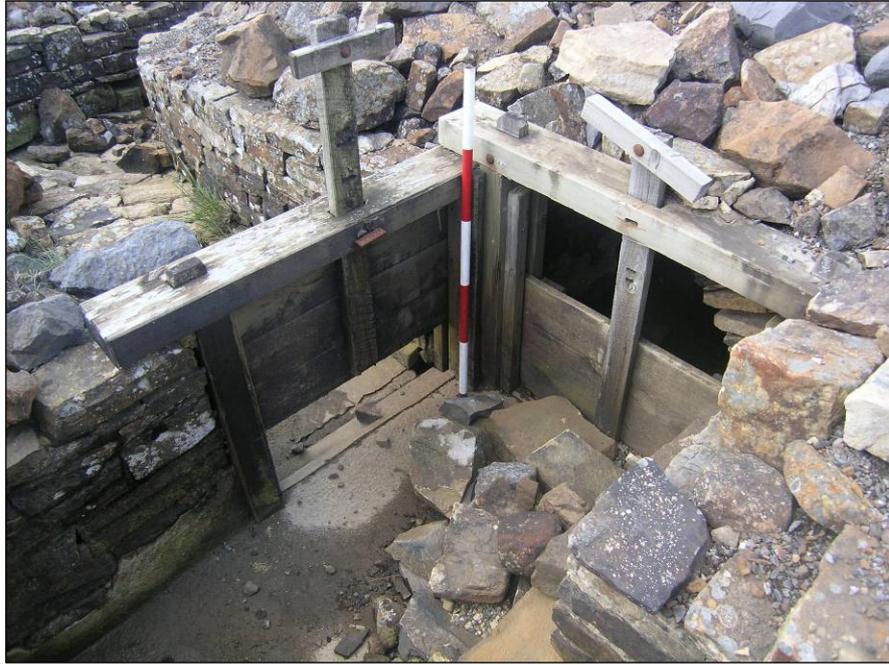
*Plate 52: Sluice gates controlling flow of water from culvert (2462).*

14.10 It is recommended that the setup of the sluice gates shown in Plate 52 is swapped. This would divert water away from culvert (2462) and across the modern launder that carries water into culvert (2575). A summary of all of the recommendations for this feature are listed below.

- Swap setup of sluice gates to divert water into Stagg Condenser wheel pit (Plate 52).
- Examine flow of water from sluice gate (2619) to inspection hatch at (2445) across modern launder.
- General clearance of culvert (2462) between trackside leat (2460) and culvert (2440) to the northeast.
- The section of culvert (2462), particularly around pipeline (2442), is fragmentary and it is recommended further targeted clearance is carried out along this long stretch also.

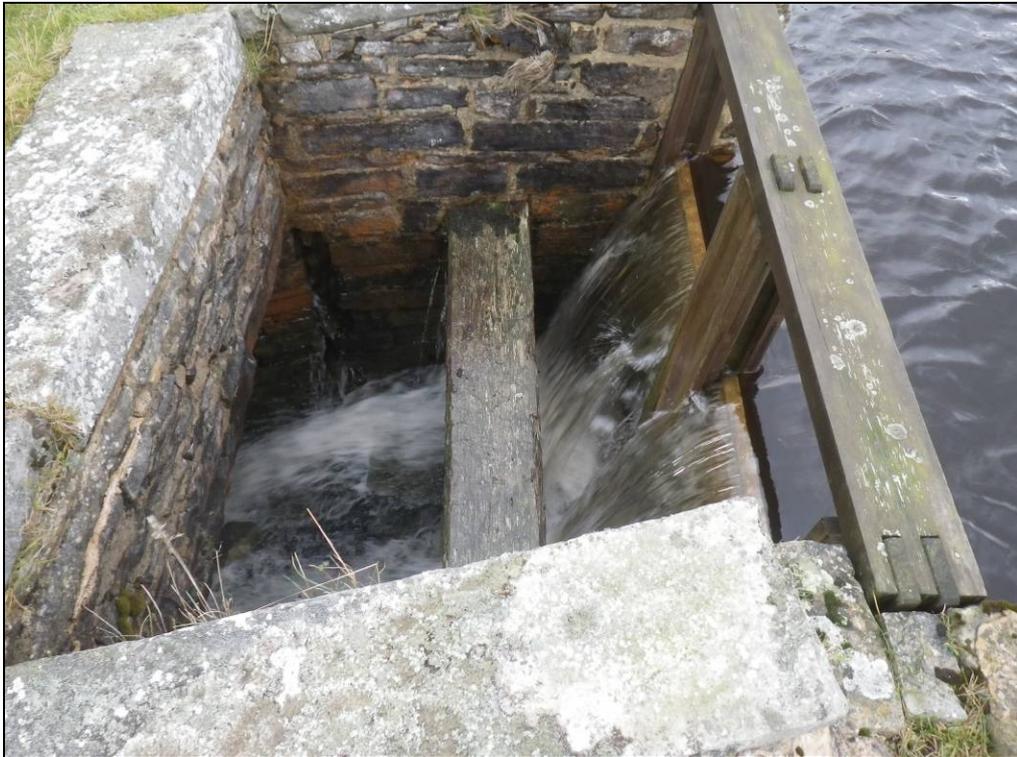
- 14.23 Culvert (2440) only stretches for a short distance between overflow leat (0032) and culvert (2439). The structure itself is mainly sound except for the junction between culvert (2439). A large collapse of culvert (2440) has fallen into culvert (2439), which has caused a substantial blockage to the overflow of the reservoir.
- 14.24 To the east, sluice gate (2578, Plates 55 and 56) controls water from the reservoir into culvert (2439) and prevents the reservoir from draining into the trackside leat. During heavy amounts of rainfall the reservoir quickly fills up and water can often flow over the top of the sluice gate and down into (2439).

*Plate 55: Sluice gate (2578) after a heavy period of rain. Note wooden sluice is in the down position.*

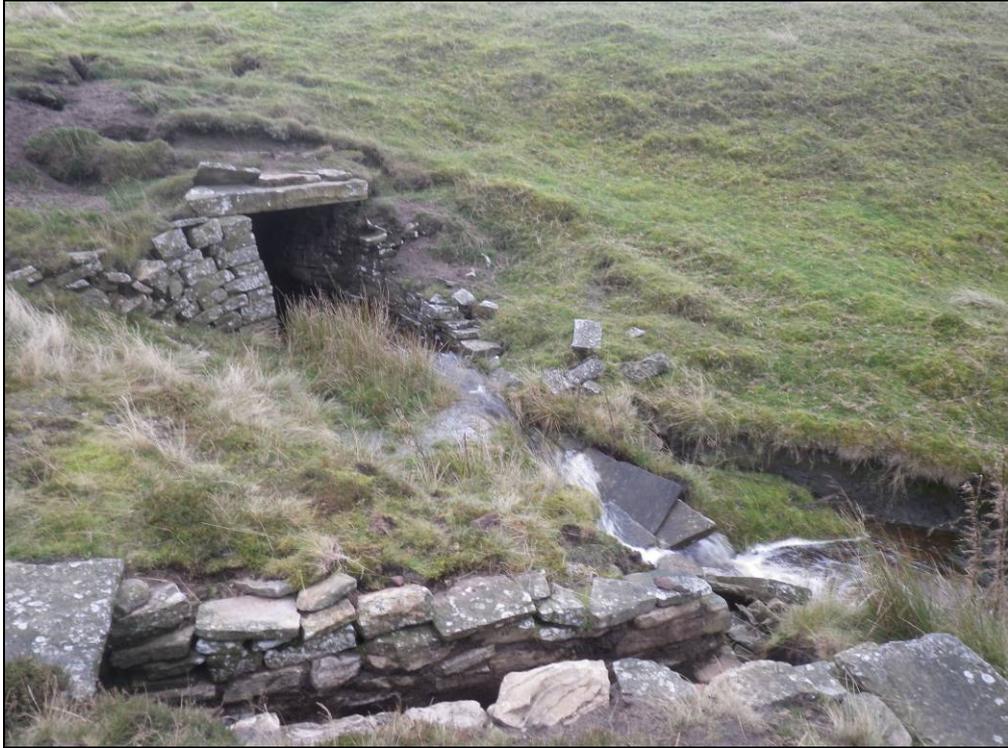
*Plate 56: Water from sluice (2578) flowing through the junction between culvert (2440) and culvert (2439).*

- 14.25 As a result, water from sluice (2578) washes over the collapsed section of culvert (2440) further eroding the bank. If left unattended this will cause culvert (2440) to collapse further and create a significant blockage. A summary of the recommendations for this feature are listed below.
- Clear substantial amounts of debris and rubble out of overflow from Handsome Mea. This will probably have to be done by machine.
  - Rebuild retaining walls.

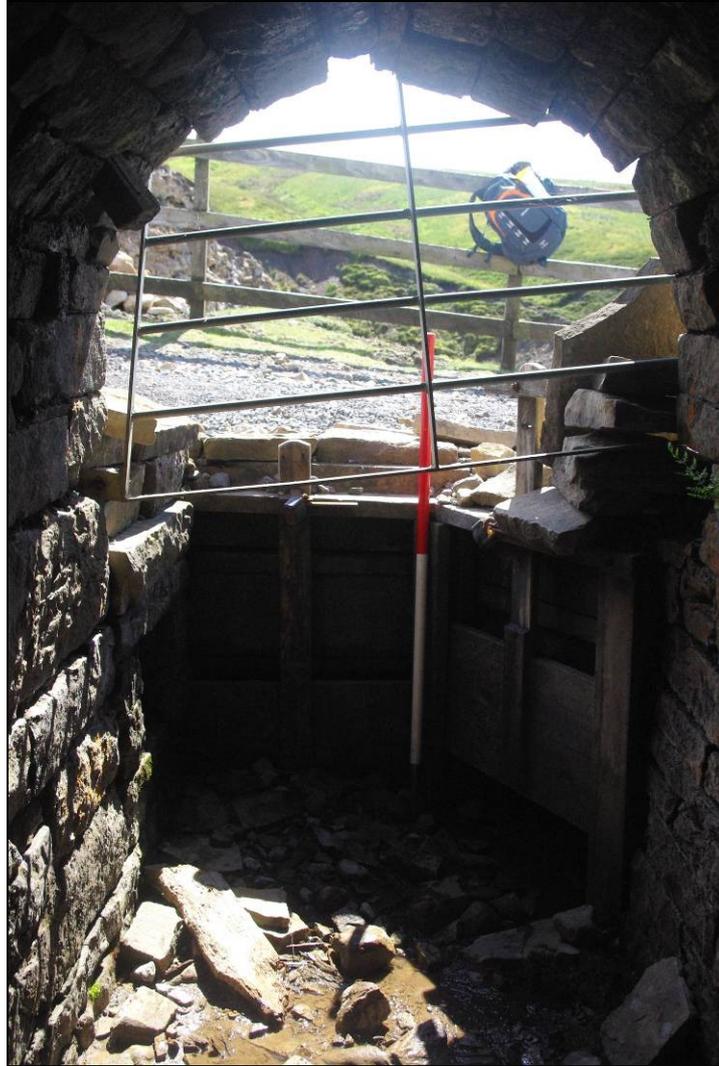
- 14.28 Once water enters (2575) it then makes its way towards the Stagg Wheel Pit through sluices (2628) and (2629) and into leat (2572). Water from leat (2572) flows into the bottom of the wheel pit through tailrace culvert (2577) and connects to (2576) junction at the south end.

*Plate 57: Junction from tailrace culvert (2577) to launder for smelt mill complex.*

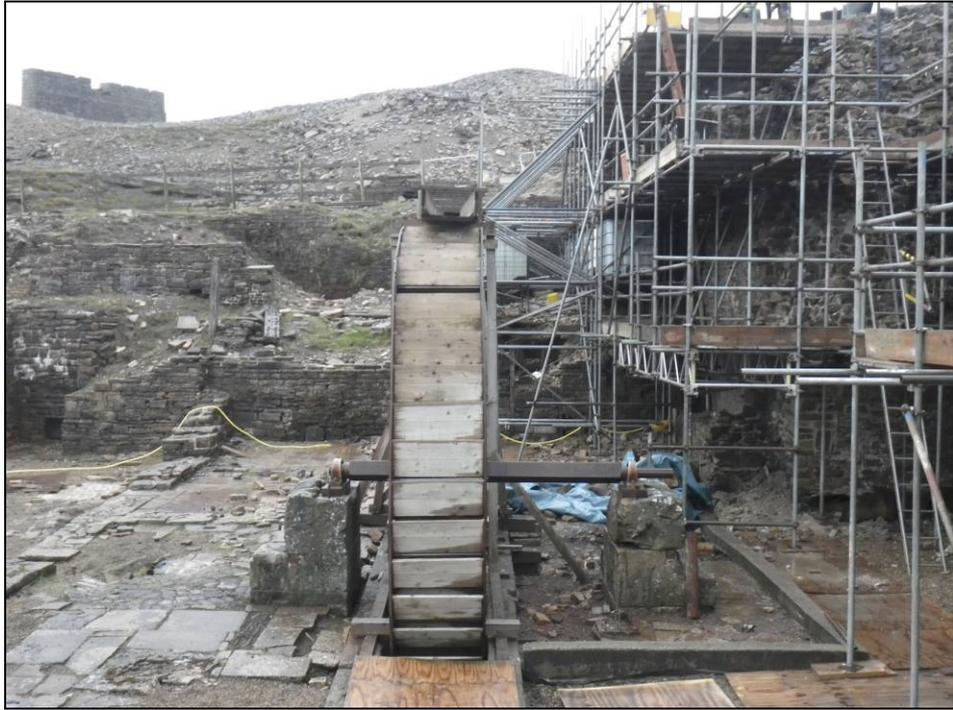
- 14.29 At this point the water from the Stagg Wheel Pit has three potential outlets. The first runs directly over the launder (2576) feeding the Smelt Mill (Plates 57 and 58), down the smelt mill wheel pit and through into the natural watercourse exiting from conduit sluice (2604) (Plate 59). If this course was taken extreme care would need to be taken so that water coming through the smelt mill is not causing issues elsewhere within the complex.

*Plate 58: Launder running from (2576) into Smelt Mill wheel pit.*

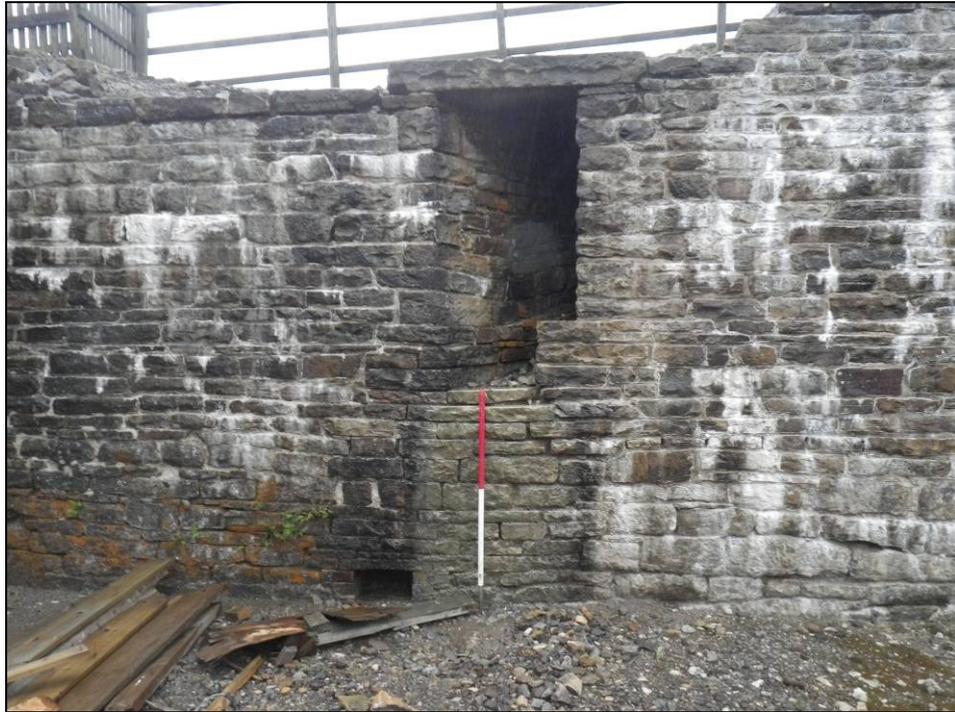
14.30 The second potential outlet runs northwest from (2576) along (2623) and out of a large opening (2624) (Plate 60) directly adjacent to the Assay House. Of the three potential courses for water from

the wheel pit to flow this is the least desirable. This would cause a large amount of water to pool inside of the smelt mill complex and adjacent to the assay house, causing damage to both structures.

*Plate 60: Exit (2624) adjacent to Assay House.*

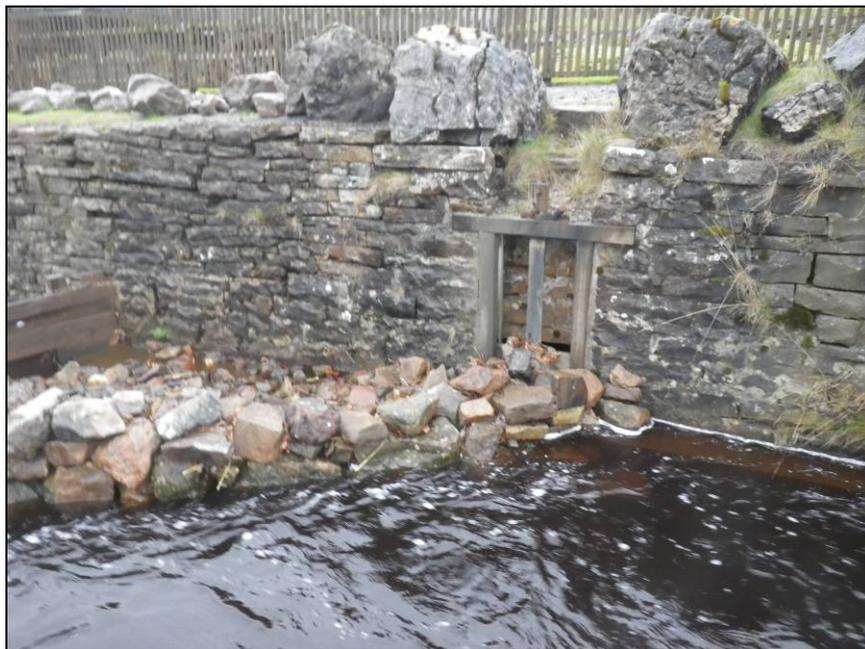
- 14.31 The third, and most preferable, outlet for water coming off the Stagg wheel pit is directly along leat (2623) avoiding outlet (2624) and out of exit (2603) (Plate 61). This would eliminate any potential danger to the smelt mill complex. Further work would need to be done around the pathway junction to ascertain the flow of (2623) as it is not currently clear how the two join.

*Plate 61: Exit (2603) alongside track way.*

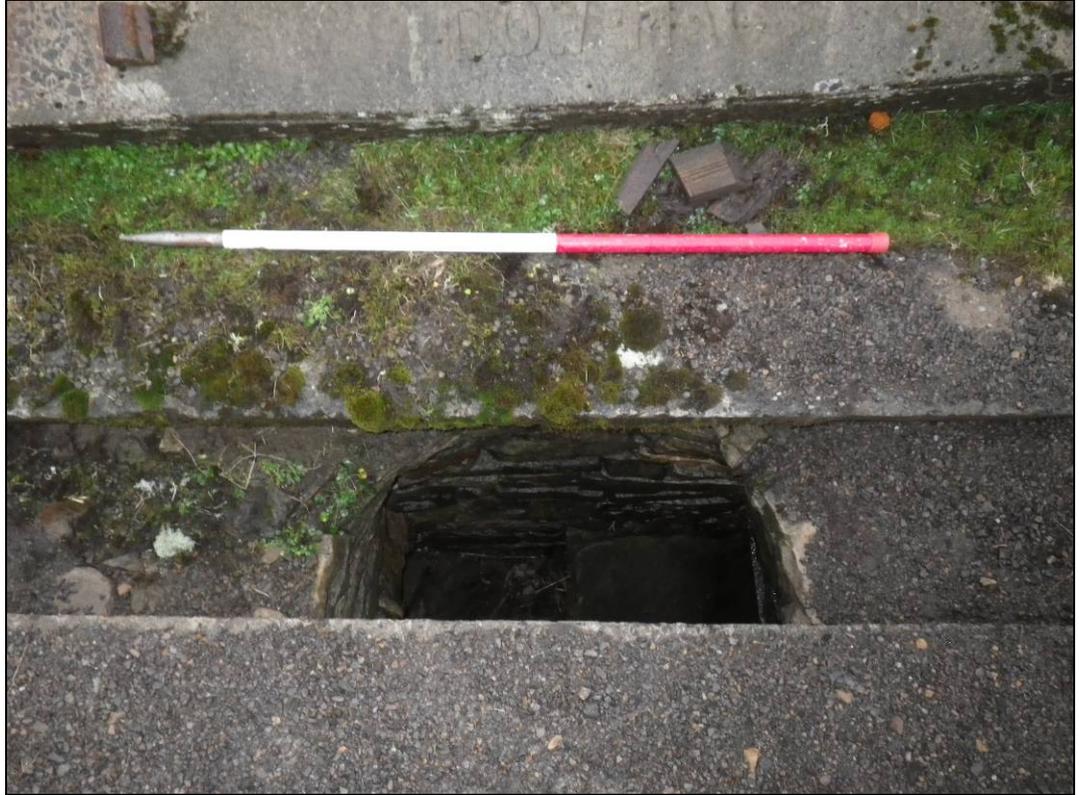
- 14.34 Previously, feature (2445, Plate 63) was recorded as a mineshaft due to the profile of the earthwork mound around the outside (BHWB 1995). Further investigation during the survey, revealed that feature (2445) is in fact an inspection hatch for culvert (2575).

*Plate 63: Railway sleeper removed at (2445) to reveal inspection hatch for (2575).*

- 14.35 It is recommended that water directly to the west of (2445) that is flowing freely down the modern track is diverted into the inspection hatch (2445). This could be achieved by blocking the flow of the track runoff heading south and digging a channel into (2445) on its western side. Water would then flow into leat (2575) and into the series of leats within Area 10 and down towards the wheel pit.
- Clear debris inside inspection hatch.
  - Block flow of roadside gully causing flooding in the smelt mill complex.
  - Excavate channel through to the side of inspection hatch (2445) which will take existing flow into leat (2575)
  - Install a grate or mesh on top of inspection hatch (2445) to prevent injury and accumulation of debris.
